HH-43B
AIRCRAFT ACCIDENT

SUBJ: H-43 ACCIDENT

HISTORY OF FLIGHT

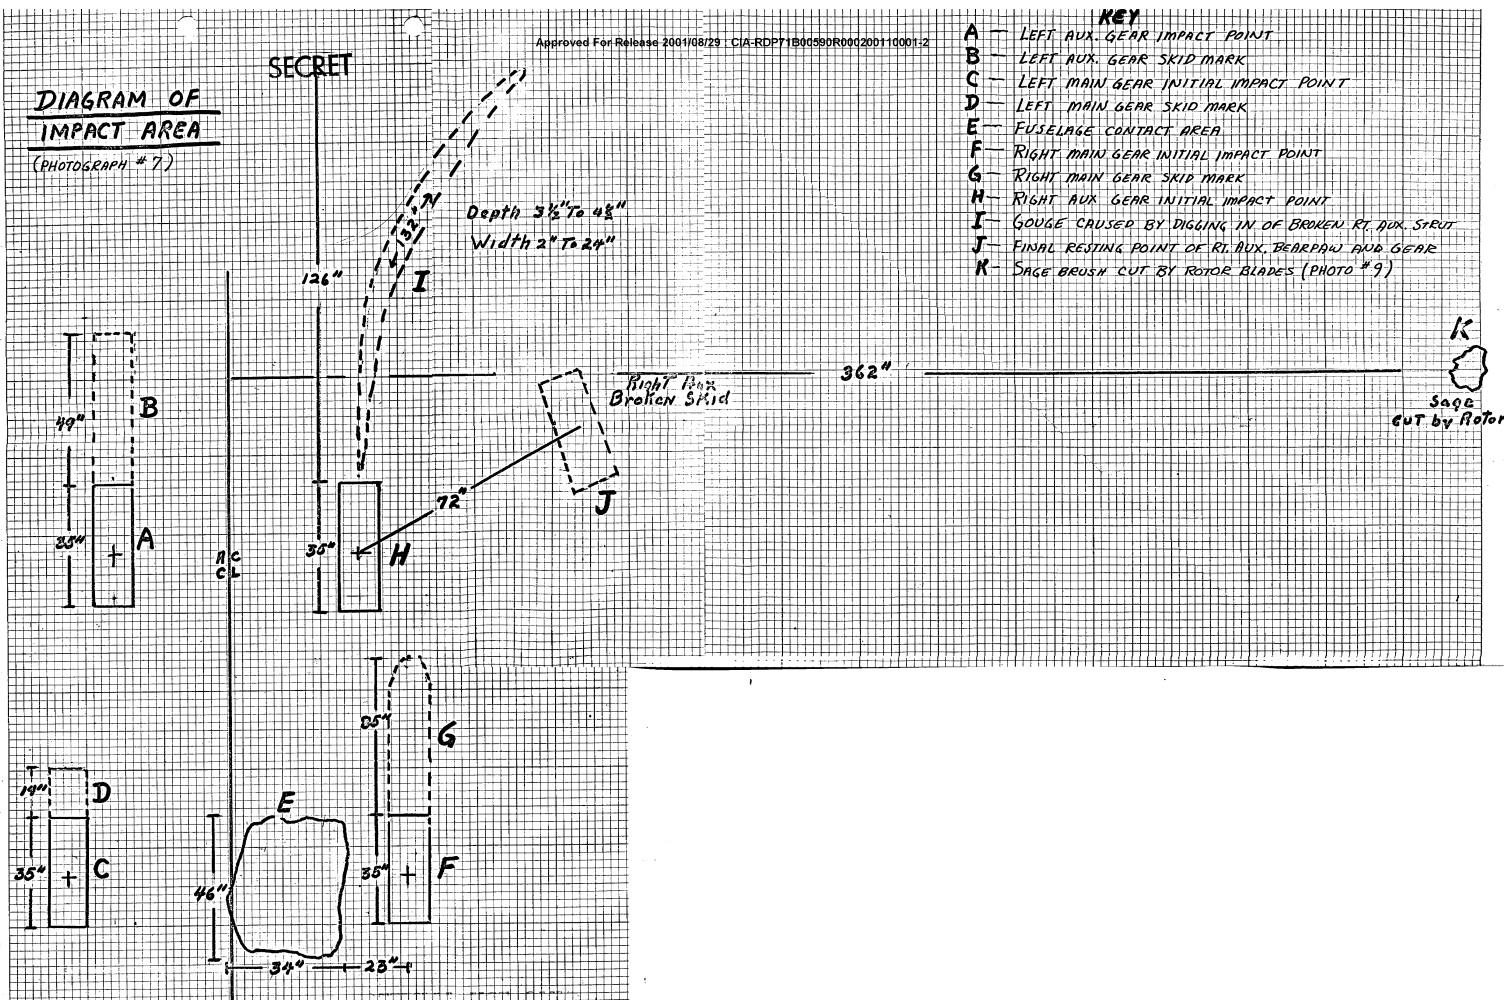
(PHOTOGRAPH # 7)

- A - LEFT AUX. GEAR IMPACT POINT
- B - LEFT AUX. GEAR SKID MARK
- C - LEFT MAIN GEAR INITIAL IMPACT POINT
- D - LEFT MAIN GEAR SKID MARK
- E - FUSELAGE CONTACT AREA
- F - RIGHT MAIN GEAR INITIAL IMPACT POINT
- G - RIGHT MAIN GEAR SKID MARK
- H - RIGHT AUX. GEAR INITIAL IMPACT POINT
- I - GOUGE CAUSED BY DIGGING IN OF BROKEN RT. AUX. STRUT
- J - FINAL RESTING POINT OF RT. AUX. BEARPAW AND GEAR
- K - SAGE BRUSH CUT BY ROTOR BLADES (PHOTO # 9)

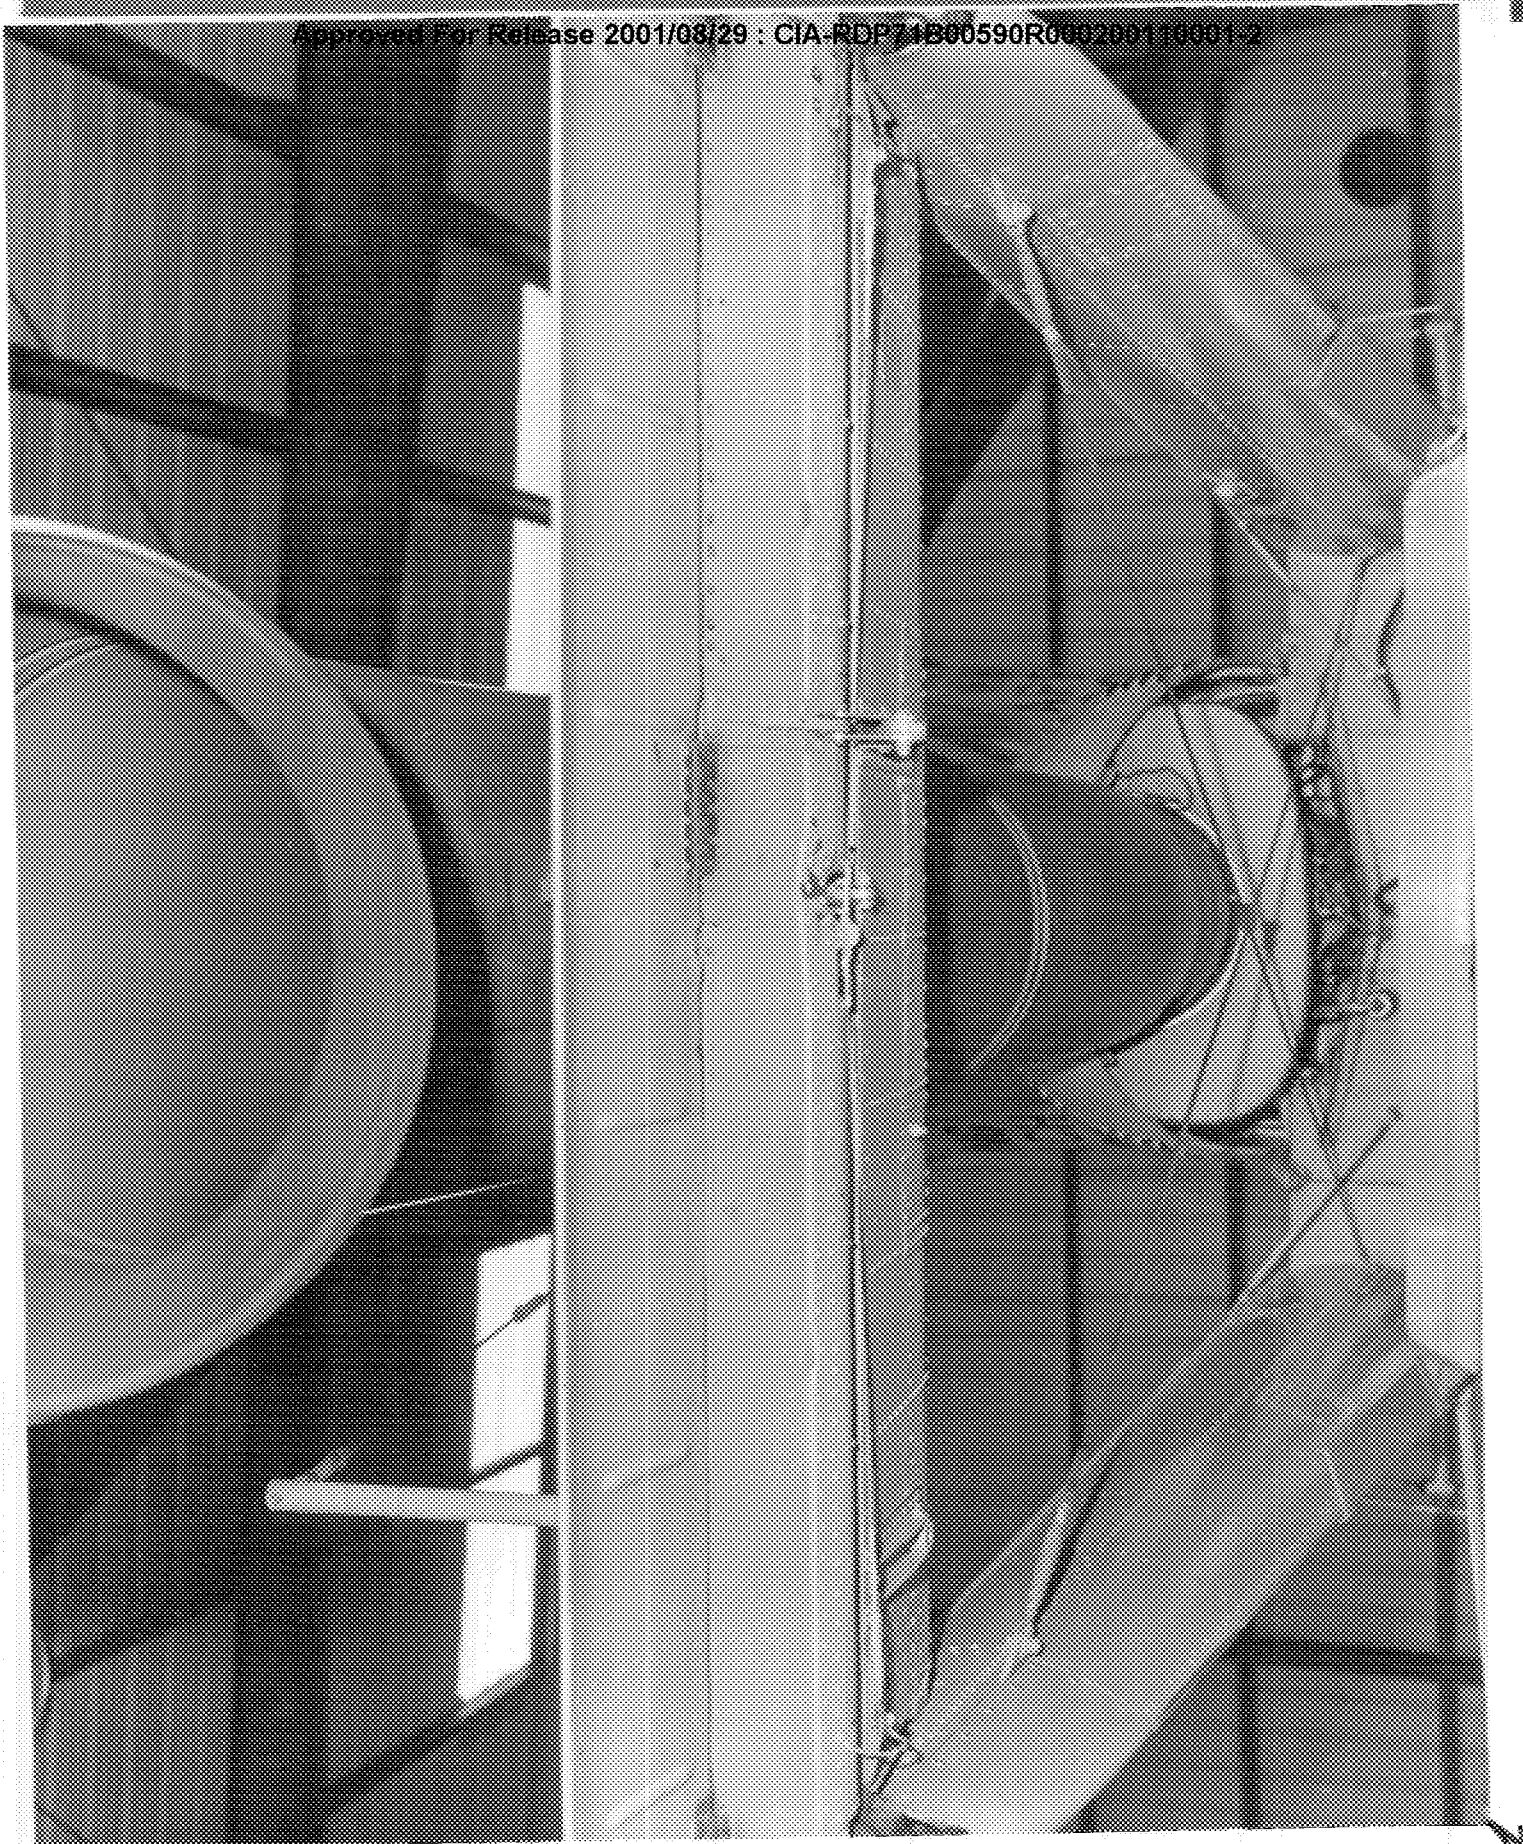
1. HORIZONTAL STABILIZER DAMAGE
2. AFT CABIN, BOTTOM OF FUSELAGE, AND RIGHT MAIN GEAR DAMAGE
3. LEFT AUXILIARY GEAR DAMAGE
4. LEFT MAIN GEAR DAMAGE
5. RIGHT AUXILIARY GEAR DAMAGE
6. RIGHT MAIN GEAR DAMAGE
7. IMPACT AREA, DIRECTION OF TRAVEL RIGHT TO LEFT
8. CLOSE UP OF RIGHT AUXILIARY GEAR IMPACT AREA. GOUGE ON LEFT SIDE IS WHERE THE BROKEN STRUT DUG INTO THE GROUND.
9. SAGEBRUSH CUT OFF BY ROTOR BLADES DURING RECOVERY. MATCHBOOK COVER INDICATES RELATIVE SIZE.

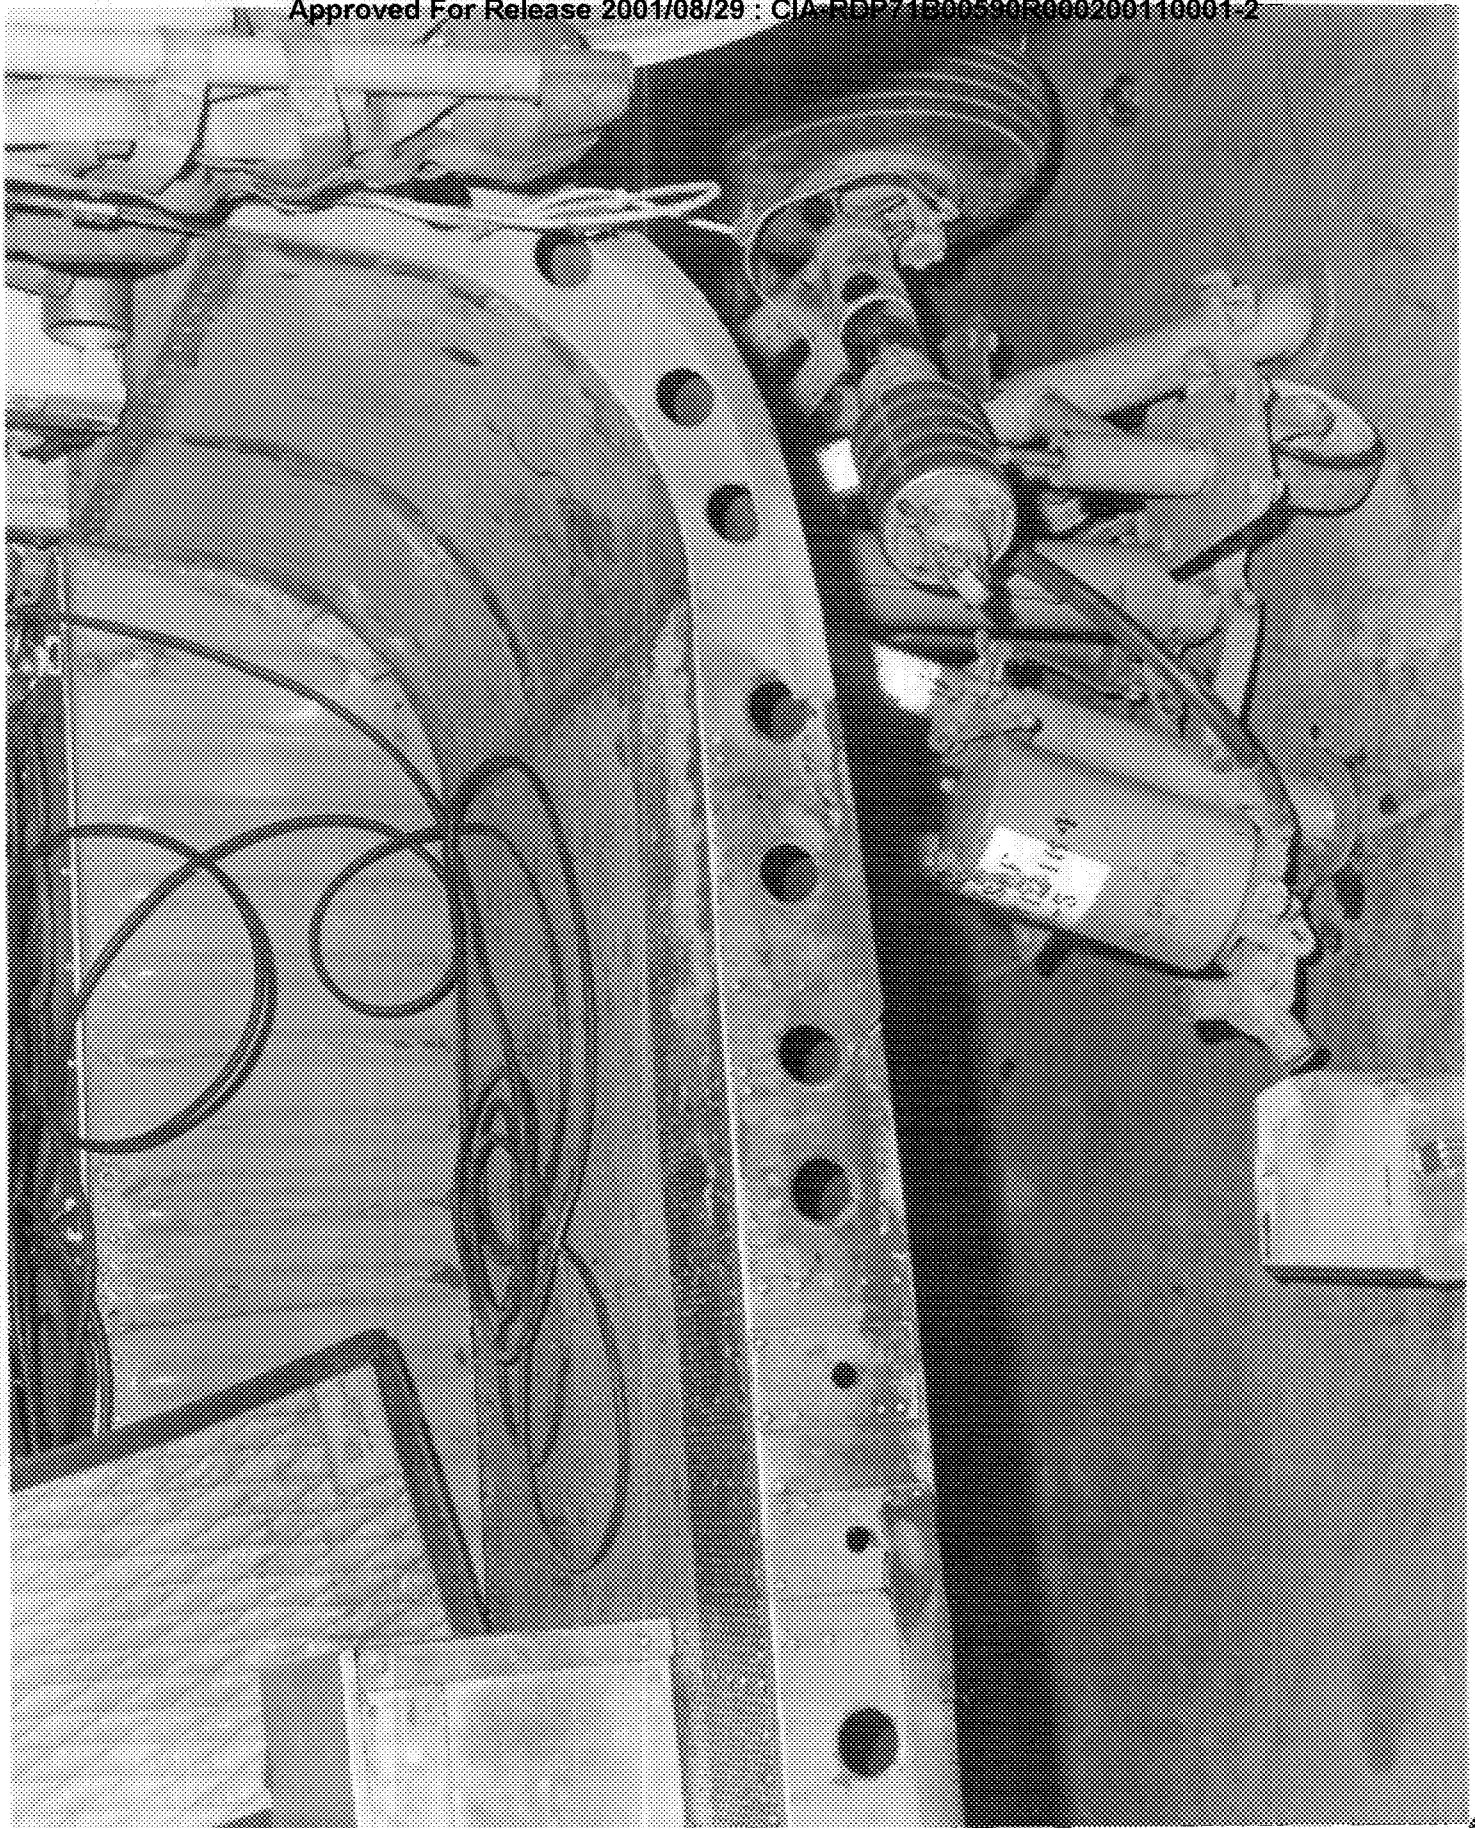
Bottom aft right hand skin and stringers badly dented, scraped and broken aft of fuel sump area.

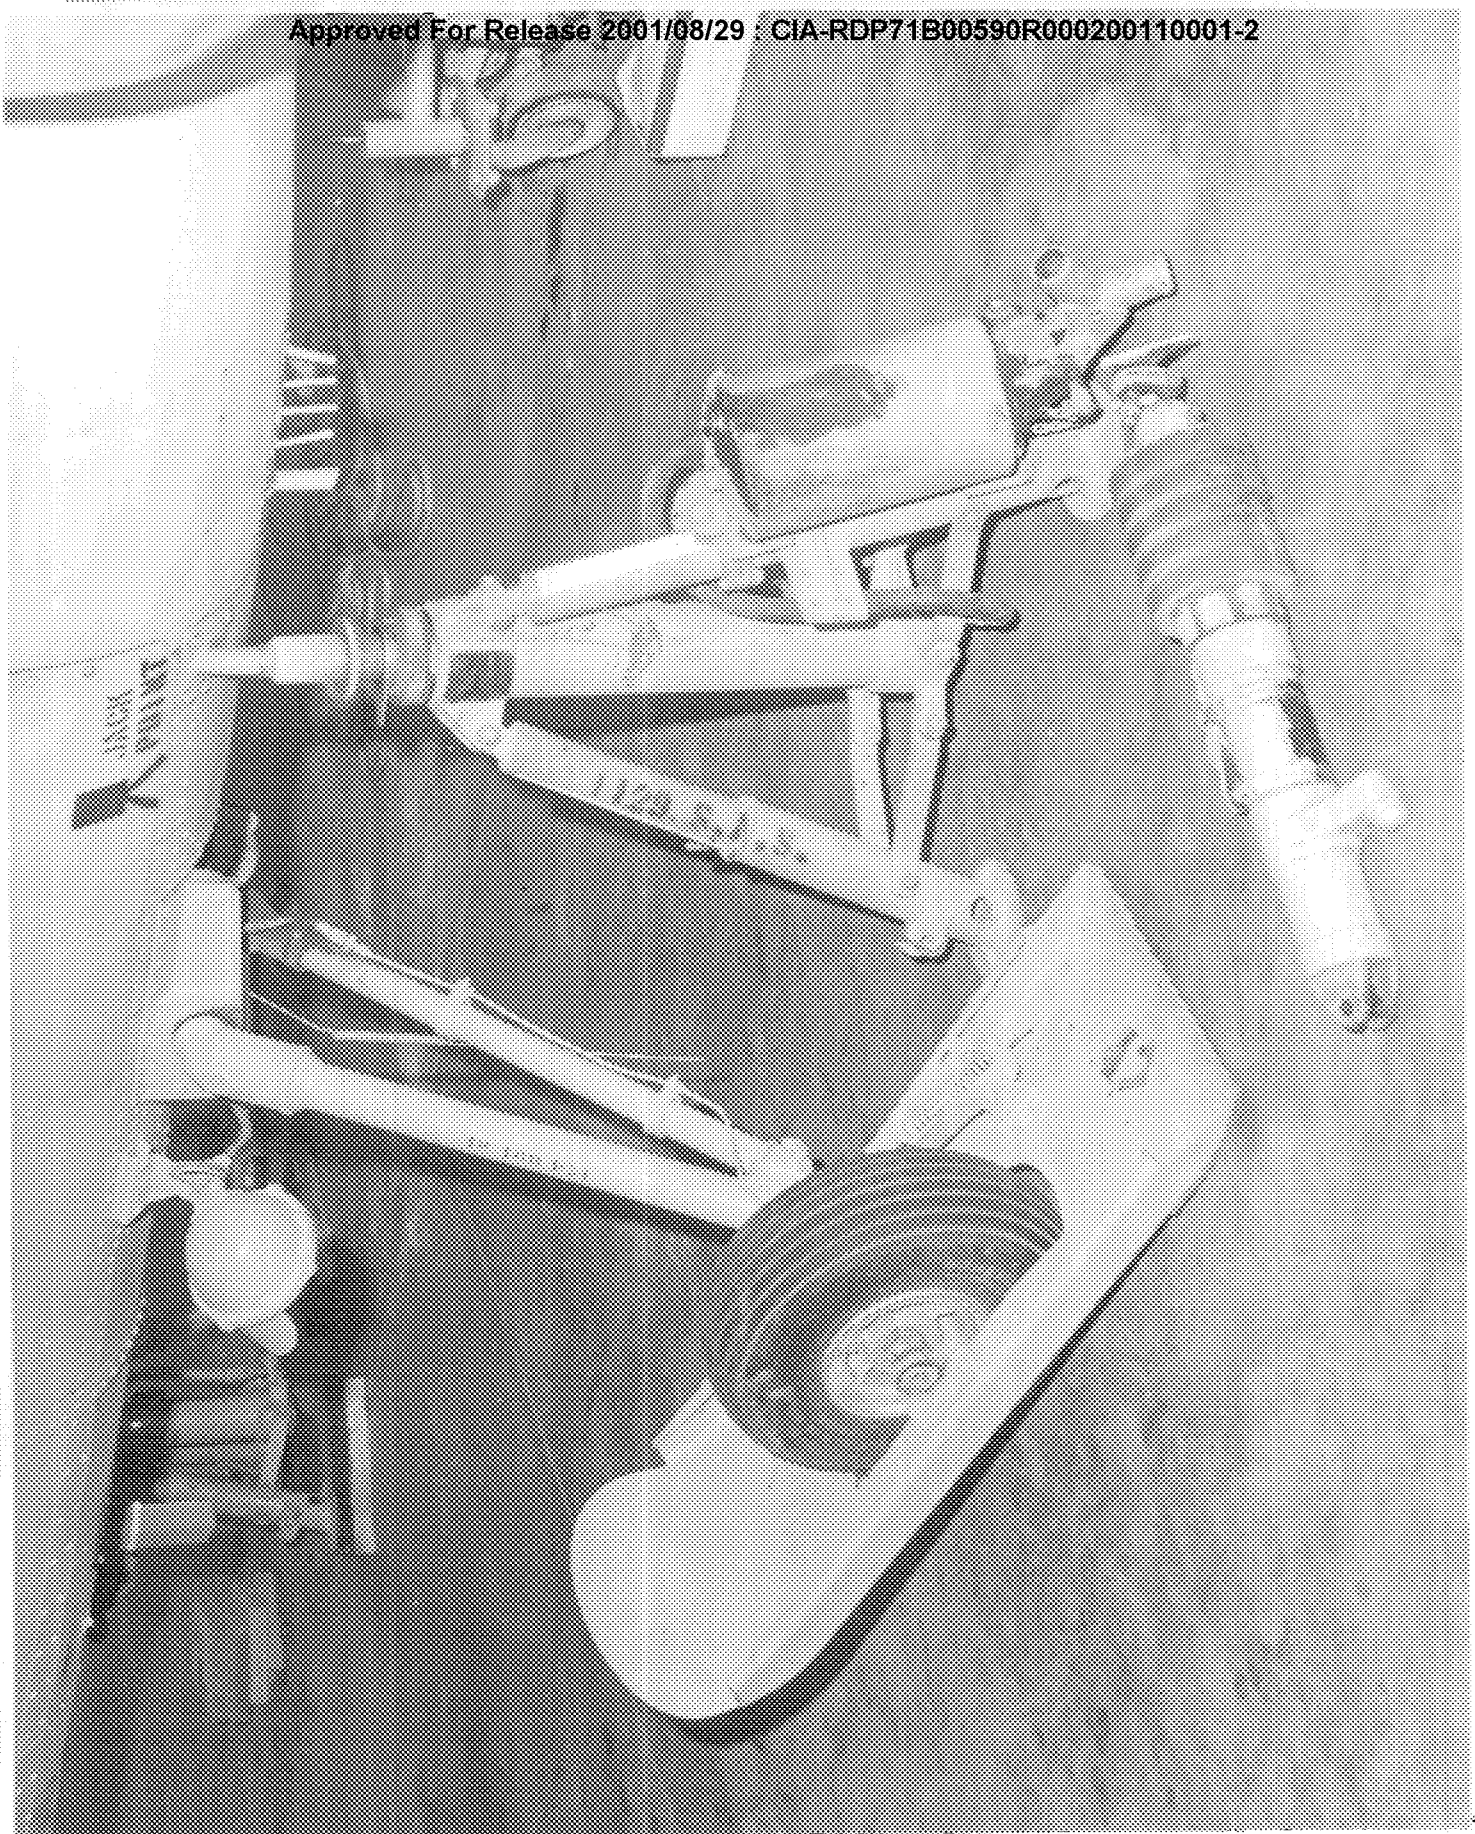
Strut collapsed (piston failure).
Strut mount torn from fuselage.
Skin torn out at mount and stringers and reinforcing material bent, broken and cracked.
Leg assembly bent.
Bearpaw bungee bolt bent slightly.

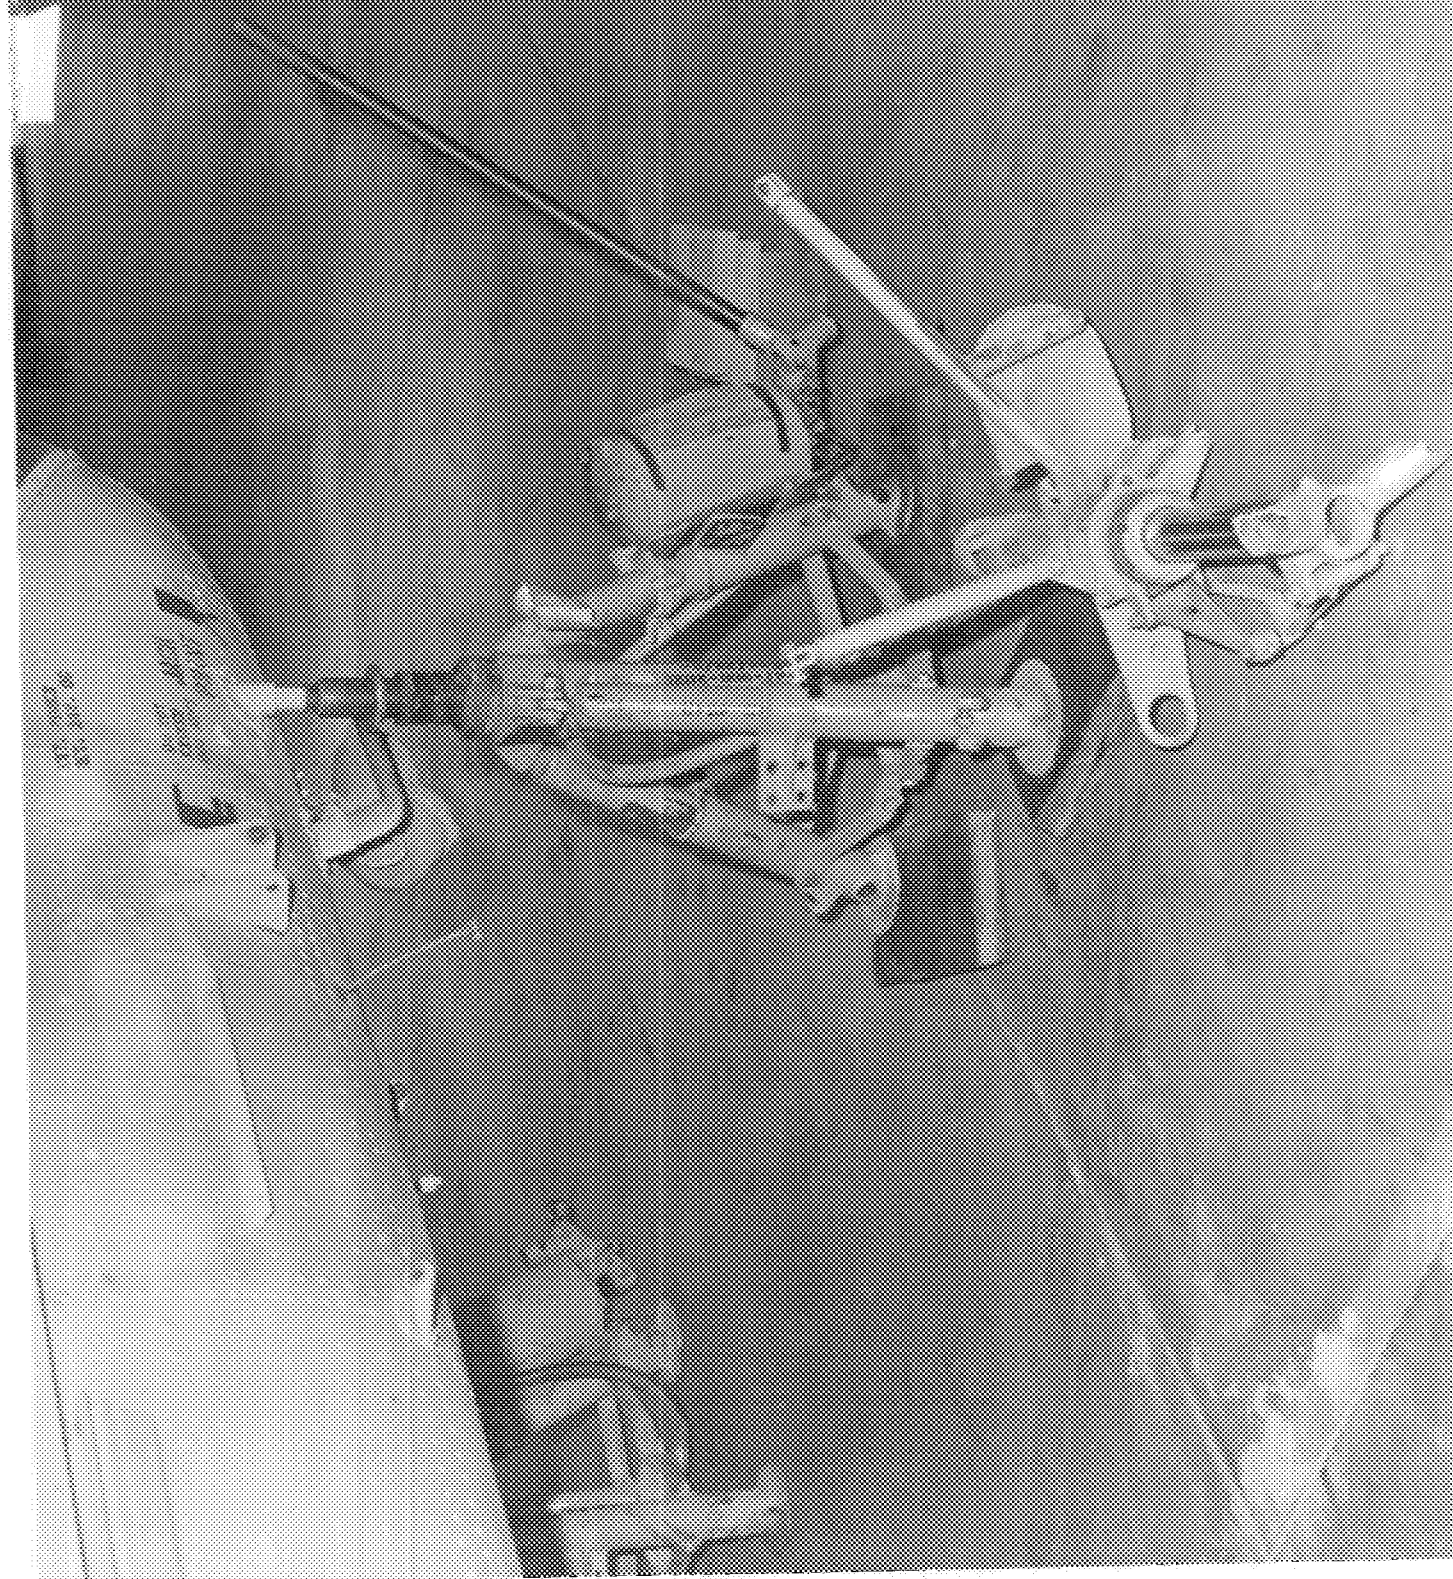
Fork broken.
Bearpaw bungee bolt bent
Bearpaw bent and deep scratches.
Bungee support has pulled rivet.

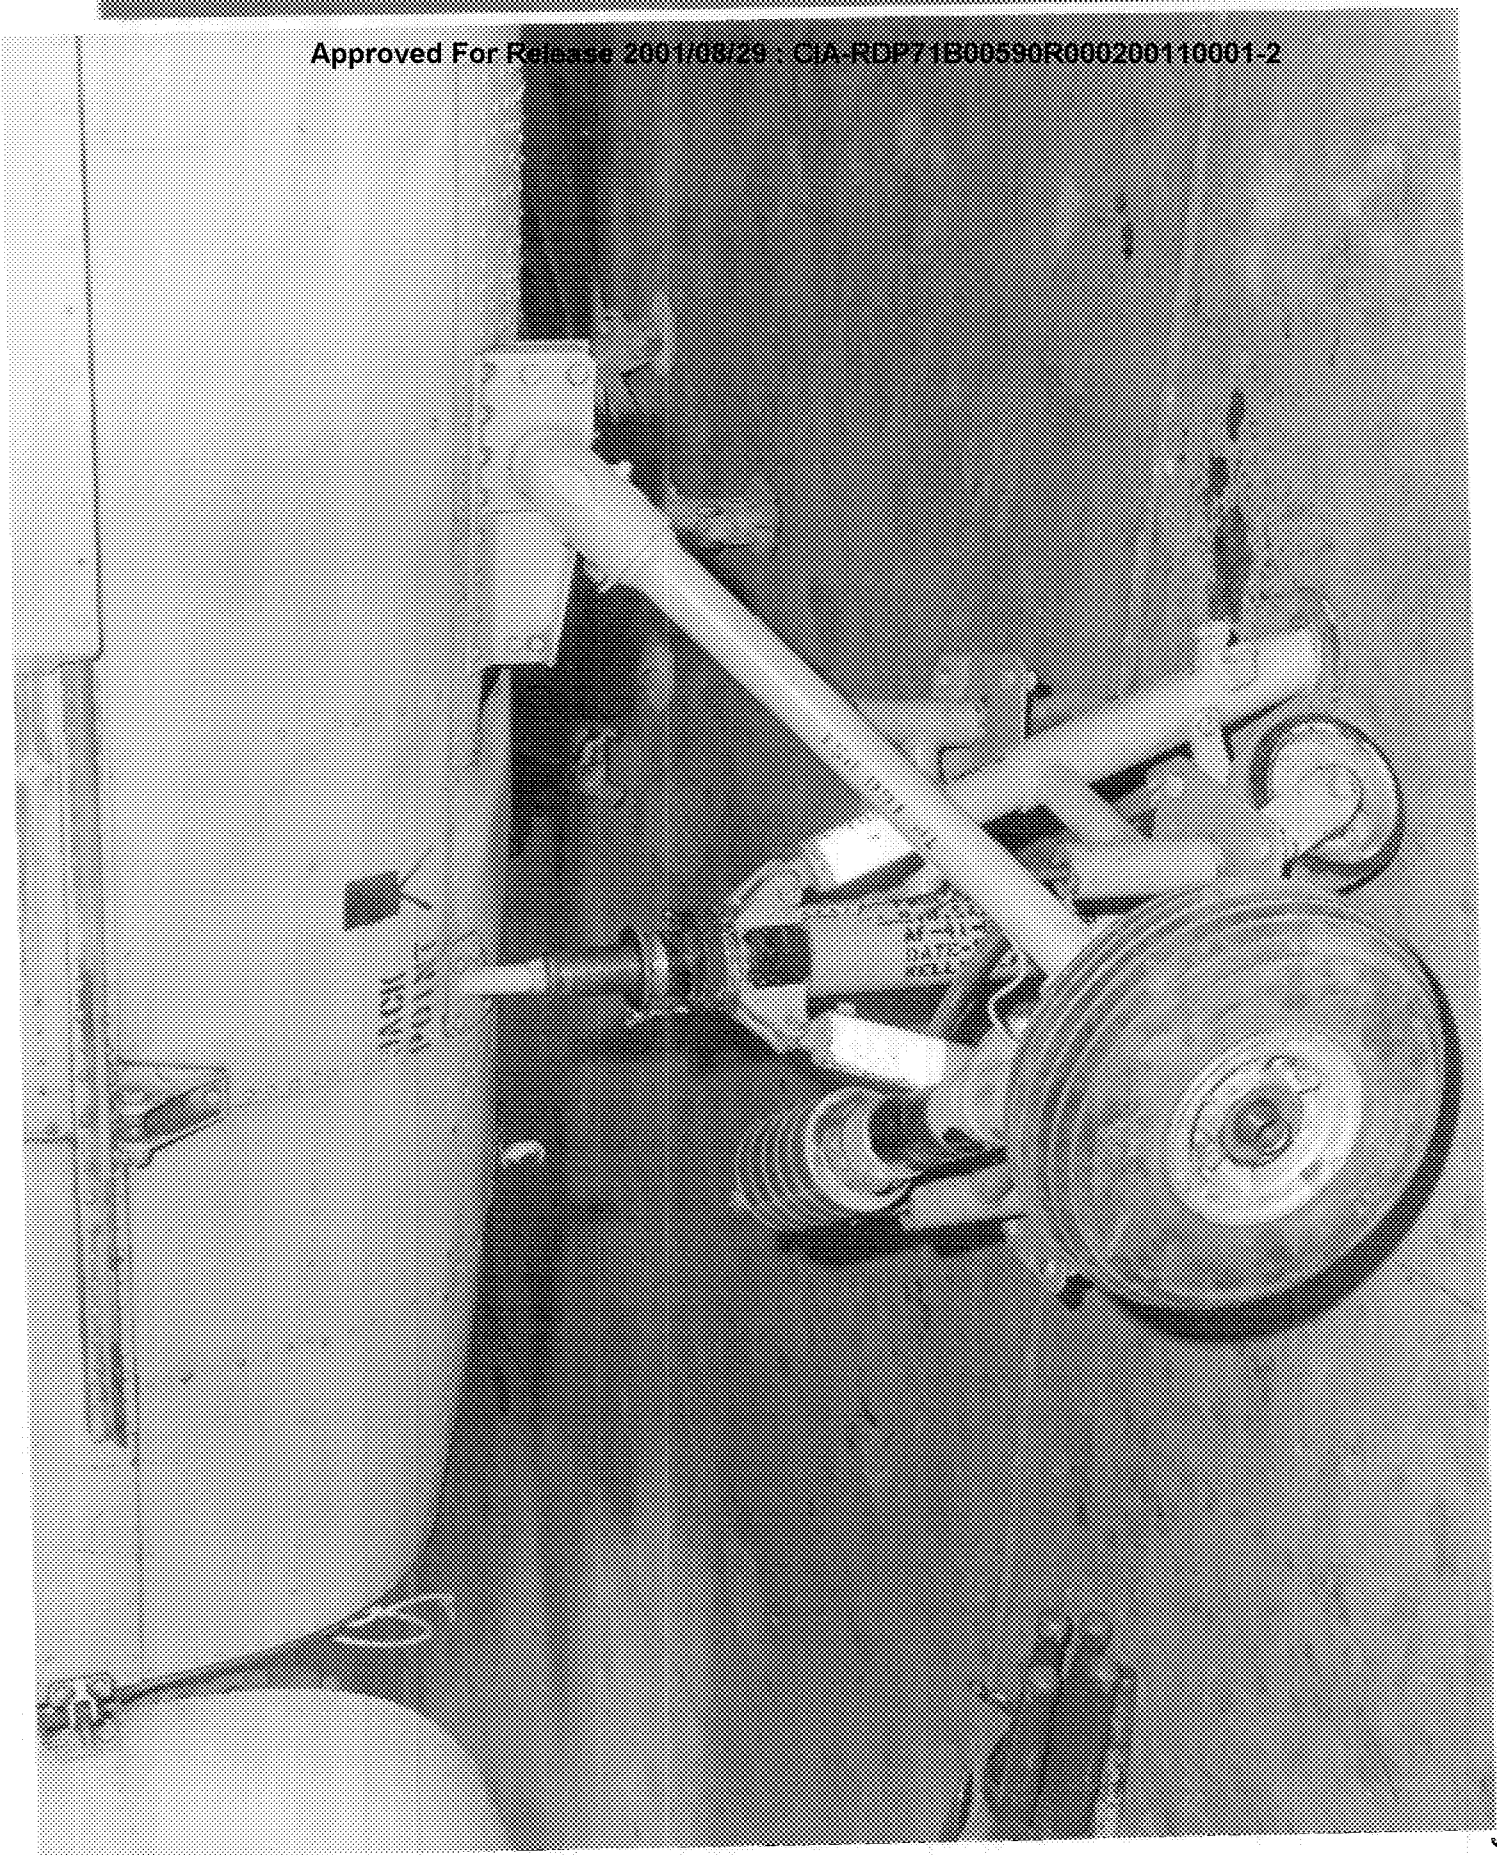
Strut collapsed (piston failure).
Link at strut mount broken.
Mount partially sheared.
Skin at, and above, mount buckled.
Main vertical stringer buckled.
Door track bent at mount area (replacing approx 1 1/2 ft).
Leg assembly bent.
Brake line broken at fitting.
Stringer and skin torn where landing gear leg contacts fuselage.
