CARRIER SUITABILITY DEMONSTRATION

SP-1564

MODEL U2-R

TITLE CARRIER SUITABILITY DEMONSTRATION

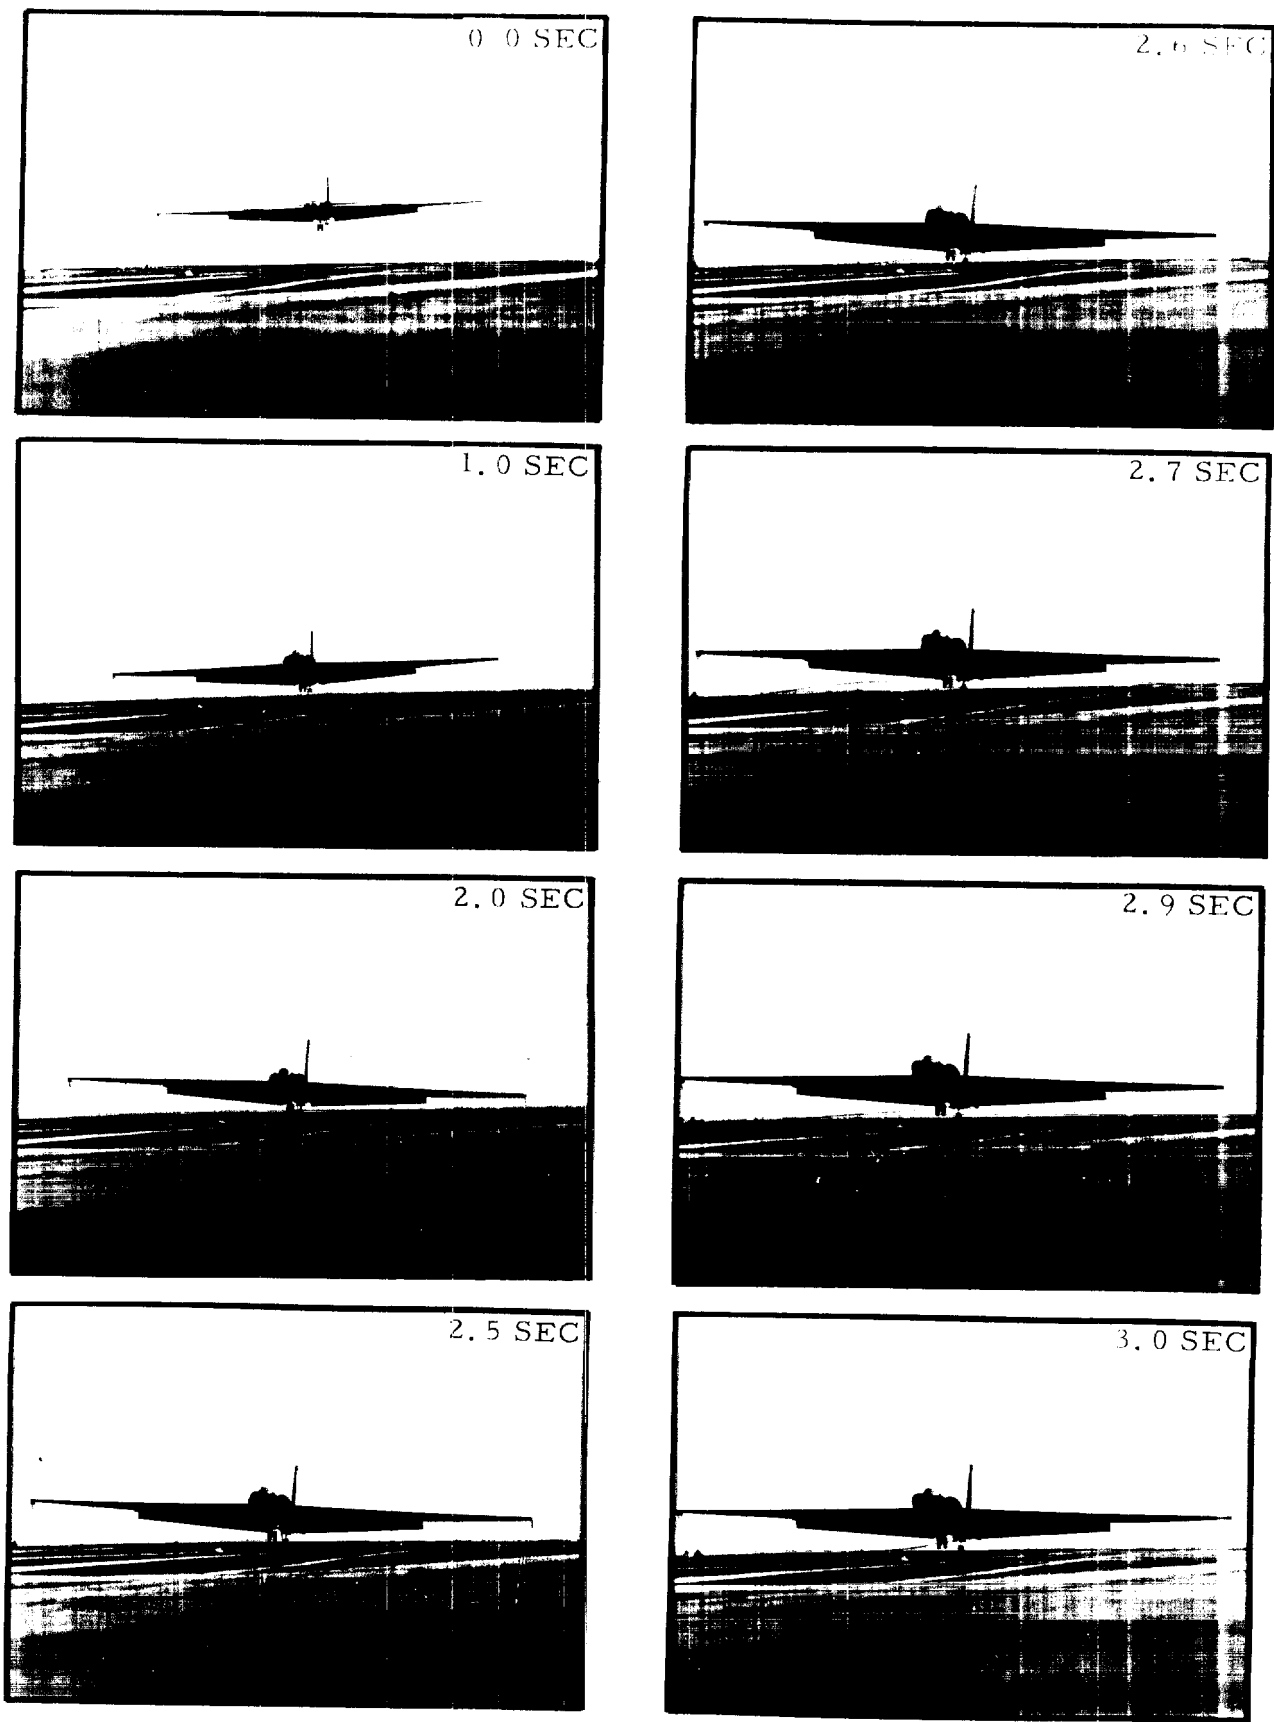
FIG. 1 SECOND LANDING

The second landing was much better than the first one. Although the same conditions were encountered on final approach, the wings were held level at landing and through the runout. On both landings the aircraft was steered with the rudder pedals during runout. Wind speed at arrestment was 30 knots on the second landing.

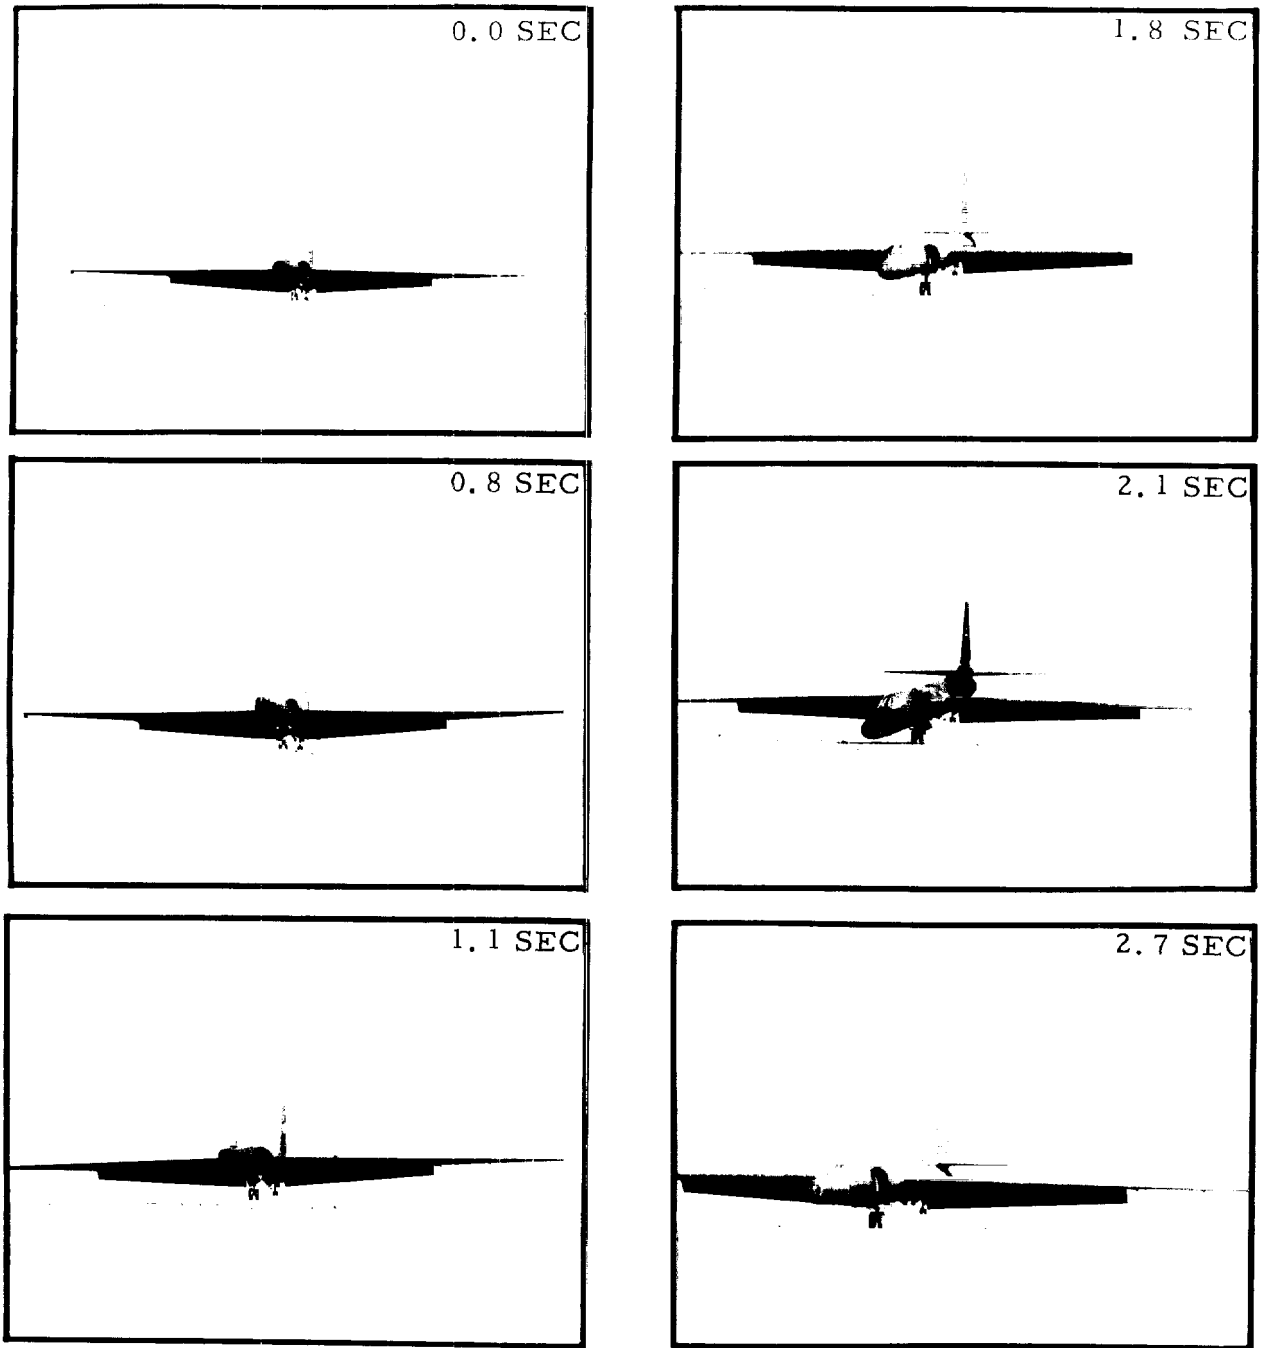
the range to expect for the U2-R. In one case where the pilot missed the #1 cable due to hook bounce, he advanced the throttle to go around and caught #2 cable. The power response was so rapid the aircraft had started to fly again as it caught the cable. This caused the main gear to slam down and the aircraft pitched around the main gear. The nose dipped below horizontal but still had adequate deck clearance. This "power on" arrestment gave the longest deck runout of 217 feet. All engagements were within two feet of centerline. There were two go arounds caused by missed cables. Otherwise all engagements were with the #1 cable. It is believed that all cable misses were caused by a hook snubber malfunction. This is discussed in detail under Aircraft Damage in this report.

FIG. 3 LOW NOSE DIP CAUSED BY CABLE HOOKUP ON BOUNCE

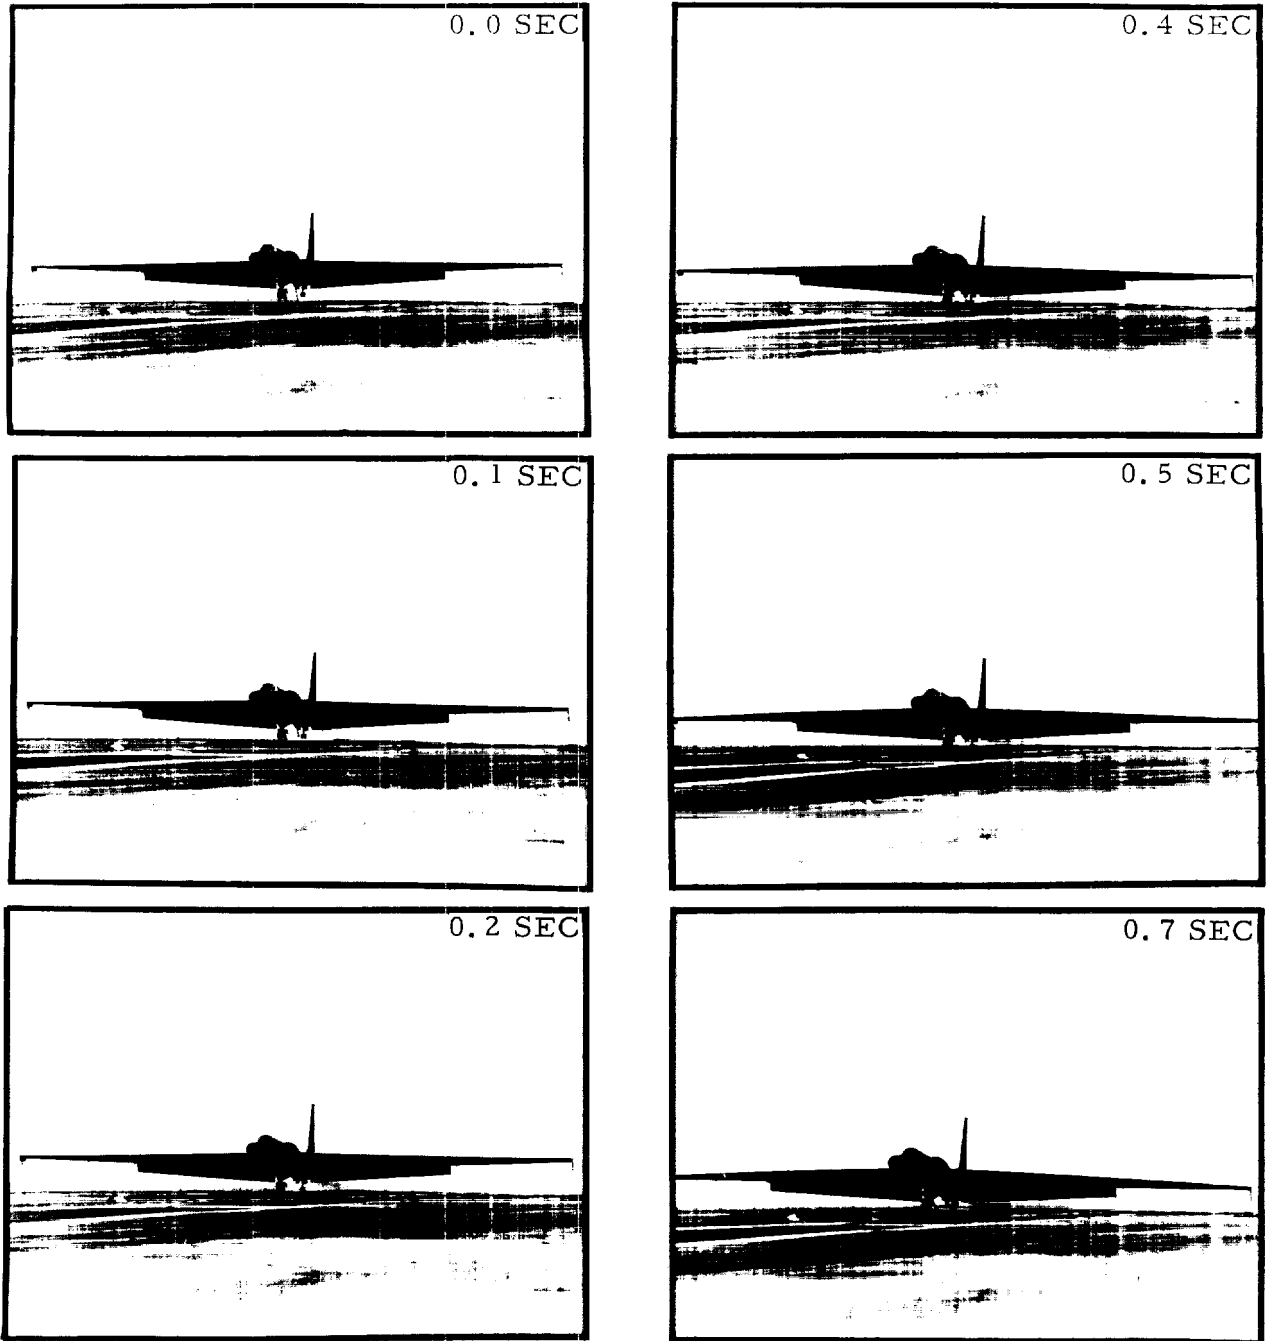
The damper had been serviced prior to the runway tests at Lakehurst in September 1969. During the Lakehurst tests it was subjected to ten taxi arrestments and two landing arrestments. Engaging speeds in the Lakehurst tests were much higher than those on the carrier. Prior to deployment to Wallops Sta. the damper was checked and found to be satisfactory and did not require reservicing. Pictures taken of the hook on the first landings show it staying "glued" to the deck from initial contact until it picked up the cable. The damper is under investigation and appropriate corrective action will be taken.

FIG. 9 HOOK BOUNCE CAUSED BY DEFLATED HOOK SNUBBER
