Lockheed Aircraft Corporation

REPORT NO. SP-1622
DATE 5-18-70
COPY NO. 3

MODEL	U-2R
TITLE	TEST OF EJECTION SEAT CANOPY BREAKER EXTENSION

TEST OF EJECTION SEAT CANOPY BREAKER EXTENSION

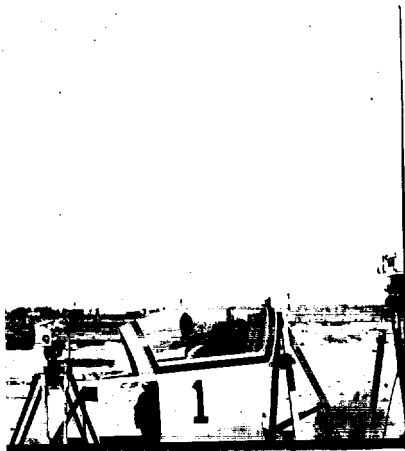
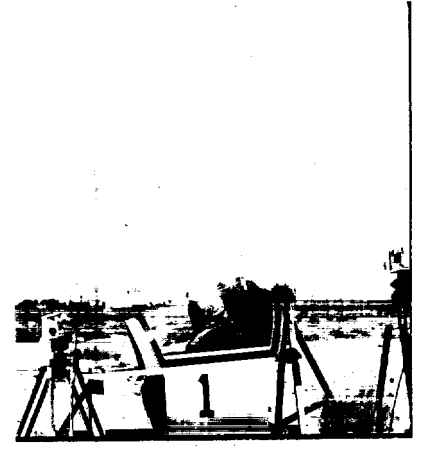
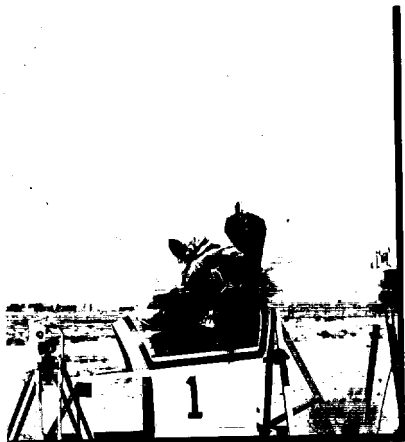
1. Prior to firing.
2. The initiator has fired the catapult and the seat has moved up to contact the glass. Note the black smoke from the initiator coming up the aft bulkhead. This occurs after the catapult moves the rocket up far enough to separate the mated connections of the initiator line.
3. The catapult has forced the Canopy Breaker through the canopy.
4. The pilot and seat are emerging through the canopy and the rocket has ignited.
5. The seat has cleared the tracks and the Seat Drogue Chute Gun has fired to deploy the stabilizing chute.
6. The test is successful.

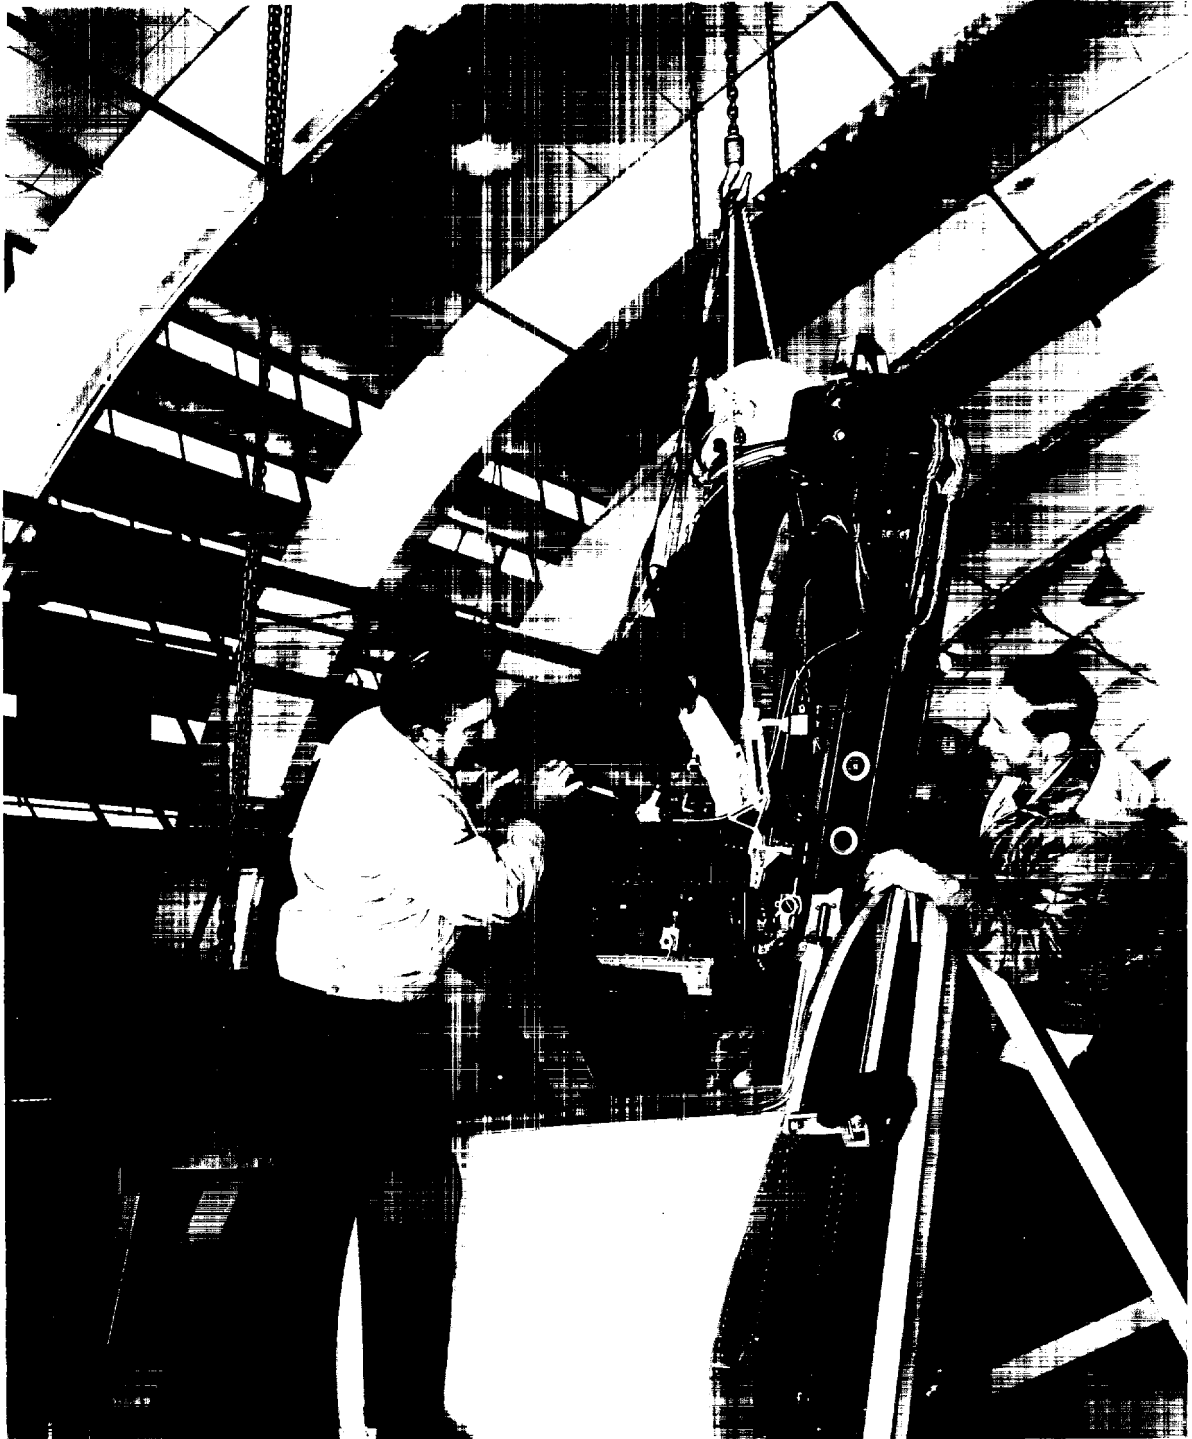
PHOTO NO. 2

The thicker cushion raises the pilot to the point where the shoulder straps of the parachute will bear on his shoulders. (See Photo No. 2.) The dummy had to be pushed down into the cushion to allow the chute to slip into its allotted space. Thus the dummy was carrying the weight of the chute on his shoulders.

The thicker cushion must be carefully analyzed with reference to the short armed pilot being able to reach the "D" Ring when his suit is inflated. The same study must be made concerning the controls during suit inflation.

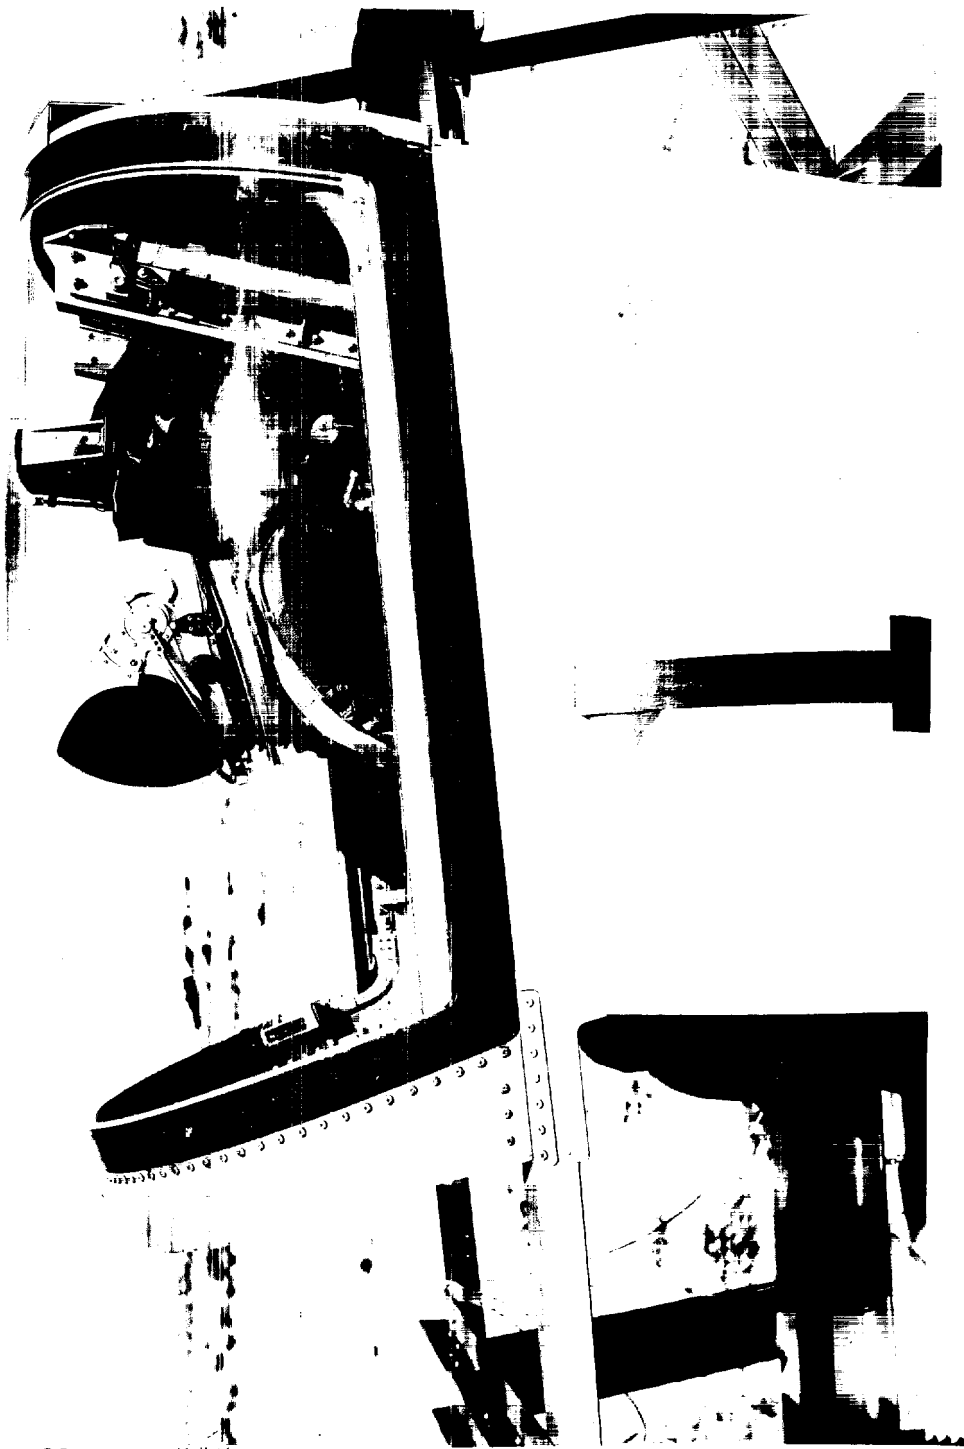
PHOTO NO. 3

- 5.1.1 Photo No. 3 illustrates the proximity of the canopy breaker and the dummy's helmet to the canopy. This is the uppermost position permitted by the limit switch in the seat raising circuit. The small ball tipped rod on the breaker is the feeler that opens the limit switch when the rubber pad is one quarter inch from the glass.
