18 November 1958

MEMORANDUM FOR THE RECORD

SUBJECT: Destructor System Tests

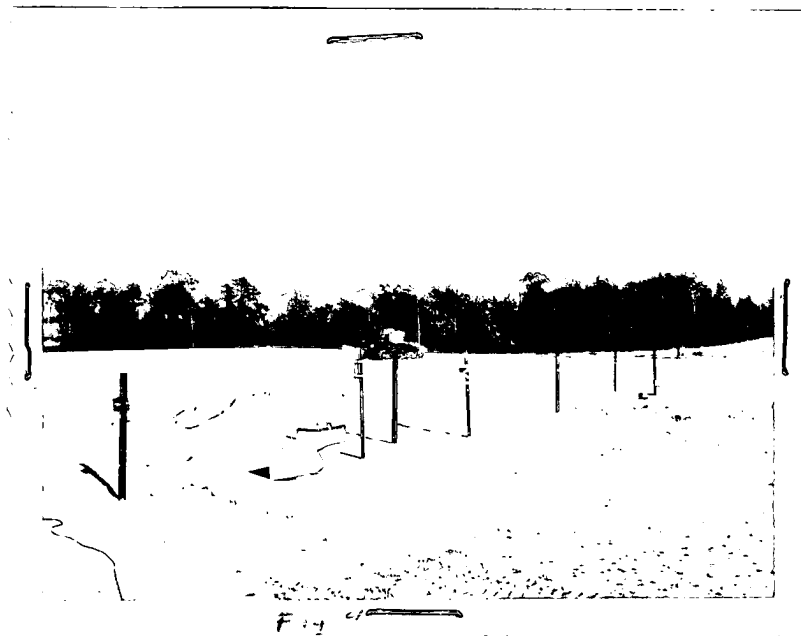
Fig. 9

Complete Mock-Up of Destructor System Test.

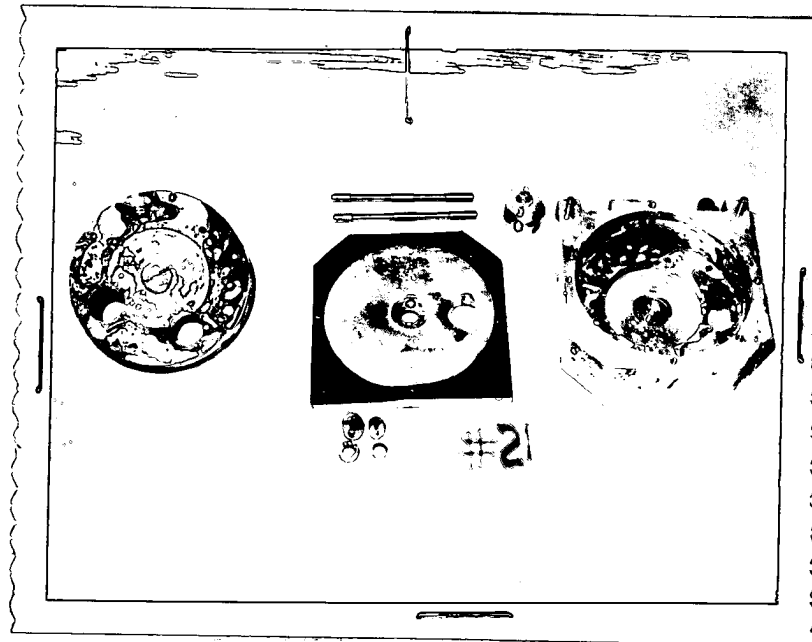
Fig. 11

Unit No. 21 was tried first; however, the undersigned was able to depress the safety button only with considerable force and then was not able to turn the crank. It is felt that this failure was caused by the water submersion tests. (Two other units which had been through the water tests functioned satisfactorily during tests at the contractor's facility on 28 October 1958.) Unit No. 23 was substituted and it operated with ease and detonated the primacord after an arming delay of 35 seconds. Figure 10 shows the results [redacted] -- nothing except a few small fragments of film and tape were left at the area. Several twisted scraps from the aluminum mock-ups were founded scattered as far as 100 yards away.

4. Unit No. 21 was taken apart to determine the cause of failure. A considerable amount of water was found inside and Figure 11 shows the corrosion which caused the rotor to seize. From examining the firing pins and springs, it is questionable as to whether they would have functioned had it been possible to turn the rotor.

Disassembled Safeguard Unit Showing Corrosion from Water Leakage

The overall system appears reliable and the amount of explosive for each target equipment is ~~more~~ than adequate for complete destruction. Although Unit No. 21 was considered a failure, it is felt that the units can be protected from excessive water by canning and this will be done in the near future. Unit No. 23 has already been stored unprotected for six months and functioned properly.
