The following entries in this ledger are made in accordance with paragraph 3.2 of Service Test Procedures of the [REDACTED] Model HJA/5 Photographic Film Processor dtd 5 July 1963 prepared by Target Materials Division, Directorate of Intelligence Hq SAC.

Monday 30 Sep 1963:
Entry #1 ~~Tuesday 1 Oct 1963: Fd~~

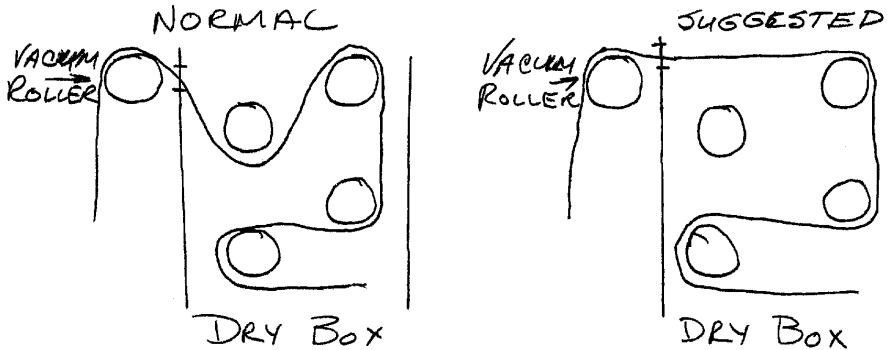
This permits the film to leave the vacuum roller at about 45° or approx. 3" sooner. As follows:

Several hundred feet of film was processed in this method without any trouble. This also eliminated the indentation marks made by the vacuum holes in the roller. General screw came loose in the torque take up and had to be operated by hand until the lights were turned on and the unit could be fix^{ed}.
 Record of night's run:
