CIA IMAGERY ANALYSIS DIVISION		
COUNTRY	COORDINATES	
North Vietnam	22 09N/104 23E VK 368493	
	BRIEF NO:	
	COUNTRY

LOCATION: 0.5 nm NE of Lang Bun on the Hanoi - Lao Cai Rail Line

CIA IMAGERY ANALYSIS DIVISION COUNTRY COORDINATES Lang Bun R. R. Bridge 22 09N/104 23E Bridge No. 1 on NF 48-6 North Vietnam VK 368493 BRIEF NO: MAP <u> AMS L509 NF 48-6</u> PIB - 65002

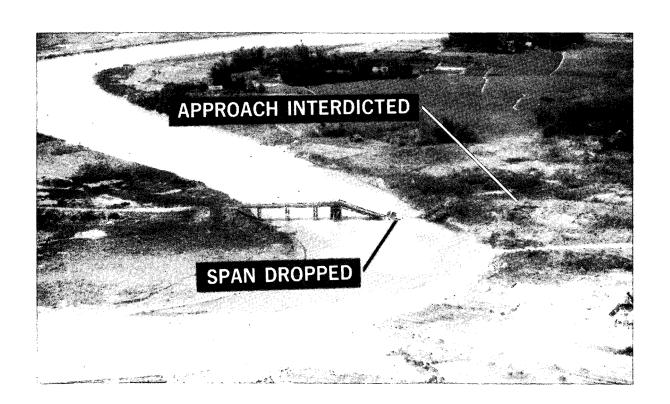
NAME	COUNTRY	COORDINATES
Da Ben Highway Bridge		18 25N - 105 48 WF 851362
Da Ben Highway Bridge Bridge No. 16 on NE 48-7	North Vietnam	WF 851362
		BRIEF NO:
		·
MAP AMS 1,509 NE 48	3_7	PIB - 65006

STATUS: Heavily damaged, 1 span dropped, approach interdicted

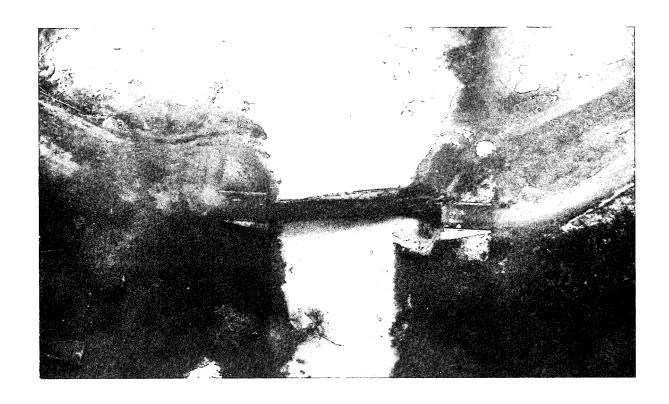
Status: Severely damaged - unserviceable, western end of span twisted and out of alignment

COMPENSATIVE ACTION: Ford

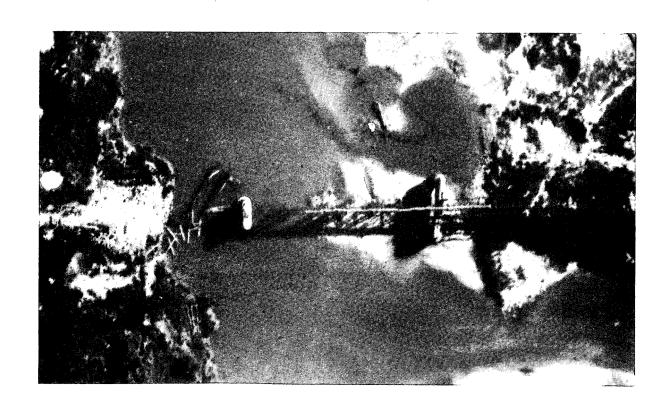
CIA IMAGEI	RY ANALYSIS DIVISION	
	NAME	COUNTRY	COORDINATES
	La Khe Thon R.R. Bridge Bridge No. 13 on NE 48-7	North Vietnam	18 03N - 105 49E WE 871969
25X1			BRIEF NO:
	MAP AMS L509 NE 48-7		PIB - 65019
	LOCATION:		
25X1	DESCRIPTION: LENGTH WIDTH Single Track TYPE Half-through truss and	MATERIAL NO. OF SPANS LENGTH OF EACH SPAN	Wood, Steel, Concrete
	trestle status: 1 span heavily damaged, uns	ervice a ble	25X

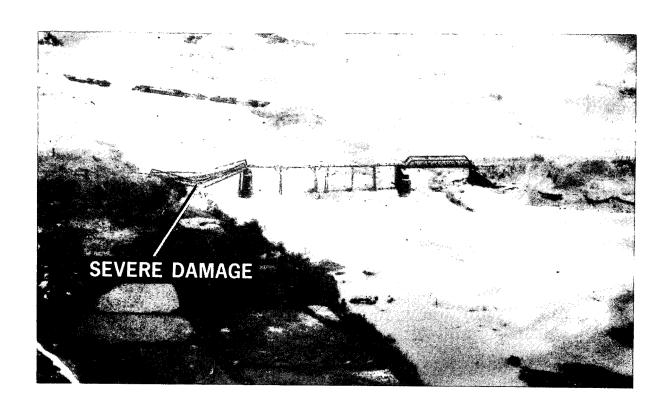
CIA IMAGERY ANALYSIS DIVISION		
	La Khe Thon R.R. Bridge Bridge No. 13 on NE 48-7	COUNTRY North Vietnam	COORDINATES 18 03N - 105 49E WE 871969
25X1			BRIEF NO:
	MAP AMS L509 NE 48-7 LOCATION: 2.0 nm SE of La Khe Thon,	, on the Vihn-Dong Hoi	PIB - 65020 Rail Line
	DESCRIPTION:		
25X1	LENGTH WIDTH Single track TYPE Half-through truss and	MATERIAL NO. OF SPANS LENGTH OF EACH SPAN	Wood, steel and concrete
	trestle status: One span heavily damaged,	, unserviceable	25X

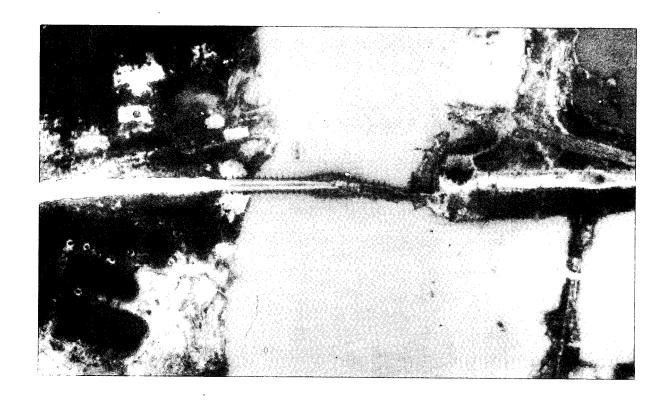
CIA IMAGERY ANALYSIS DIVISION		
NAME	COUNTRY	COORDINATES
Ngoc Luy Highway Bridge		18 21N - 105 52E
Bridge No. 27 on NE 48-7	North Vietnam	WF 922303
		BRIEF NO:
MAP AMS L509 NE 48-7		PIB - 65021

STATUS: Partially damaged on east end - unserviceable

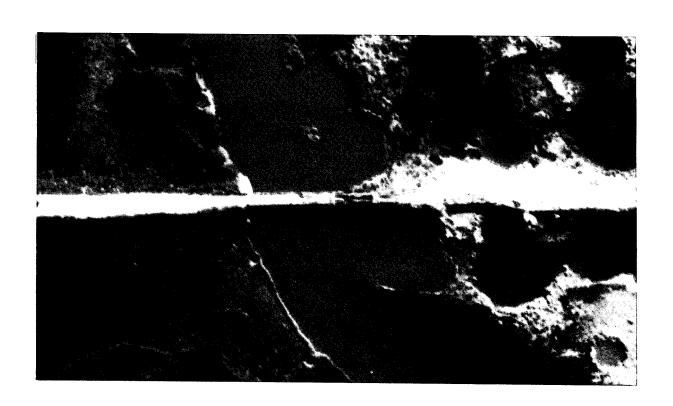
status: 1 span severely damaged

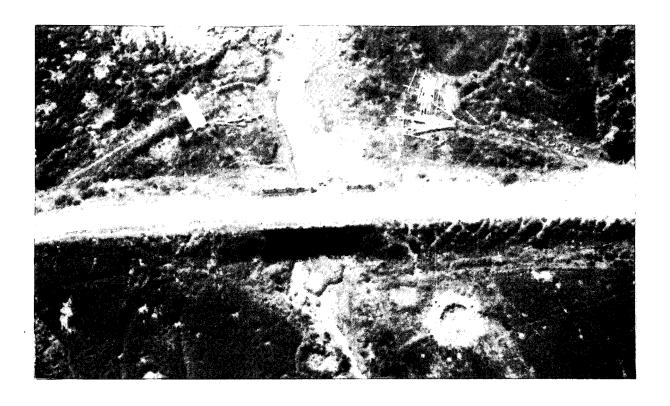
STATUS: Moderate damage to guard rail, bridge still serviceable

COMPENSATIVE ACTION: None

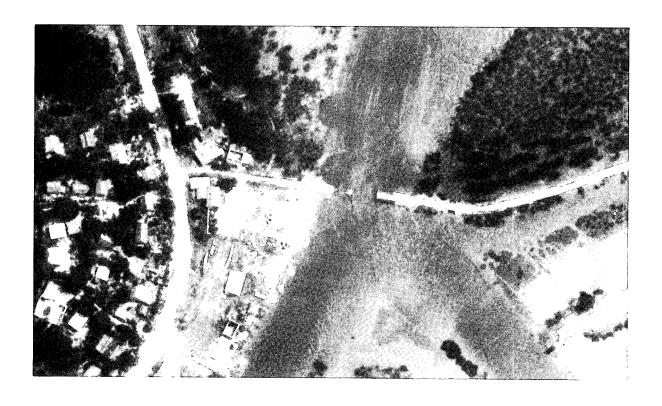
STATUS: Two spans completely destroyed, two spans heavily damaged

compensative action: None

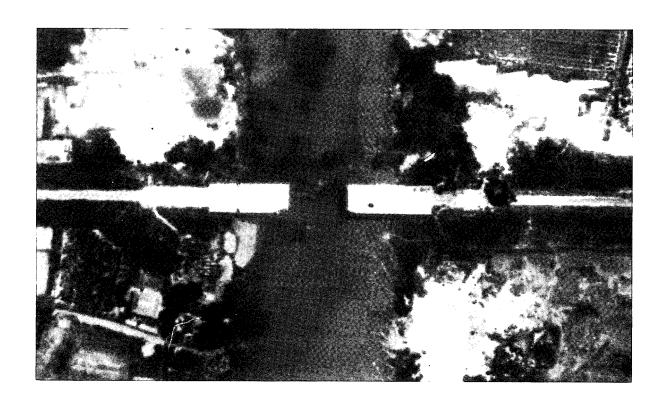
status: 1 span destroyed, 1 damaged - Unserviceable

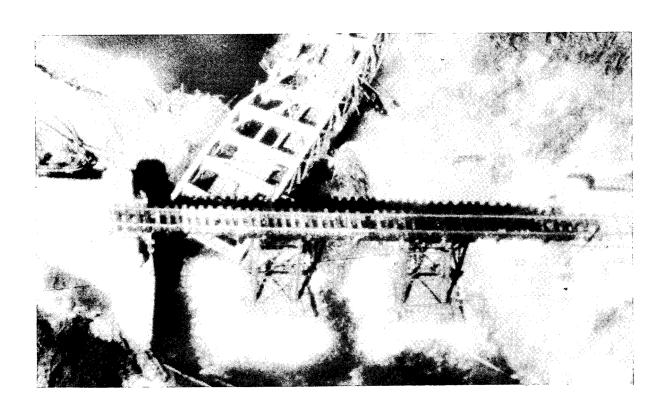
-		CIA IMAG	ERY ANALYSIS DIVISION		
-		m Nuoc Nong R.R. Br. idge No. 2 on NF 48-10	COUNTRY North Vietnam	COORDINATES 21 54N - 104 39E VK 647 235	
25X1	101	Tuge NO. 2 Oil Nr 40-10	NOT OIT VIC OTTAIN	BRIEF NO:	
	MAP	AMS L509 NF 48-10		65050	
25X1	DESCRIPTION: LENGTH WIDTH TYPE	1.8 N.M.E. of Xom Nuoc No Single track Deck, Beam	ong on the Hanoi Lao-Ca MATERIAL WOOD NO. OF SPANS 3 LENGTH OF EACH SPAN	i Rail Line	25>
	STATUS:	Serviceable replacement f by beams, two wooden tow

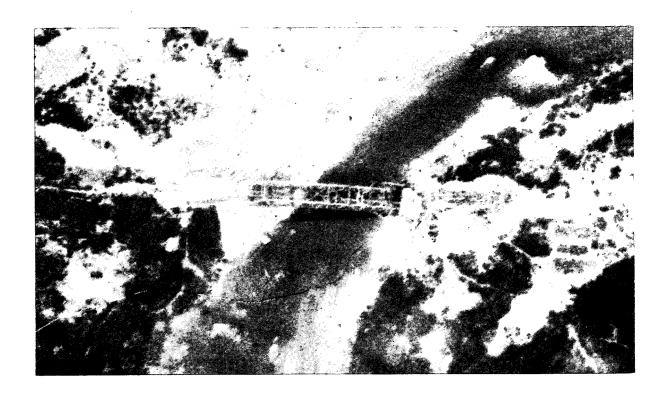
One end of span dropped and one abutment severly damaged.

COMPENSATIVE ACTION: Ford

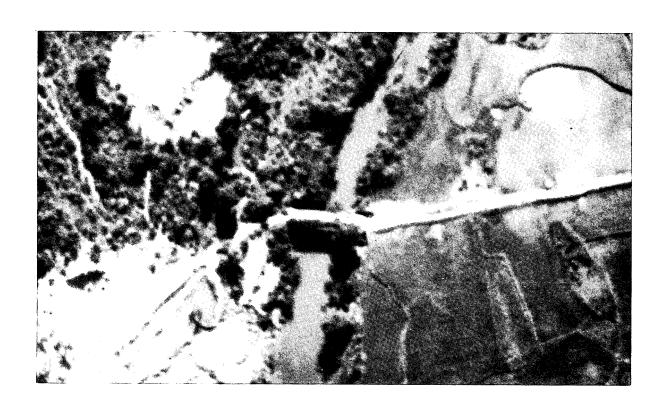
The 100' truss span destroyed, 1 abutment damaged.

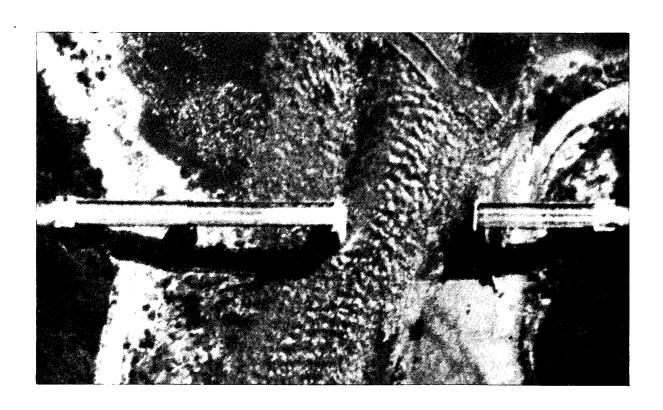
CIA IMAGERY ANALYSIS DIVISION COUNTRY COORDINATES 17 50N - 106 06 Dong Tam Hwy. Br. Bridge #18 on NE 48-11 North Vietnam XE 166 714 25X1 BRIEF NO: AMS L509 NE 48-11 PIB- 65065 MAP LOCATION: 0.3 N.M. S.W. of Dong Tam on abandon R.R. DESCRIPTION: 50' approx. MATERIAL Wood, concrete abutments LENGTH 25X1 WIDTH NO. OF SPANS LENGTH OF EACH SPAN 50' approx. deck STATUS: Light damage to timber decking.

Ford approximately 400 feet west of damaged bridge.

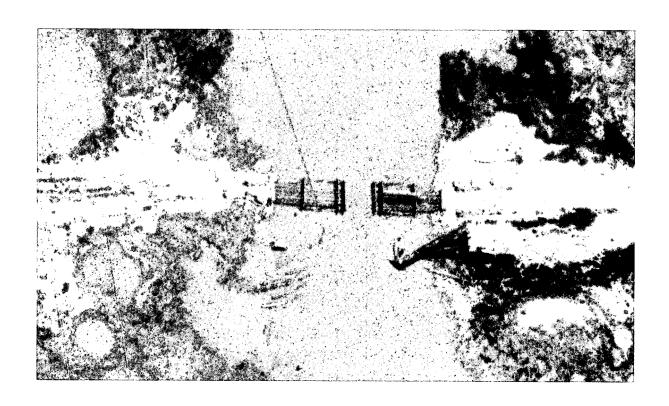
Under construction, as a replacement for previously destroyed bridge.

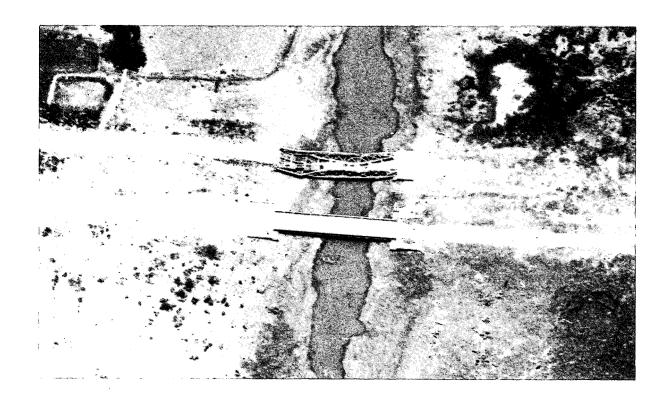
One end of span dropped, truss severly damaged, abutments undamaged, adjacent highway bridge is undamaged.

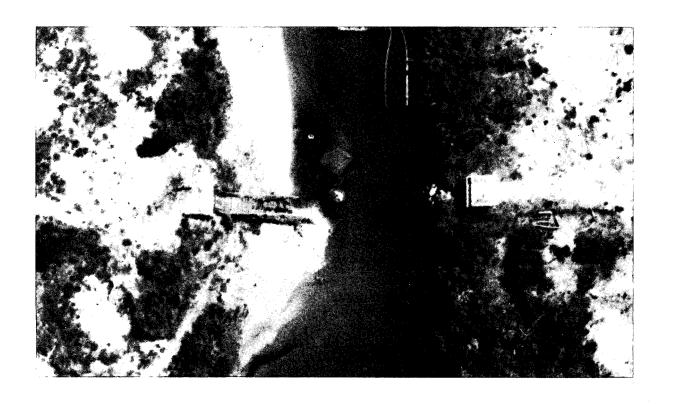
All 3 spans destroyed, 2 piers severly damaged, abutments appear undamaged.

compensative action: Ford approximately 800' east of bridge.

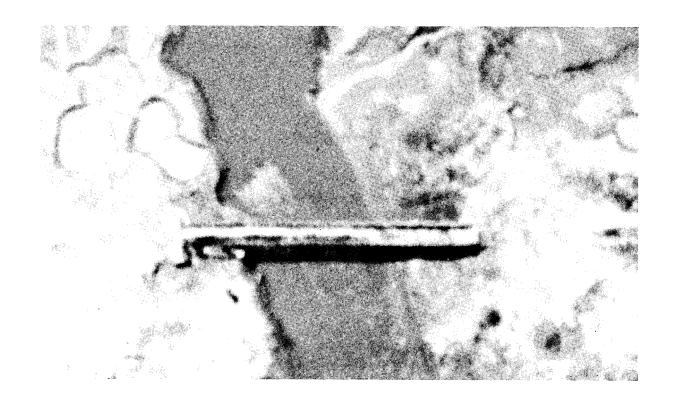
STATUS: One end of bridge knocked off abutment, truss severly damaged, one pier and both abutments damaged.

COMPENSATIVE ACTION: None

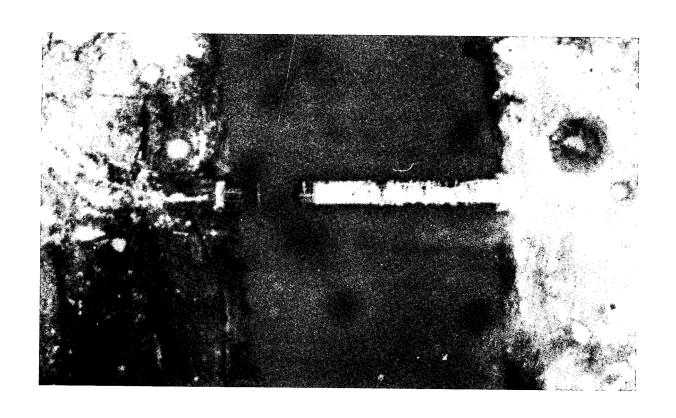
Approved For Release 2002/	08/1 §E@RE RDP78T05161	1A001600020001-0	
				25X1
		GERY ANALYSIS DIVISION		
	Ban Na Ty Hwy. Bridge Bridge No. 6 on NE 48-12	COUNTRY North Vietnam	COORDINATES 17 12N - 106 49E XE 942020	
25X1	MAP AMS 1509 NF 48-12 . LOCATION: 0.4 nm N.W. of My Hos on F	Route 101	BRIEF NO: PIB - 65081 October 1965	
25X1	DESCRIPTION: LENGTH WIDTH TYPE Deck	MATERIAL NO. OF SPANS LENGTH OF EACH SPAN	Timber 6	25X1
	status: Two spans destroyed, 4 span	s damaged.		
	compensative action: None

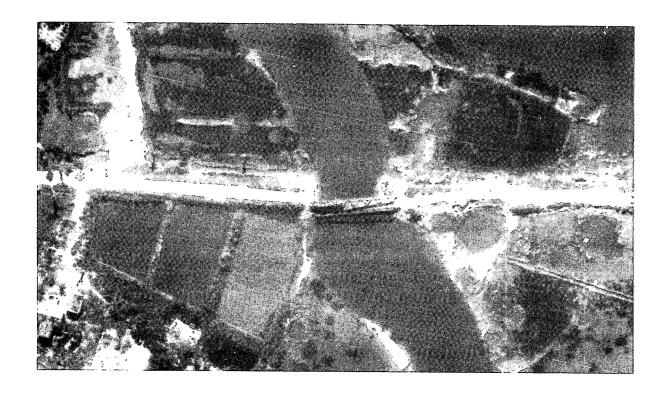
Span dropped from one abutment. 1 abutment damaged.

COMPENSATIVE ACTION: By-pass bridge under construction 360' east.

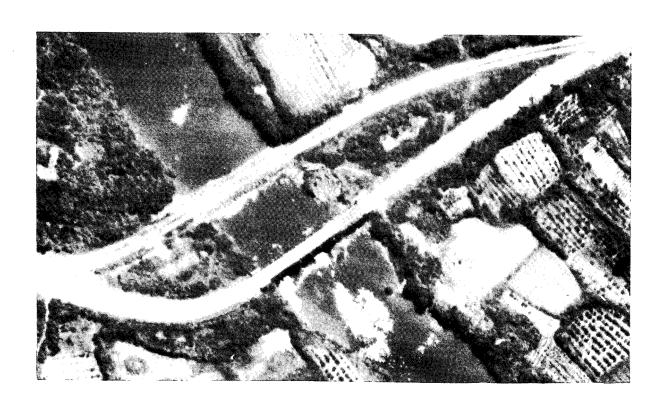
CIA IMAGERY ANALYSIS DIVISION	
Trach Hau Hwy. Bridge Bridge No. 45 on NE 48-7	North Vietnam	18 02N - 106 24E XE 482948
5X1 MAP AMS L509 NE 48) r	BRIEF NO: PIB - 65096 October 1965
LOCATION: 0.5 mm S. of Track	The second secon	1 de desact 1707
DESCRIPTION: LENGTH 801	MATERIAL CONCT	rete
25X1 TYPE Deck	LENGTH OF EACH SPAN	10'
status: 2 spans damaged

COMPENSATIVE ACTION: Bridge is under repair, by-pass causeway with culvert is in use.

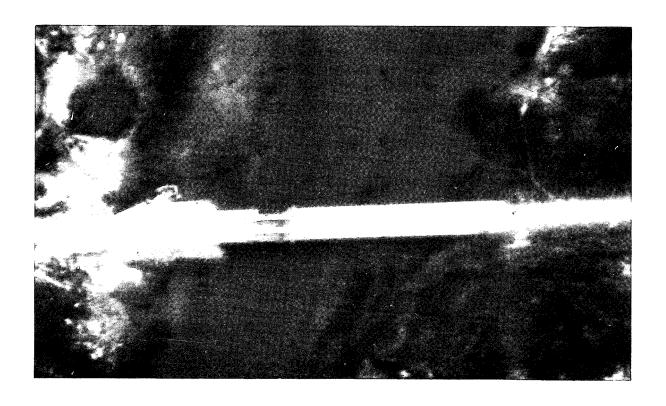
STATUS: 3 spans destroyed, abutment damaged

COMPENSATIVE ACTION: Two spans replaced and wood planking used as temporary replacement for third damaged span.

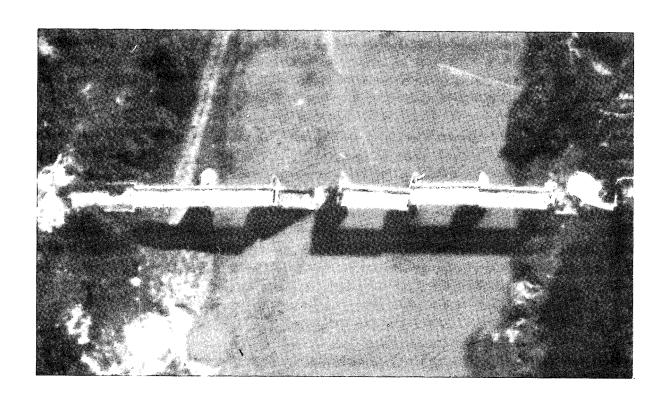
STATUS: Two spans destroyed, three spans knocked out of alignment, one abutment damaged.

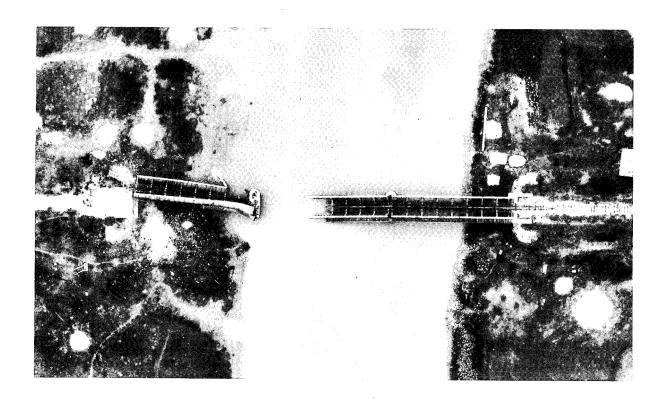
CIA IA	MAGERY ANALYSIS DIVISION		
	Trang Than R.R Bridge No. 6 c		North Vietnam	COORDINATES 18 58N - 105 35E WF 613978	
25X1	MAP AMS L			BRIEF NO: PIB - 65105 October 1965	
			han on Hanoi-Vinh Rail Lin		
25X1	WIDTH 201 TYPE Half-	through truss	MATERIAL Steel, NO. OF SPANS 3 LENGTH OF EACH SPAN	concrete	25X1
	STATUS: Two s	spans dropped

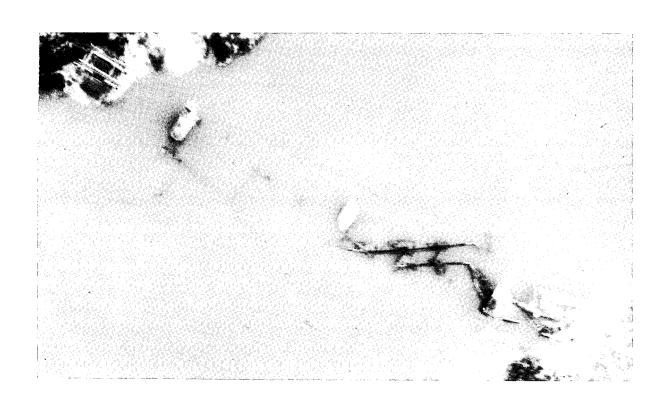
CIA IMAGE	RY ANALYSIS DIVISION		
	NAME Trai Hoi Doumer Bridge Bridge No. 9 on NE 48-7	North Vietnam	COORDINATES 18 21N - 105 37E WF 650300	
25X1	MAP AMS L509 NE 48-7		BRIEF NO: PIB - 65106 October 1965	
25X1	DESCRIPTION: LENGTH WIDTH TYPE Half-through truss		and concrete	25X1
	STATUS: All spans completely destro	oyed, 1 abutment destroy	yed, 2 piers damaged.	
	COMPENSATIVE ACTION: None

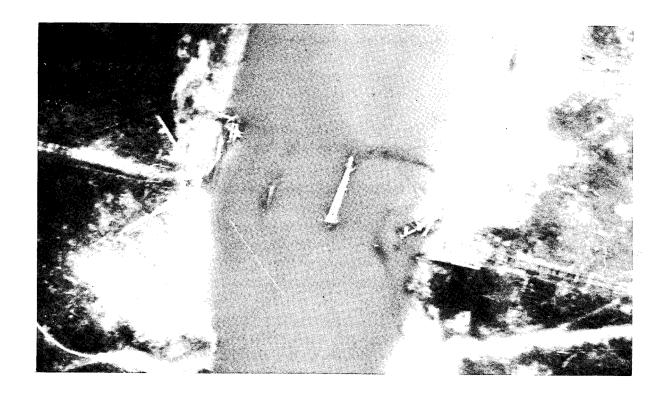
STATUS: All spans completely destroyed, 1 abutment damaged, 2 piers damaged.

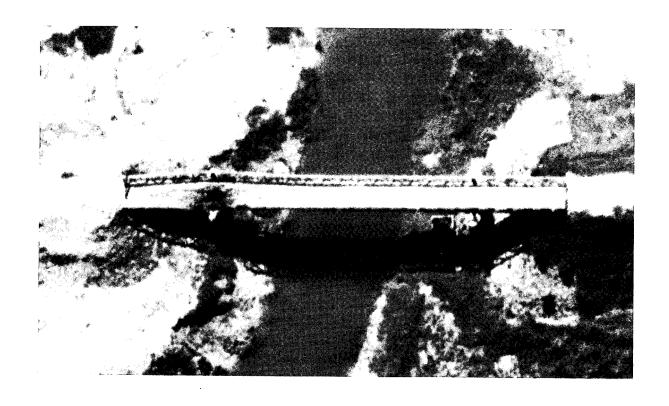
East end splintered and truss is damaged.

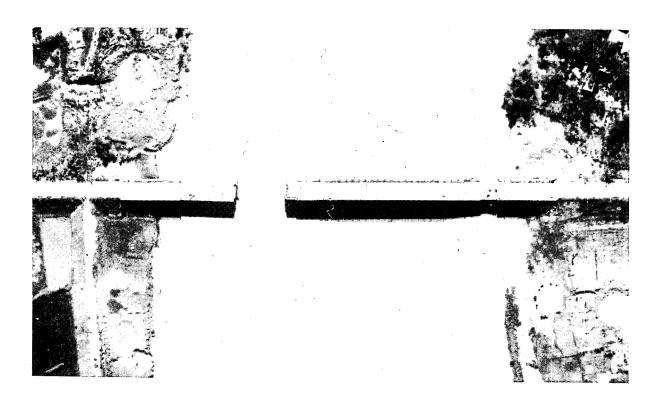
status: 1 span destroyed, 1 span severly damaged.

COMPENSATIVE ACTION: Ferry

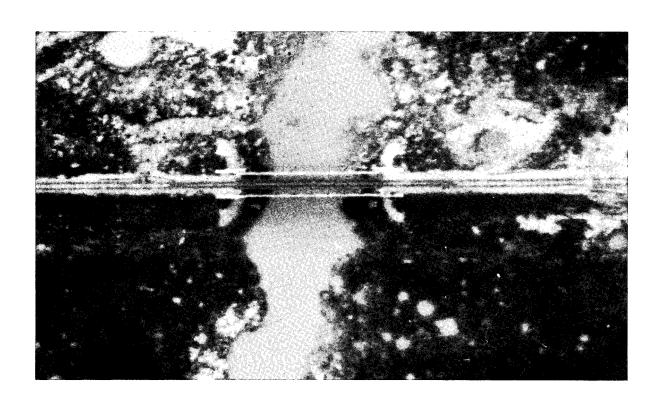
STATUS: Severely damaged, Bridge twisted and off abutment on one end.

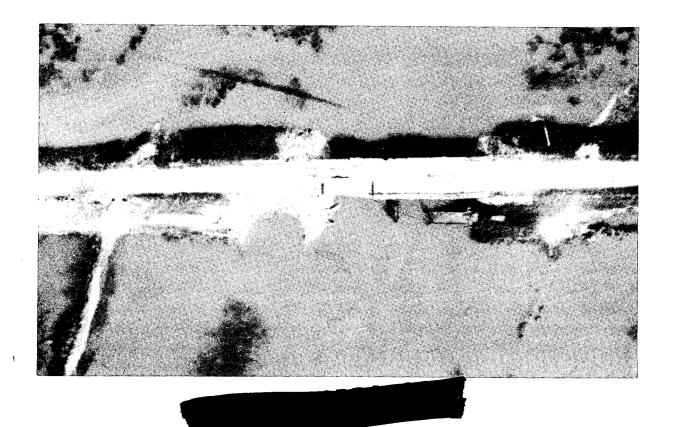
North end of bridge is severely damaged; abutment is undamaged.

COMPENSATIVE ACTION: Bypass of damaged section with planks.

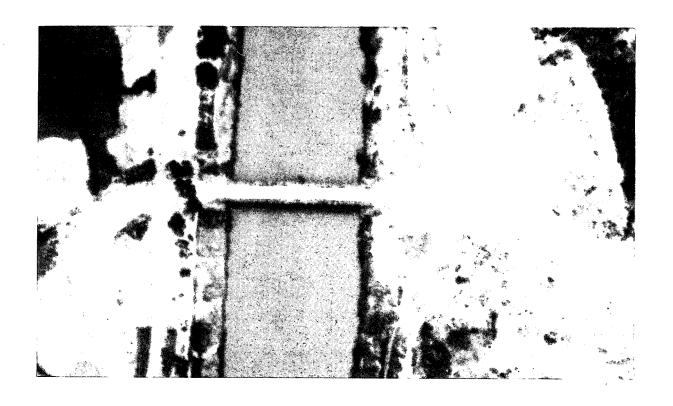
Note: This bridge was constructed to replace the destroyed bridge 700'

north (Bridge No. 25 on NE 48-7, PIB 65009

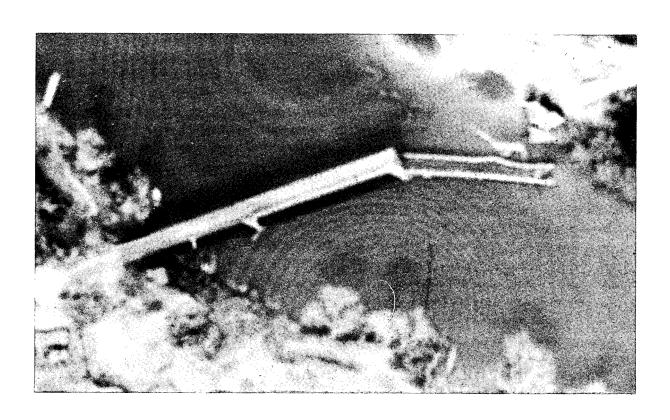
The 95' span is dropped and its structural members are distorted. STATUS: The adjacent approach span is destroyed. One pier is damaged.

COMPENSATIVE ACTION: None

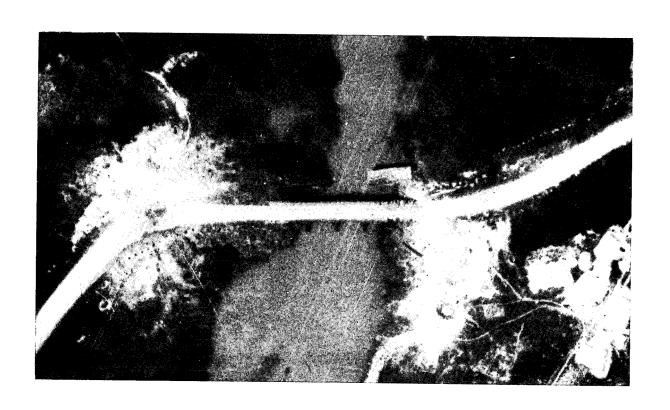
CIA	MAGERY ANALYSIS DIVISION	
NAME	COUNTRY	COORDINATES
Son Chan Hwy. Bridge		19 19N - 105 43E
Bridge No. 31 on NE 48-3	North Vietnam	WG 758 370
		BRIEF NO:
		PIB 65187
LOCATION: 0 3 W. F. C. C. C.	1 8-3	November 1965
DESCRIPTION: LENGTH WIDTH TYPE Deck	material Concre no. of spans 6 length of each span	te
status: 2 spans dropped, 1 a	butment damaged, l pier de	estroyed.
compensative action: Bridge has	been repaired.
