STATUS REPORT
for period
1 September through 30 September 1970
U. S. GOVERNMENT

The report period represented herein covers the
period 1 September through 30 September 1970.

PROGRAM SUMMARY

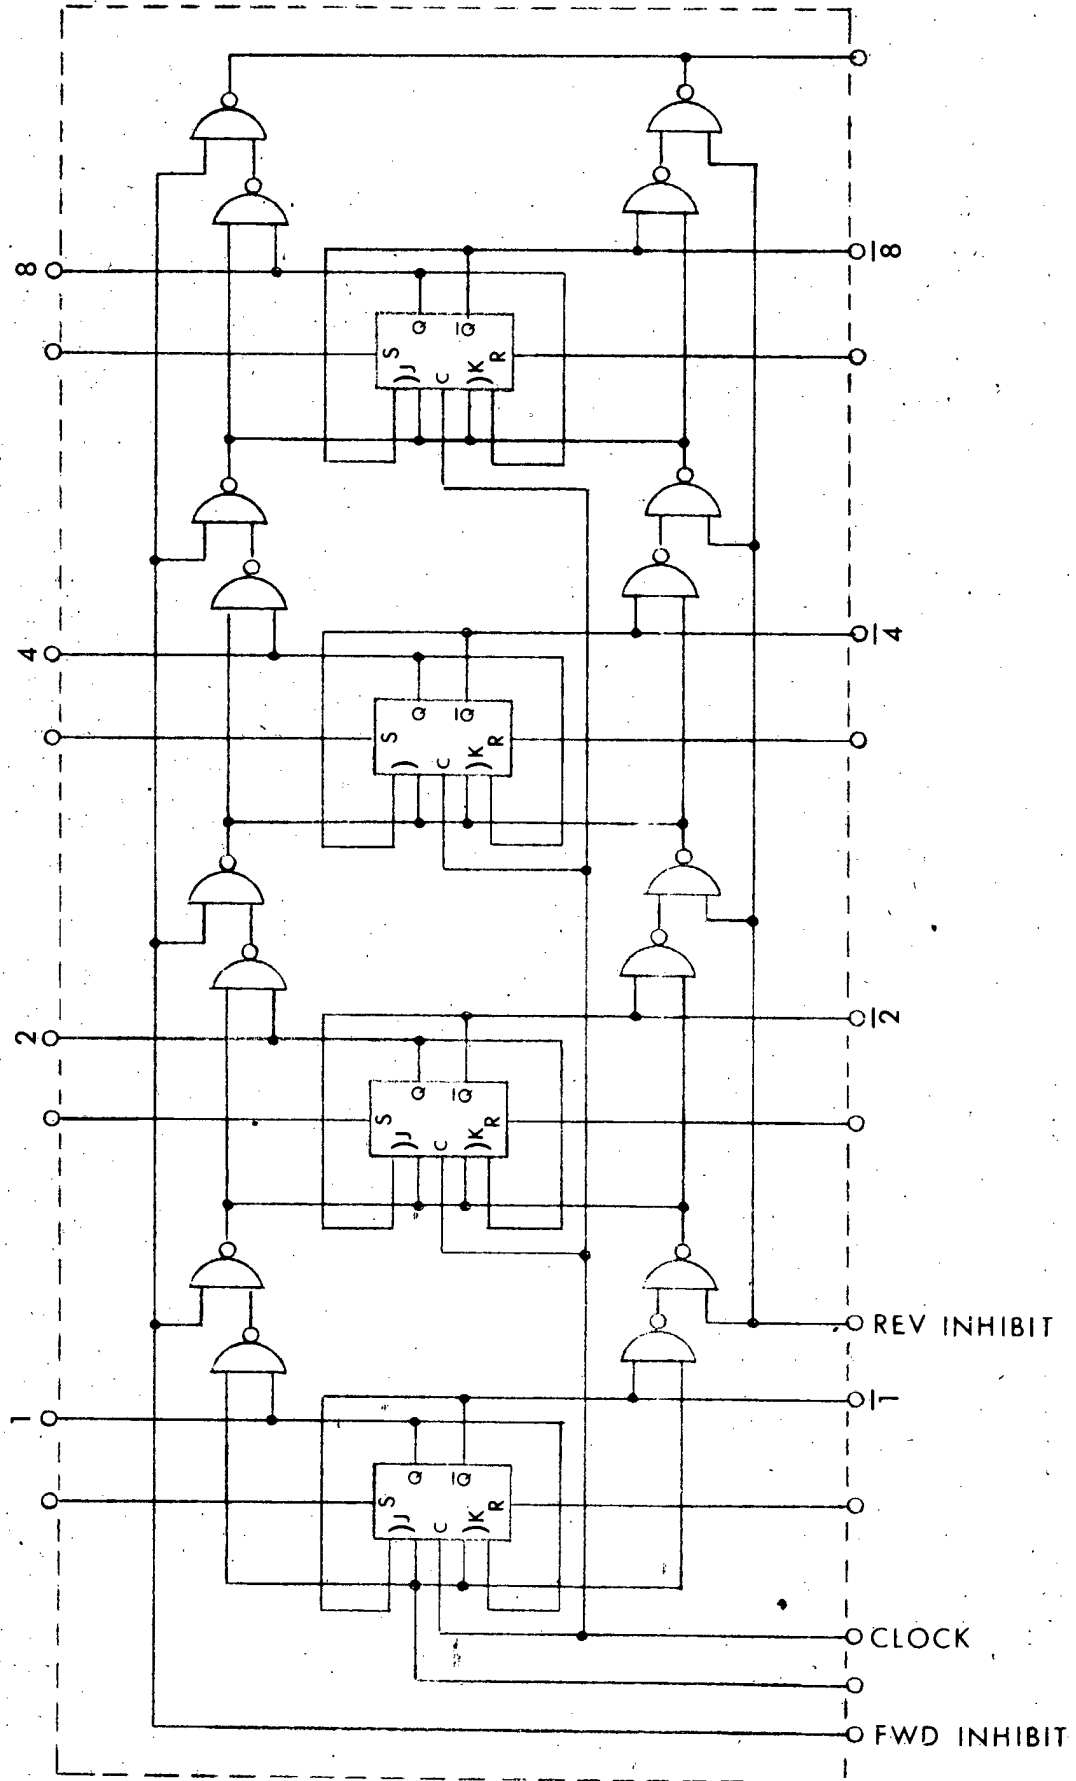
FIG T28-A SYNCHRONOUS COUNTER

A synchronous counter circuit of the type used in the machine is shown in Figure T28-A. It consists of J-K flip-flops and 2-NAND gates for carry and borrow pulses. The 2-NAND gates monitor the states of a given flip-flop and the forward-reverse count lines and enable or inhibit toggling of the next stage, depending on whether a carry occurs. For example, assume that the counter shown contains all zeros (0000). With the Reverse Inhibit line at Logic "1", the first clock pulse will merely toggle the first flip-flop in the string, giving a count of 0001. The next clock pulse will reset the first flip-flop on the trailing edge of the pulse. Meanwhile, however, since the first flip-flop is at a logic "1", the second flip-flop is enabled to toggle as well by the 2-NAND gates. Thus, at the end of the clock period, the counter contains the

Now, in operation, it may be seen that in between clock pulses, the carry signals are developed for the next count. Examination of the logic diagram for the counter shows, however, that the carry signals are propagated through two NAND gates per stage of the counter. Thus the propagation through a 23-bit counter is approximately 1.5 microsecond, maximum.

Now, since the state of any given flip-flop is determined by the state of the carry gates at clock time, it can be seen that if another clock pulse occurs before the

carry signals have fully propagated, then incorrect results will be obtained. And since the carry signals propagate from least significant to most significant place in the counter, it can be seen that any errors generated will be large ones. Thus, if a counter is going from 0000... to 11111... (zero to -1) and a pulse or noise occurs on the clock line at the time that the carry signal has propagated to (say) bit 16, then all higher order bits will be clocked to the incorrect state, and a very large error results; this error mechanism has been the source of much of the unsatisfactory performance in the counters.

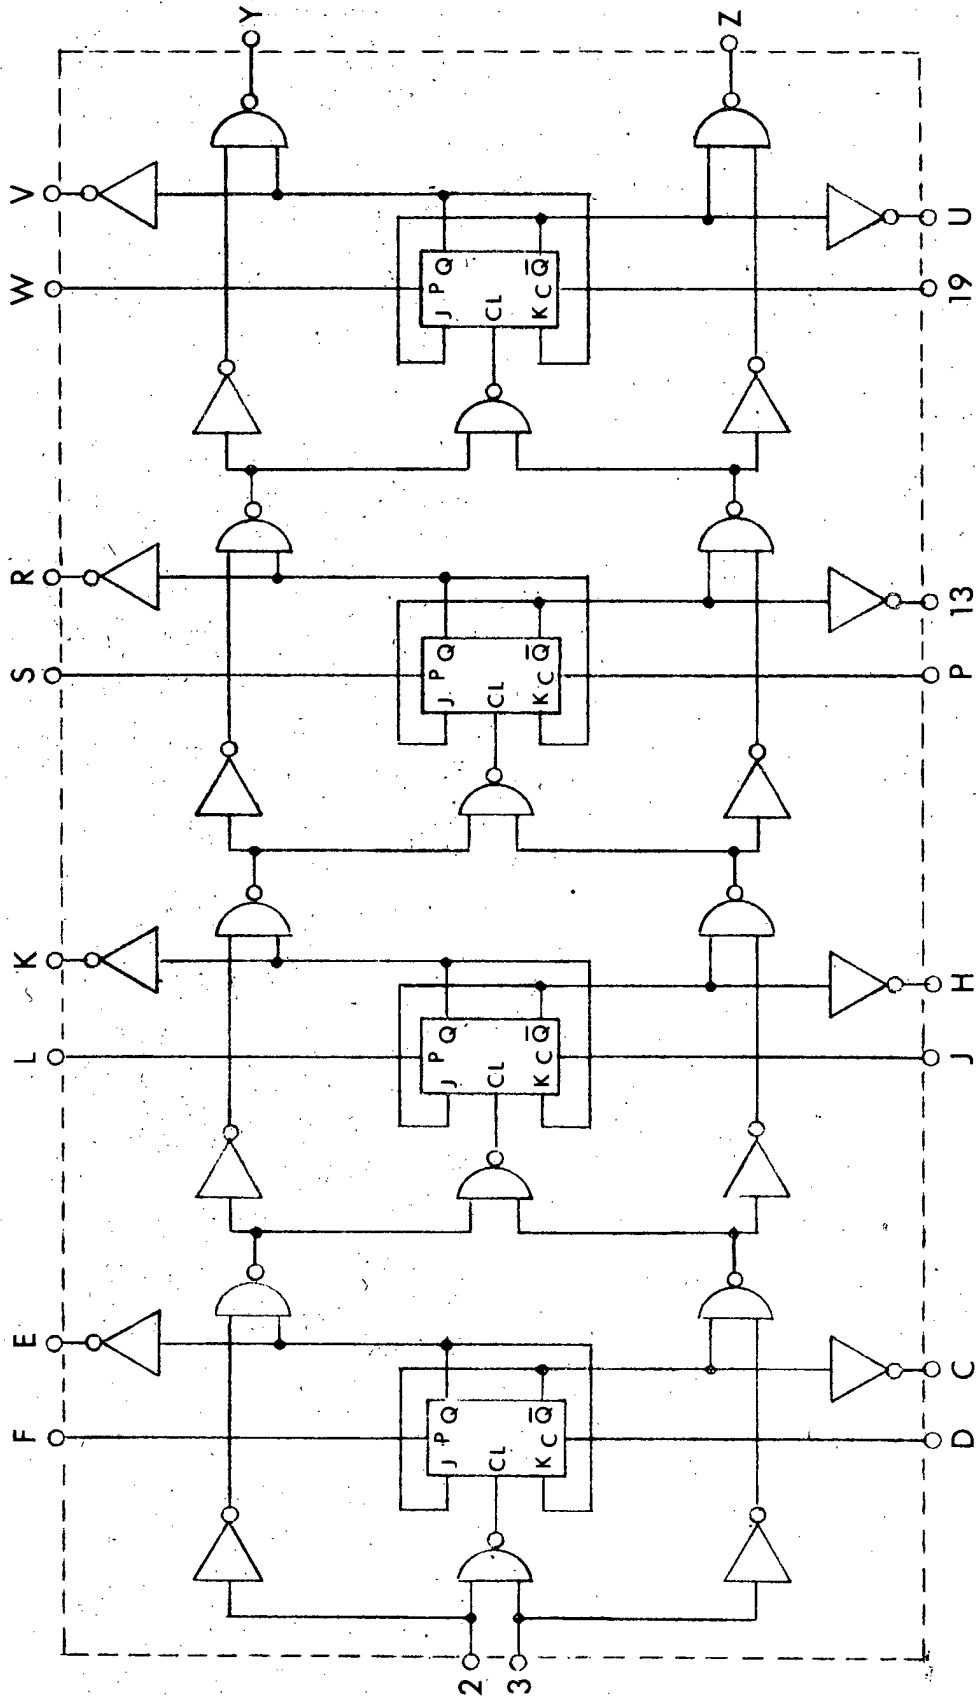
FIG T28-B ASYNCHRONOUS COUNTER

An asynchronous counter is diagrammed in Figure T28-B. In many respects the counters look very similar, the main difference between synchronous and asynchronous counters being the manner in which carry signals and clock signals are generated.

It will be noticed that the J-K flip-flop inputs are not used in this system; only the toggle (clock) input is required. Examination of the gating structure shows that the rule, for clocking any given flip-flop is, "if the preceding stage is at a Logic 1 and an "up" count comes into the system such as to

Thus, it may be seen that operation of any given flip-flop is dependent only on the state of the two previous flip-flops.

The input of the counter has no direct access to the higher order bits, since the clock signal for each stage of the counter is determined by the previous stage. It is thus impossible for the clock to get out of synchronism with the carry signals, since both the carry and clock signals are one and the same.

Thus, in order for a noise pulse to affect bit 16 of an asynchronous counter, it would be the 16,384th mistake on the input - a highly unlikely situation. The important advantage of this type of counter is that the effect of an erroneous noise pulse is to make the counter wrong by 1 count only. Also, since the counter can have inputs applied only at the input end of the clocking string, the speed at which the counter can operate is the speed of a single stage. It is even possible to have two counts propagating simultaneously through the counter with no bad effects! It is true that if one attempts to read out the contents of the counter before the carries have all rippled out, an erroneous reading will be obtained, but in our application we have buffers in the circuitry to eliminate this problem entirely. Any mistakes made are thus small (low-order) ones.

In conclusion, the asynchronous counter logic should be highly advantageous in solving the foregoing problems. The use of buffered asynchronous counter logic is thus indicated since it will provide:

In order to incorporate the improved counting logic within the Stereocomparator machine with a minimum of changes to the hardware, a new counter card is being designed which will be a plug-in replacement for the synchronous counter cards in the machine. Some slight modifications to the pulse-steering circuitry will be performed in order to accommodate the different input clocking arrangement for the asynchronous counters.
