## Fire on Soviet Nuclear-Powered Submarine

An Intelligence Memorandum

SI 81-10031  
April 1981

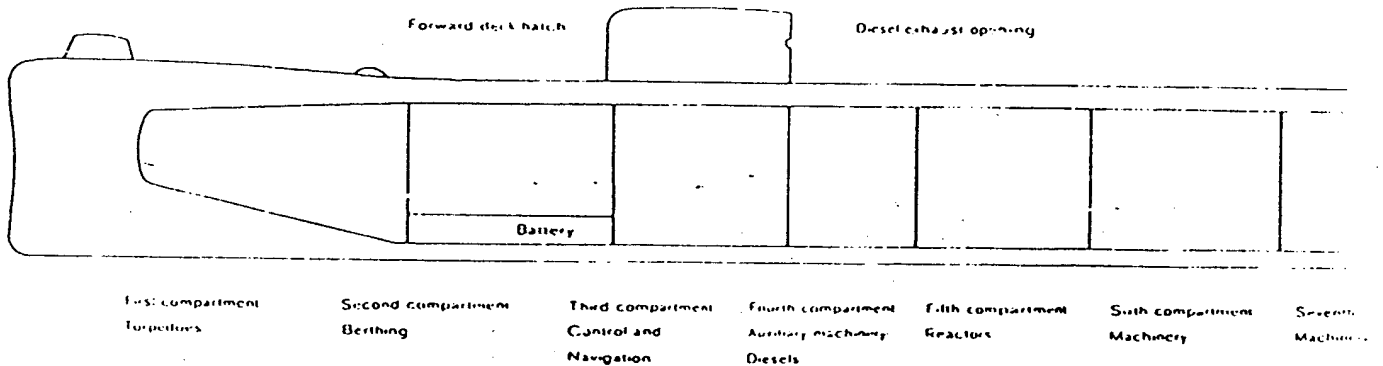
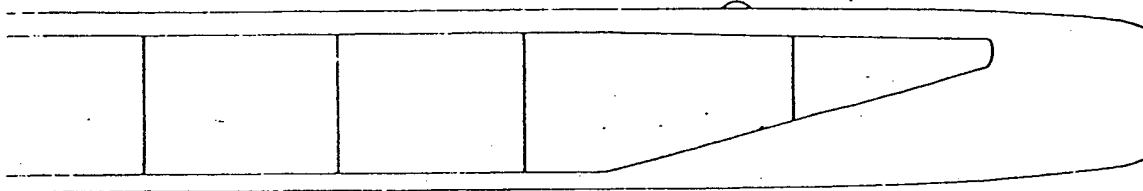
Figure 4

Officer berthing and the storage battery are located in the second compartment of the E-class submarine, the control center and the radio room are in the third, and the diesel generators are in the fourth (see figure 4). A toxic

Compartmentation of E-Class Submarine

gas generated by the flash fire may have incapacitated most, if not all, of the men in these compartments. We do not believe that the diesel generators were damaged by the accident because the port generator was running two days later.
