PHOTOGRAPHIC INTERPRETATION REPORT

SOVIET MILITARY ORDER OF BATTLE BALTIC MD

VILNIUS ARMY BARRACKS EAST
(54-41N 025-25E)
VILNIUS, LITOVSKAYA SSR, USSR
BALTIC MD

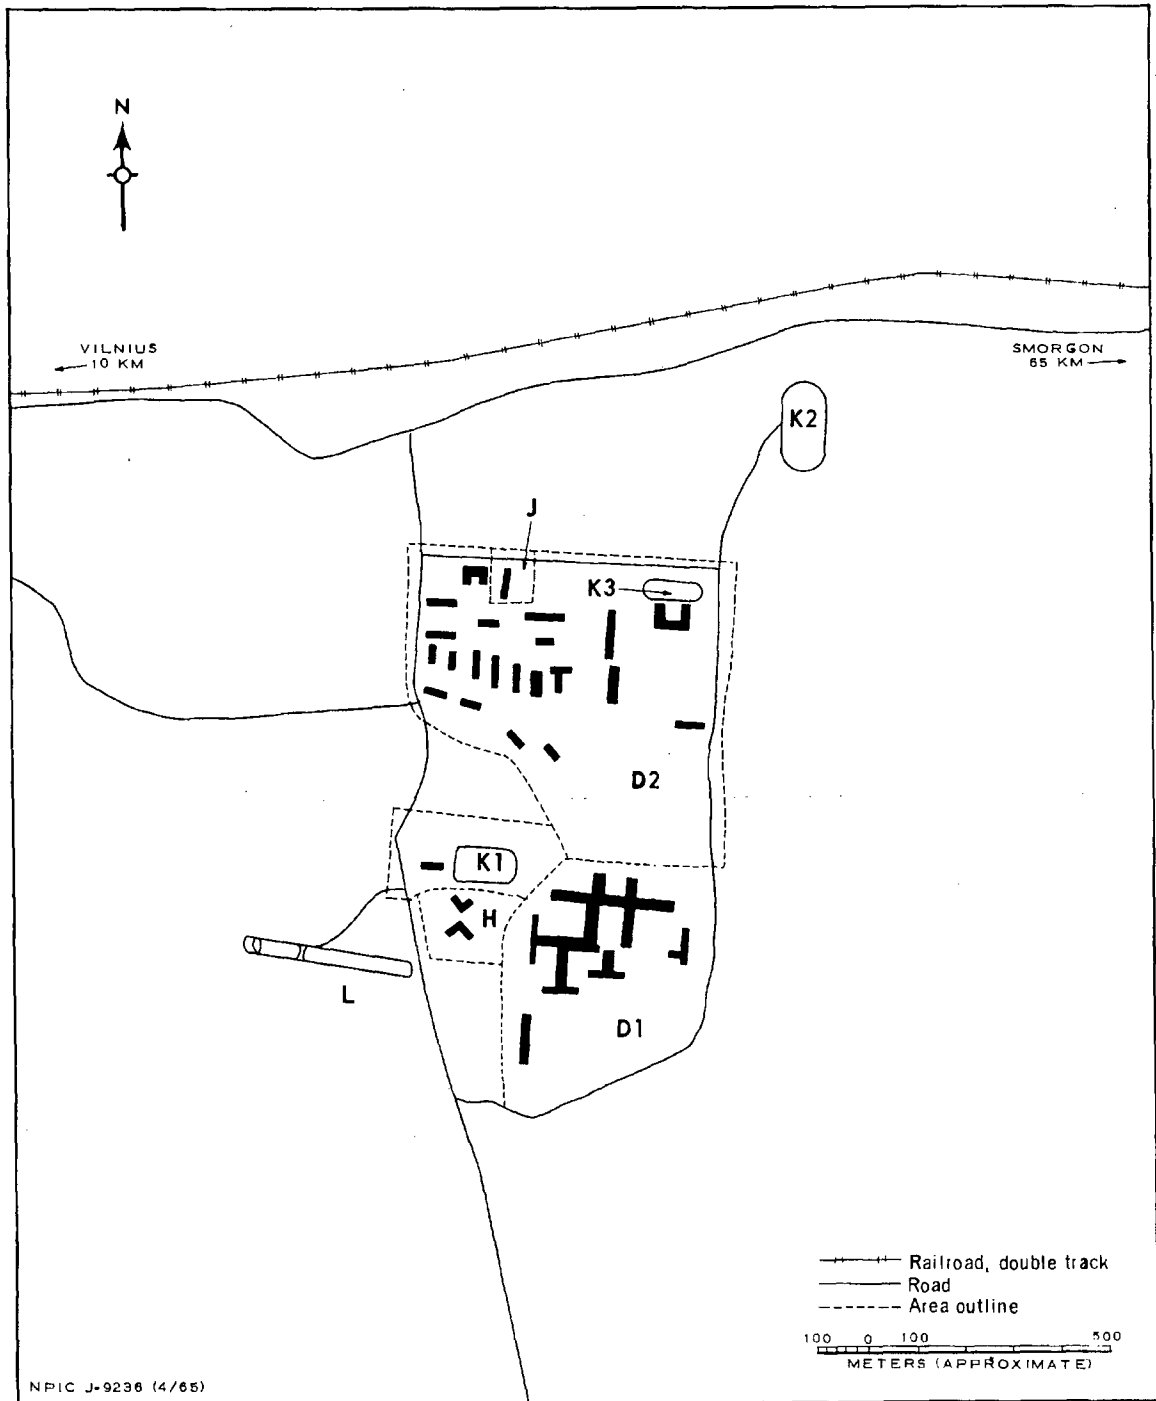
FIGURE 3. VILNIUS ARMY BARRACKS EAST. Sketch compiled from

Area D1 contains a large multistory, multiwing training building, 2 support buildings, and a storage building. Approximately half of the training building has never been roofed.

Area D2 contains 6 multistory barracks, 3 multistory probable barracks, 6 other barracks, 2 administration buildings, 3 support buildings and a multistory administration building with a parade ground and track.

Area H contains 2 unidentified buildings.

Area J contains a vehicle storage/maintenance building, 180 by 45 feet.

Area K1 contains an oval athletic track and a support building.

Area K2 contains a large oval track.

Area K3 contains a large oval track.

Area L contains a 1,100- by 90-foot firing range. The distance from the head of this range to the first firing wall is 720 feet, and the distance from the first firing wall to end of the range is 380 feet.
