PHOTOGRAPHIC INTELLIGENCE REPORT

~~POSSIBLE TACTICAL SURFACE-TO-SURFACE~~
MISSILE SUPPORT FACILITY
UZHGOROD, USSR

CIA/PIR 67265

DATE APRIL 1966
COPY
PAGES 13

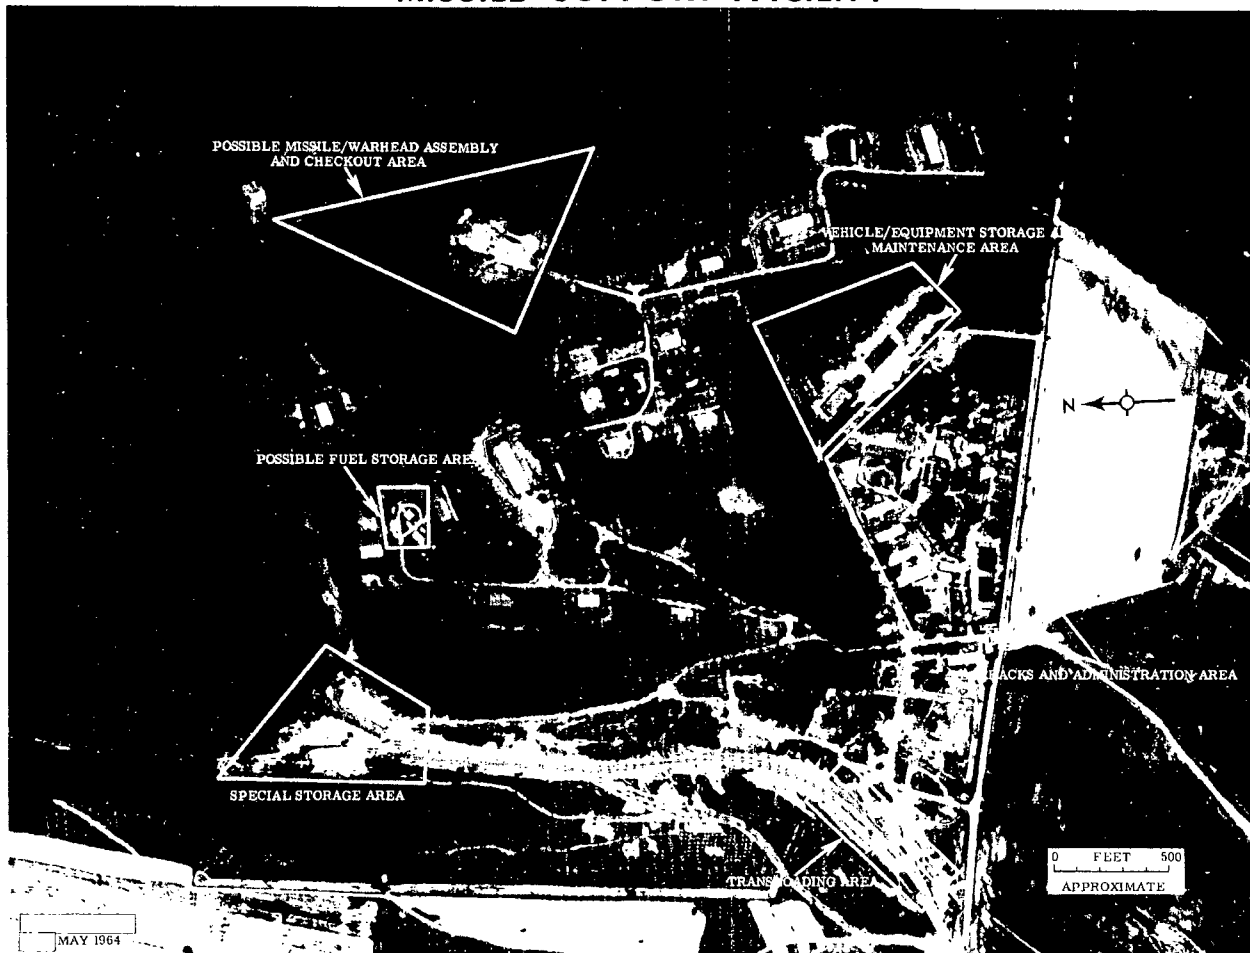
FIGURE 2

The possible missile/warhead assembly and checkout facility consists of a separately secured area containing one building and a hardstand with a 40 foot gantry crane. The internal security, crane, and hardstand bear resemblance to those observed at the surface-to-surface tactical missile support facility at [REDACTED]

The possible fuel storage area consists of a possible pump house associated with possible underground fuel tanks along a looped road. The facility does not appear to be separately secured.

A vehicle/equipment storage and maintenance area is located adjacent to the east side of the barracks and administration area. The area consists of 4 vehicle/equipment storage buildings (see Figure 3), a maintenance building, and a support building. The maintenance building appears similar to the irregularly-shaped maintenance building in the barracks and administration area at [REDACTED]. Most of the vehicles and equipment observed on May 1964 and more recent coverage have been located in this area.

The barracks and administration area consists of 6 barracks (see Figure 3), 8 quarters, an administration building, 2 probable vehicle sheds, a probable storage building, a possible messhall, a possible theater, a possible guardhouse, a probable guardhouse, and 5 support buildings. The personnel capacity has been periodically increased by the addition of new barracks.

The transloading area consists of a loop road adjacent to the railroad sidings. This area appears to be separately secured from the main depot area.

Photography [REDACTED] May 1964 (Figure 2) revealed that construction of the bunkers, possible missile/warhead assembly and checkout facility, a possible fuel storage area, and the rail line had been completed. Two vehicle/equipment buildings and a maintenance building had also been built between August 1962 and May 1964.
