## *Imagery Analysis Report*

Naro Fominsk Probable ABM Phased Array Radar Complex

NARO POMINSK PROBABLE AEM PHASED ARRAY RADAR COMPLEX

MARCH 1965 TO JUNE 1967

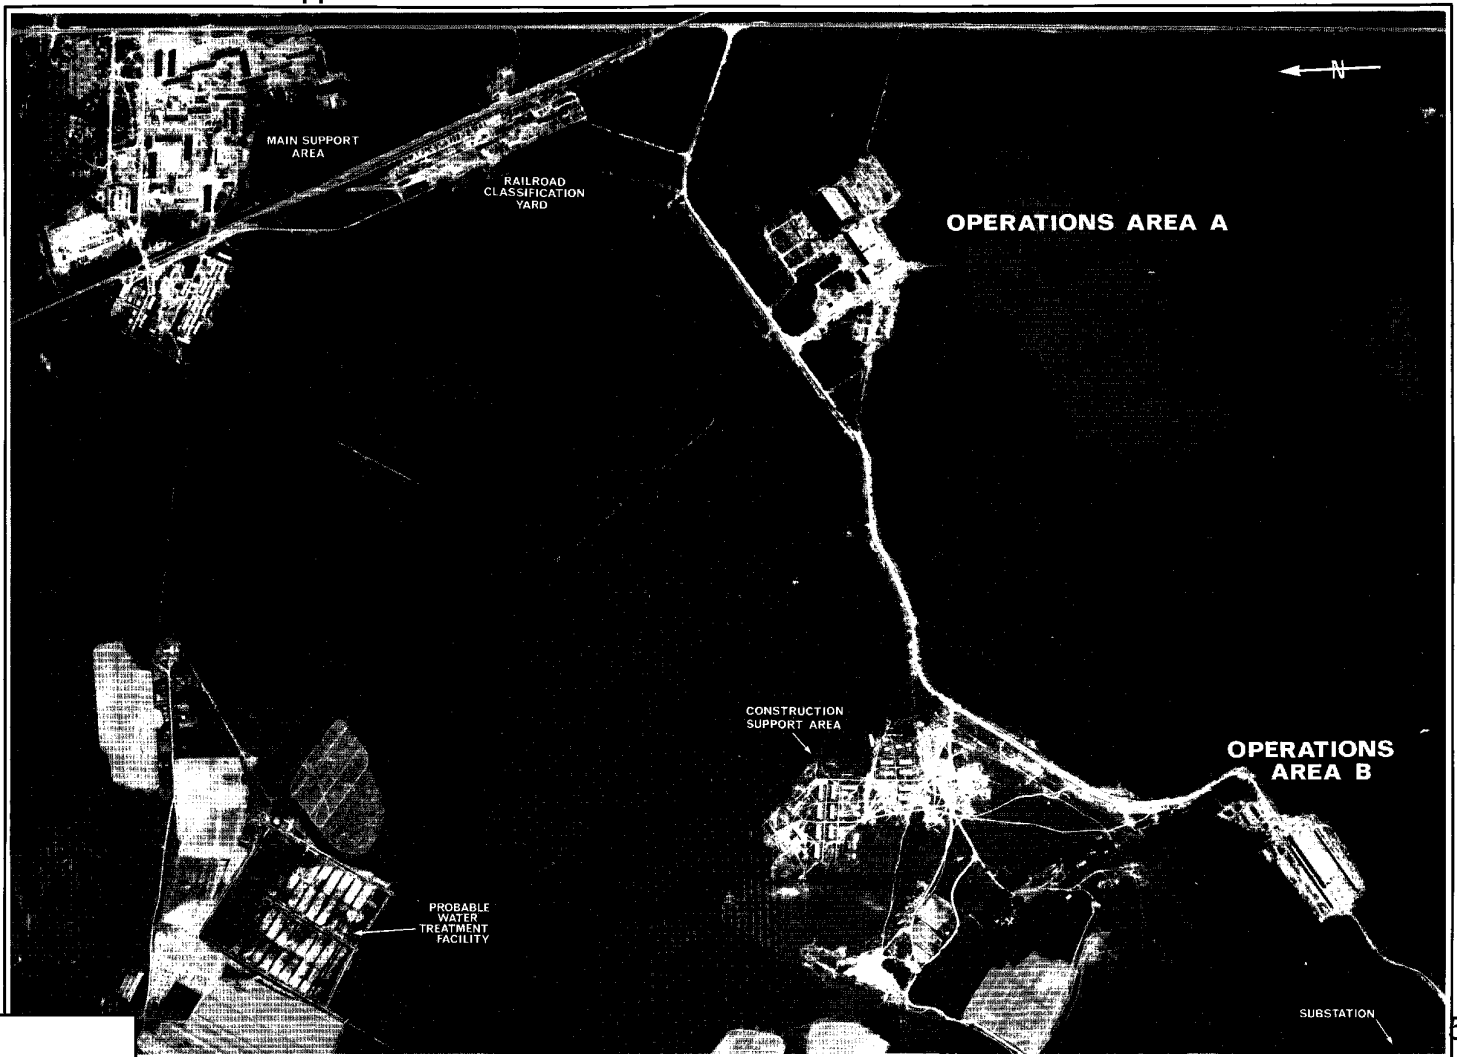
Figure 2

NARO FOMINSK DOGHOUSE RADAR COMPLEX AND RELATED FACILITIES.

Operations Area A is located in the southeast corner of the complex (Figure 2). The major structure in the area is a large A-frame antenna structure (Doghouse A), which has been under construction for over three years. Other permanent facilities include a control building, a T-shaped earth-mounded structure, and a steam plant. A photograph and drawings with detailed mensuration of the structures in Operations Area A are shown in Figures 4, 5, and 6.

A large probable water treatment facility (Figure 2) is located approximately 8,500 feet northwest of Doghouse A. Its relationship to the Doghouse complex is unknown at present. It was constructed concurrently with the Doghouse complex and consists of 43 earth-banked basins or compartments occupying some 35 acres. Each compartment is 300 feet long and 120 feet wide. Although facilities similar to this are found elsewhere throughout the Soviet Union, no known operations at the Doghouse complex would appear to require such an extensive treatment facility.

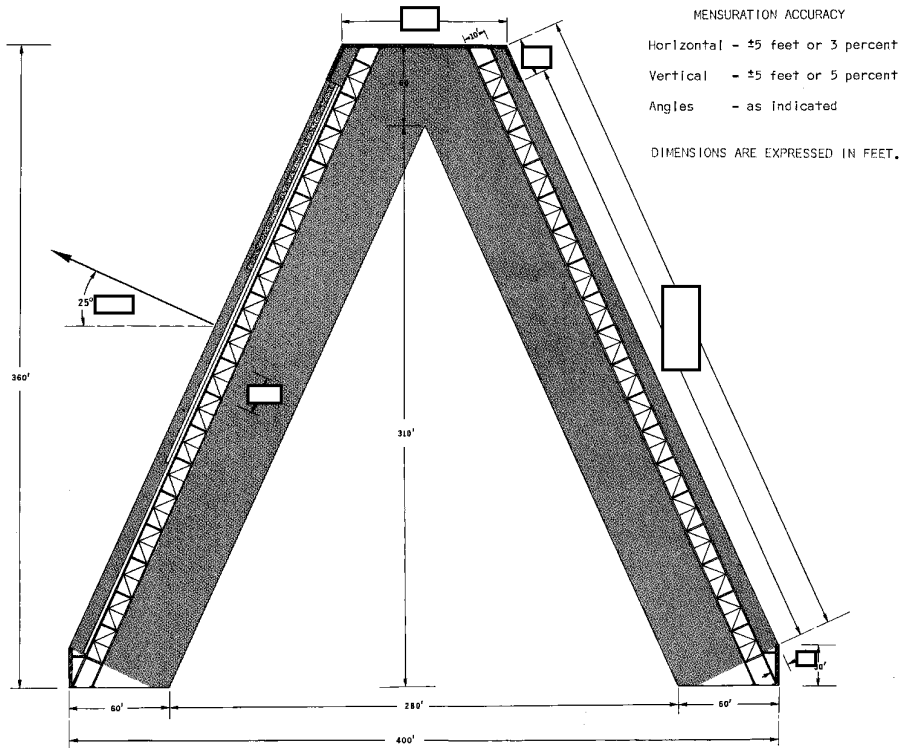
Figure 6

DRAWINGS ARE INTENDED FOR PRESENTATION OF PROFILE DIMENSIONS AND ARE NOT TO PRECISE SCALE.

PROFILE DIMENSIONS OF DOGHOUSE RADARS A AND B.

This is a large A-frame antenna structure, 400 feet square at the base and 360 feet high (Figures 5 and 6). It supports two 345 by 365-foot probable receiver antennas, one facing north-northwest and the other south-southeast. Both have bore-sight elevation angles of 25 degrees. A comparative graphic, showing the size of Doghhouse A relative to other large, more familiar structures, is shown in Figure 3.

The end walls of the A-frame are constructed of a solid material of undetermined thickness and are probably supported by a superstructure which is more massive than the inclined truss members within the face opening. The outer edges of the end walls on both sides of the A-frame extend approximately nine feet past the surface plane created by the inclined trusses (Figure 6). This would allow a maximum usable depth of [redacted] for application of face layers, assuming the final layer to be on an inclined plane coincident to the outer edges of the end walls. A wedge-shaped section appears to have been purposely omitted from the outer edge of the base along both sides for the full length of the structure (Figures 5 and 6). This omission may be a temporary feature for construction access, or a part of the original design. No accurate measurement is currently available for this section; however, based upon existing measurements and photo analysis, it appears that the base of the outer edge is approximately 30 feet above ground level. The result is a vertical wall 30 feet high which has been observed under construction and appears to meet the outer edge of the base of the end wall. This feature is illustrated in Figure 6.

d. Layer 4, Facing Material. Layer 4 (Figure 6) consists of a smooth light toned material forming a 20-foot-wide border along the top and both sides of the antenna structure. Although this border appears to overlap the antenna face by several feet, it does not seem to relate to the operation of the radar itself.

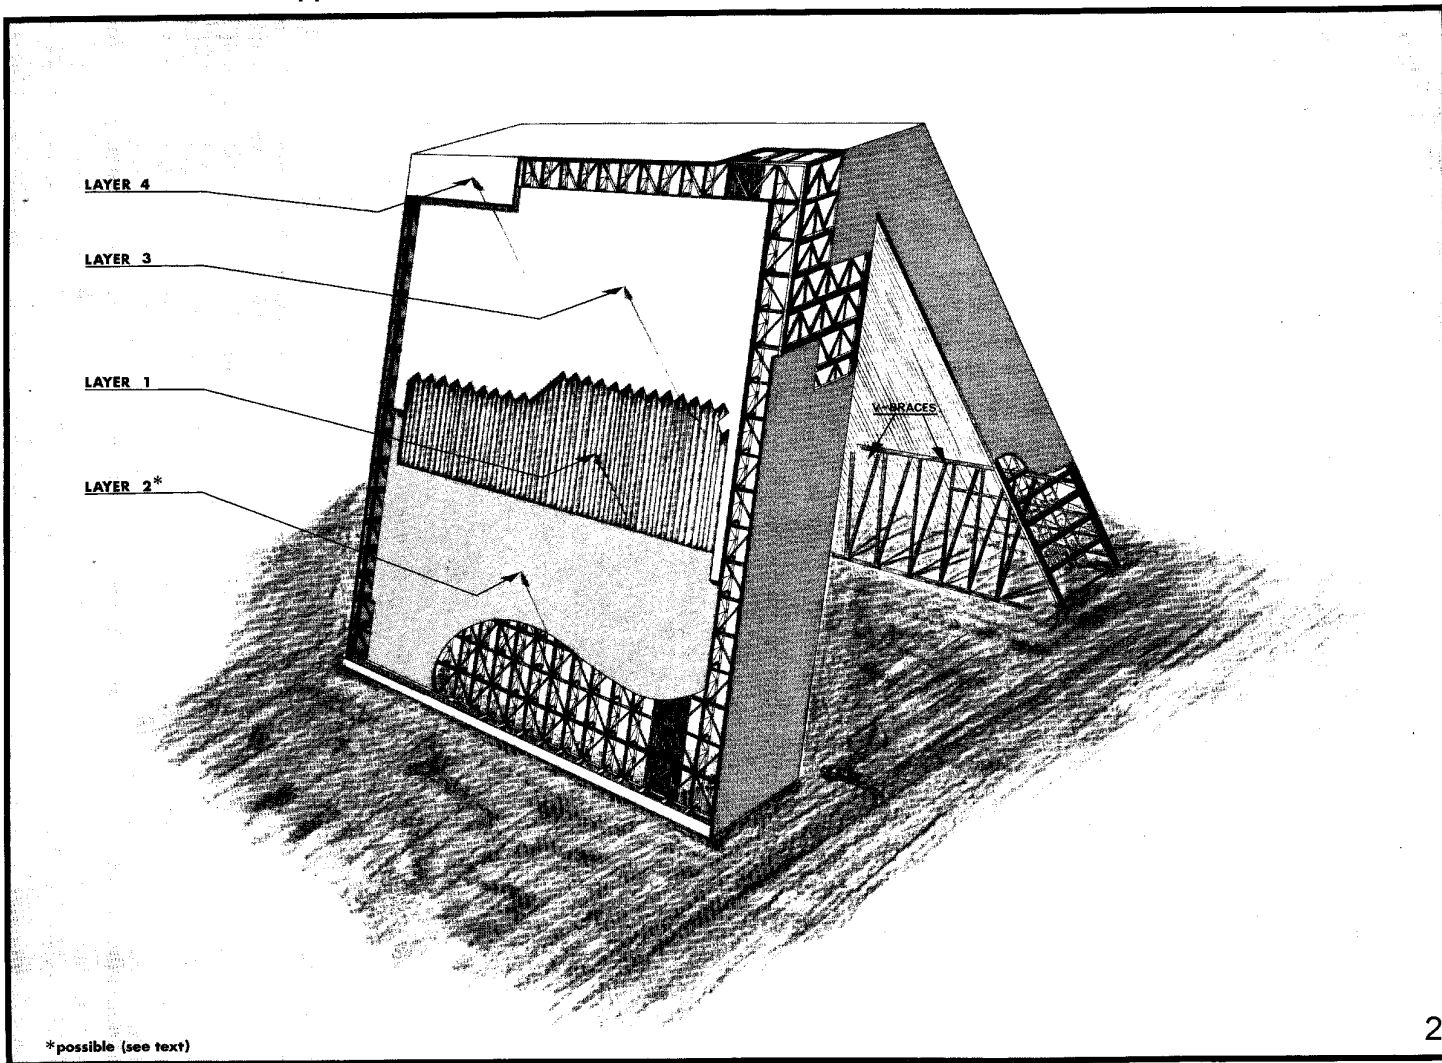
Figure 7

\*possible (see text)

Photography of [redacted] permitted the identification of a row of V-shaped probable counter-braces within the A-frame structure (Figures 7 and 9). The foundations for these counter-braces are set at 20-foot intervals, parallel to the base of the main truss

a. Layer 1, Facing Materials. The first material or component to be installed over or within the basic steel framework (Layer 1, Figure 7) consists of a vertical arrangement of approximately 50 adjacent, probable rod-like elements. Installation of these elements, each approximately five [redacted] feet in width

c. Layer 3, Facing Materials. Layer 3 (Figure 7) appears to consist of a series of sections probably ten-foot square and installed over the vertical rod-like elements (Layer 1), and is probably the thickest of the four layers. The probable square sections are light toned and are installed, commencing at the top, in lateral rows across the antenna face. Each square section is set at a 45-degree angle from the horizontal. The resulting configuration, during construction, is a saw-tooth pattern formed along the horizontal row being installed, as shown in Figures 7 and 10. A ten-foot wide column is constructed along the vertical borders of the face. It is apparently made of the same type material as the ten-foot squares, but with no evidence of a diagonal or saw-tooth pattern.

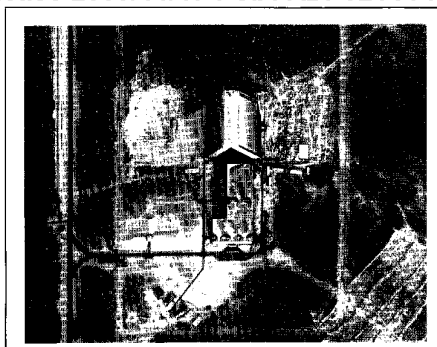
DOGHOUSE RADAR A, [redacted] Figure 12

Photography of the [redacted] pass was the best quality. The other two passes were identical to the [redacted] photography in both camera angle and time of day. The northwestern face was in shadow on all three passes, and no significant developments were visible. Only scattered remnants of the previously observed construction material remained in the cleared area in front of the northwestern face.

It is likely that the northwestern face is nearing completion and that little more construction detail will be observed from photography. Initial operation of the northwestern face can probably no longer be gauged by external construction progress. The complexity of interior construction has now become the principal factor governing this consideration. It should be noted, however, that similar large Soviet radars have become active, though not necessarily operational, before

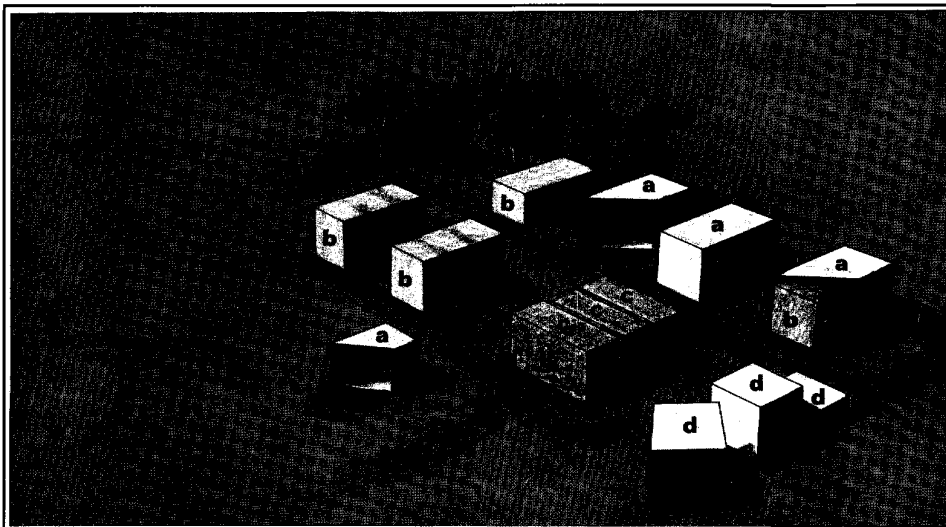
Figure 14

MAJOR TYPES OF CONSTRUCTION MATERIALS OBSERVED AT DOGHOUSE RADAR A.

While the types of construction materials vary, there appear to be four common sizes which have consistently been observed (Figure 14). The largest of the four (Figure 14a) is approximately [redacted] feet and is possibly some type of packing crate or container. It usually appears light toned and is frequently seen with a diagonal section removed from one end. Of similar size, but probably a foot or so shorter, is a rectangular object (Figure 14b) of varying shades of gray. At least one of these objects was observed partially encased within the light-toned larger crate (Figure 14a) in front of the southeastern antenna face. This object could be, or contain, a group of smaller pieces of material, as suggested by frequently observed differences in height and by the presence of nearby light-toned material on the ground.

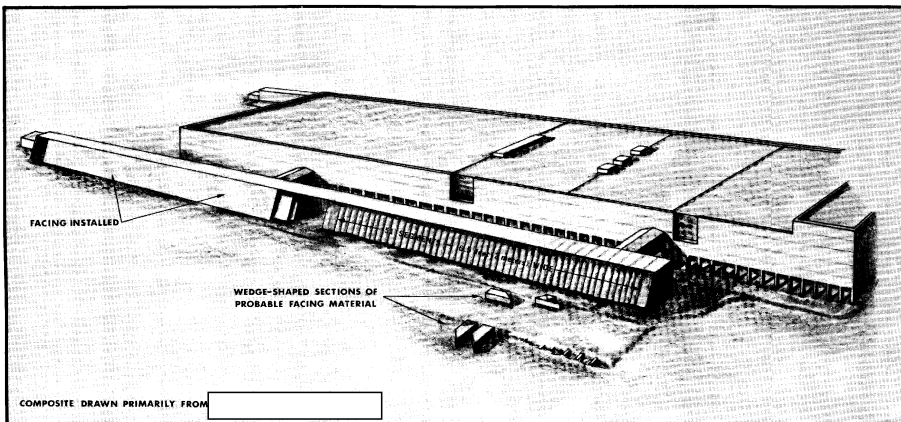
Figure 18

ARTIST CONCEPT OF DOGHOUSE RADAR B CONSTRUCTION.

Excellent quality photography of [redacted] provides the basis for the current knowledge of the internal antenna configuration (Figures 16 and 18). At this time the probable interior elements in part of the southeastern antenna structure were revealed, and it is from this observation that we derive the following analysis of the antenna.

a. Control Building. Both of the antenna structures are joined to a central control building by a pair of elevated, 15-foot-wide possible cableways (Figure 18). The building is 665 feet long, 200 feet wide, and [redacted] with a higher section on the northern end where the main entrance is located. It was externally complete in [redacted] The presence of doorways, or openings, was observed in [redacted] in the lower level of the southern wall for all but approximately 100 feet of the length of the building (Figures 15 and 18). A dark tone along the lower level of the building, observed on the latest photographic coverage, indicates that this open area is probably still present in both sides of the control building facing the rear of the antenna structure. Two "niches" or inset areas are present in identical locations in the upper portions of both side walls.

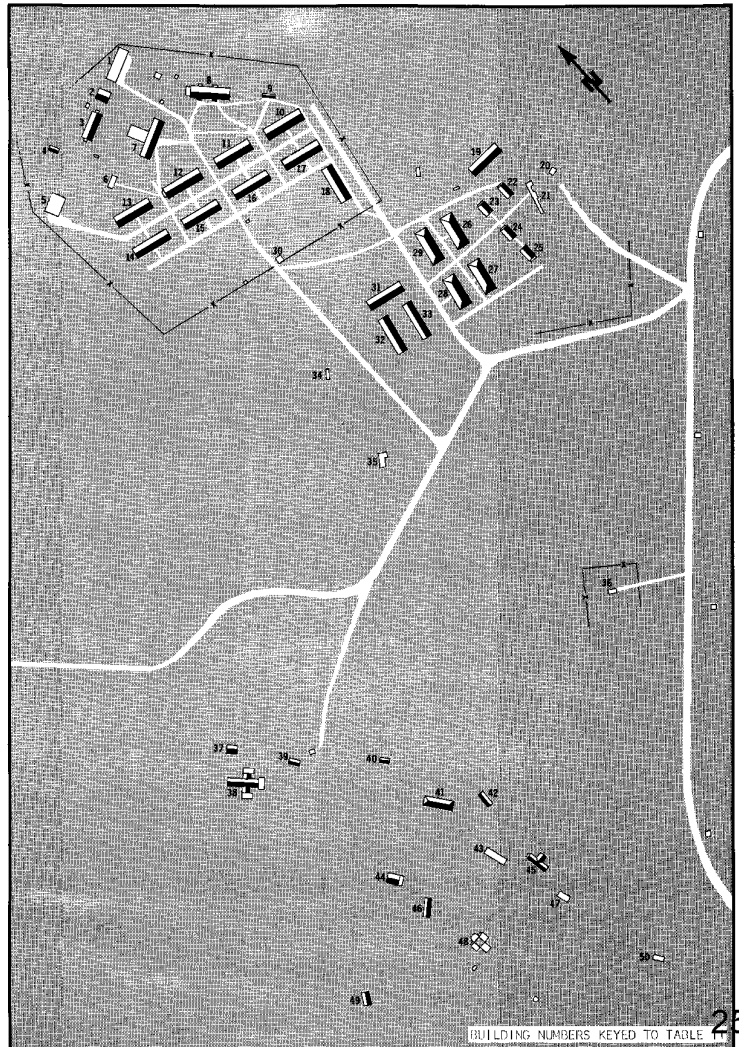
UNRECTIFIED LINE DRAWING OF CONSTRUCTION SUPPORT AREA.

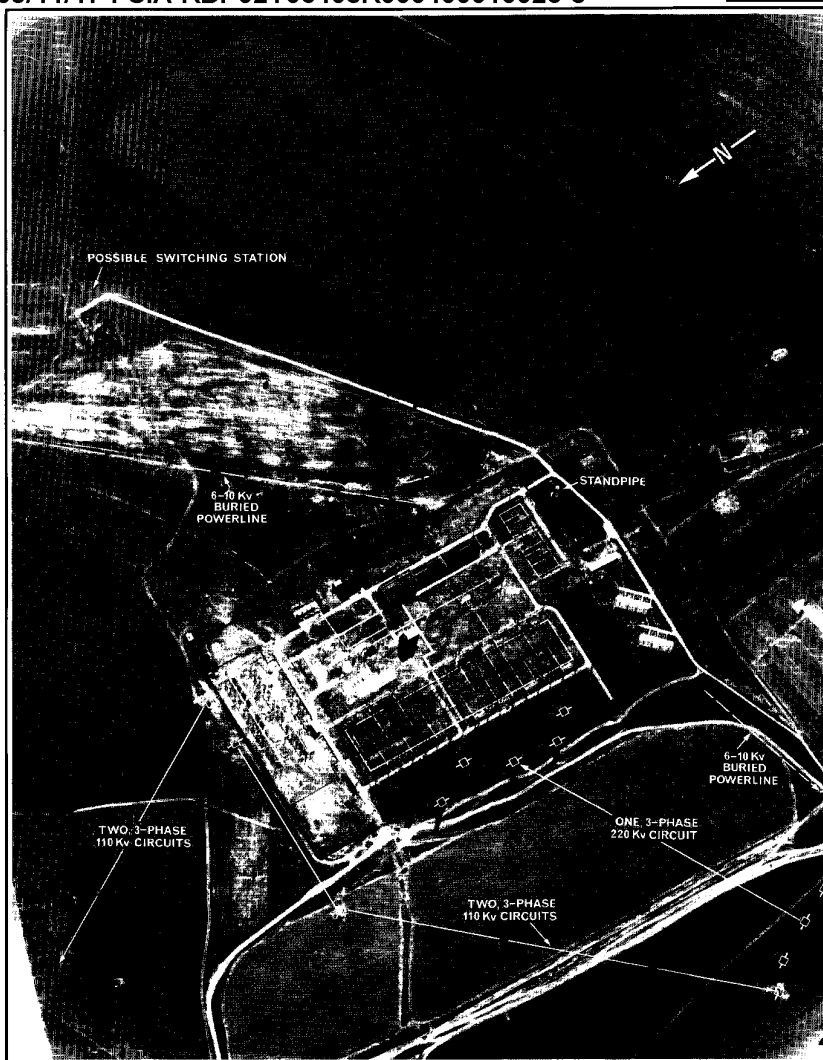
Figure 25

Item	Description	Dimensions (Feet)*
1	Control Building with Attached Switching Bay	70 by 100 50 by 255
2	Support Structure	45 by 75
3	Four Oil Storage Tanks	15 Feet Diameter
4	Support Structure	30 by 45 Overall
5	Support Structure	20 by 40
6	Possible Dumping Station	20 by 45
7	Transformer Repair/Service Facility	40 by 45
8	Stump/Plant	20 by 30
9	Support Structure	40 by 40
10	Support	25 by 95
11	Barracks	40 by 100
12	Barracks	40 by 100

POWER SUBSTATION
