PHOTOGRAPHIC INTERPRETATION REPORT

SSM HOUSING AND SUPPORT AREA AND OPERATIONAL SUPPORT FACILITIES SHUANG-CHENG-TZU MISSILE TEST CENTER, CHINA

JUNE 1967

NATIONAL PHOTOGRAPHIC INTERPRETATION CENTER

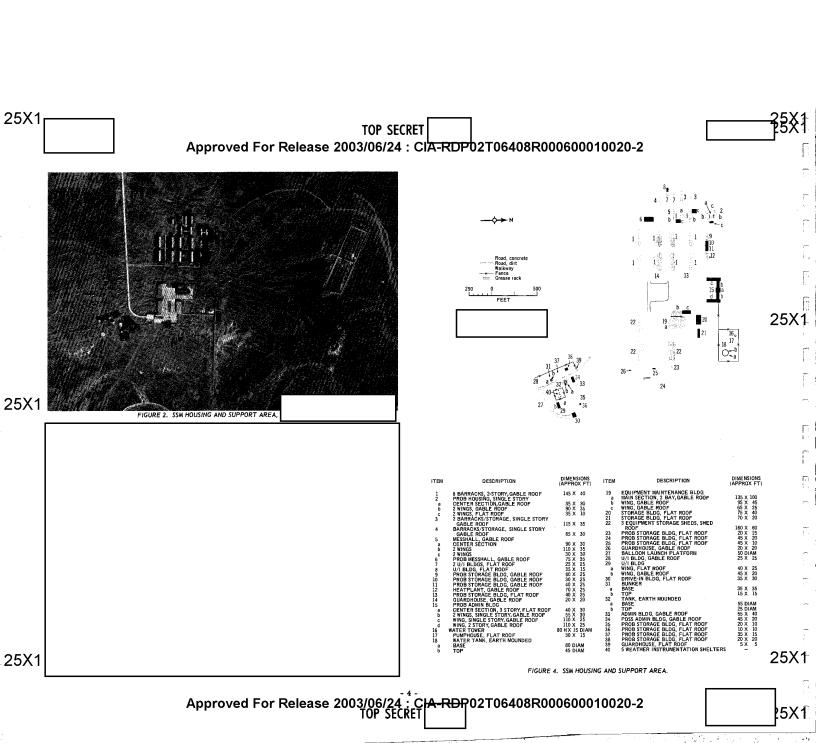
The SSM Housing and Support Area (Figures 2, 3, and 4) is located at 41-15N 100-19E, approximately 0.75 nautical mile (nm) east of the access road serving the launch complexes and approximately 1.5 nm east-southeast of Launch Complex A. The area contains, as it did in a housing section, a water supply facility, an equipment maintenance and storage section, and a meteorological station (Meteorological Station 1). These facilities provide direct support for the SSM launch complexes.

The housing section contains barracks, probable housing, barracks/storage, messhalls (1 probable), unidentified buildings, probable storage, a heatplant, and a guardhouse (items 1-14, Figure 4). Wings were added to the messhall, the probable messhall constructed, and 1 wing added to the probable housing between

The water supply facility is in the northeast part of the area and contains a water tower, a pumphouse, and an earth-mounded water tank (items 16-18).

The equipment maintenance and storage section contains equipment maintenance and storage buildings, storage and probable storage, and a guardhouse (items 19-26). A grease rack is at 1 end of the section and a new parking apron at the other. A wing was added to the equipment maintenance building and 1 of the probable storage buildings was extended between Construction began on 1 storage building (item 20) between and on the other (item 21) between

The meteorological station contains a balloon launch platform, unidentified buildings, a drive-in building, a bunker, an earth-mounded tank, administration and possible administration buildings, probable storage, and a guardhouse (items 27-39). A small secured area in the center of the station contains 5 weather instrumentation shelters (item 40). The possible administration building, 1 of the probable storage buildings (item 36), and the addition to 1 of the puridentified buildings were constructed between

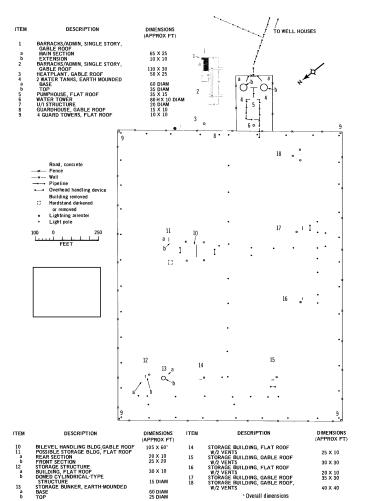
FIGURE 7. REVETTED STORAGE AND HANDLING AREA.

Supporting facilities for the area include 2 barracks/ administration buildings (items 1 and 2, Figure 7), a heatplant (item 3), 2 earth-mounded water tanks (items 4), a pumphouse (item 5), and a water tower (item 6). One of the barracks/administration buildings was constructed be-

tween	
The tank-like structure	(item 7) was constructed in
	One side of the structure has
a wedge-shaped indention i	n it. Two wellhouses, 1 con-
structed in	are near the area.

The main portion of the area is separately secured and well lighted. A guardhouse (item 8) is at the entrance and guard towers (items 9) are at each corner.

The handling building (item 10) is at the approximate center and is surrounded by a concrete hardstand. The northwestern part of the building is approximately 10 feet high and the southeastern part approximately 15 feet high. Overhead handling devices are at each end and lightning arresters on each side. The small building at the end of the hardstand may be used for storage.

The storage structure in the northwesternmost corner (item 12) is revetted and has a lightning arrester. Touching the building is a domed cylindrical-type structure similar to that at Moskva SAM Storage Site 6, USSR. The next structure (item 13) is a drive-in, earth-mounded, round

All of the remaining storage buildings (items 14-18) are revetted, fronted by a concrete hardstand, and have at least 1 lightning arrester each. Two of the buildings (items 15 and 17) have overhead handling devices and all but 1 (item 18) have covered entrances.

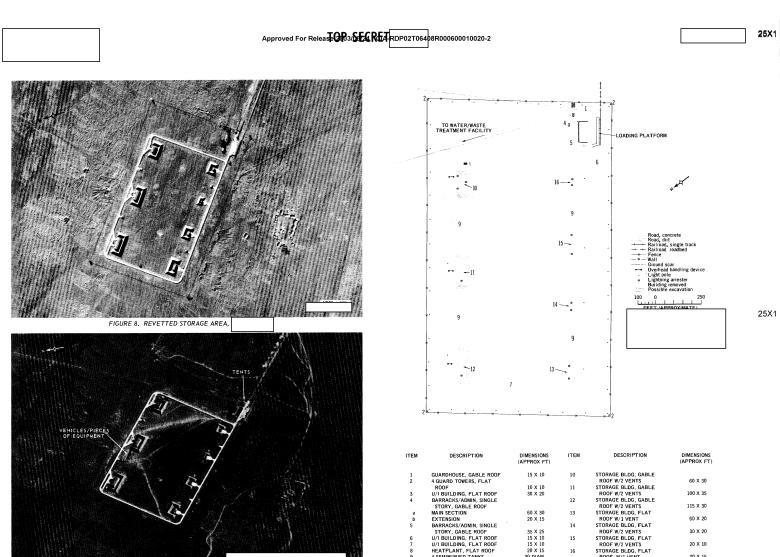
FIGURE 9. REVETTED STORAGE AREA,

The Revetted Storage Area (Figures 8, 9, and 10) is approximately 0.5 nm west of the Revetted Storage and

Handling Area. The entire area is secured and lighted			
and contains approximately 15 buildings, 2 of them new			
and 1 extended since Also since that time, 1			
small building has been removed and a small wall added.			
There are still no garden plots in the area.			
Activity was observed in the area or			
) when 2 tents and 12 vehicles/pieces of equip-			
ment were present. As with the Revetted Storage and Han-			
dling Area, this also is the only time that tents and vehicles/			
pieces of equipment have been observed in the area.			
The road and rail serving the area have never been			
completed even though those within the fence were already			
complete when first observed in A guardhouse			
(item 1, Figure 10) is at the entrance to the area and a			
guard tower (item 2) at each corner. The building next to			
the fence (item 3) was built between			
One of the barracks/administration buildings (items 4 and

5) was extended between Items			
6 and 7 are small unidentified buildings. The heatplant			
(item 8) was constructed between			
Construction began on the water/waste treatment facil-			
ity between The ditch extending			
south of the fence was dug in			
At the end of the ditch there appears to be a hole which			
may contain a small tank.			
Four road-served semiburied tanks (items 9) are inter-

spersed among the revetted storage buildings (items 10-16). Each of the storage buildings is also road served and each has at least 1 lightning arrester. Three of the buildings (items 10-12) have overhead handling devices.

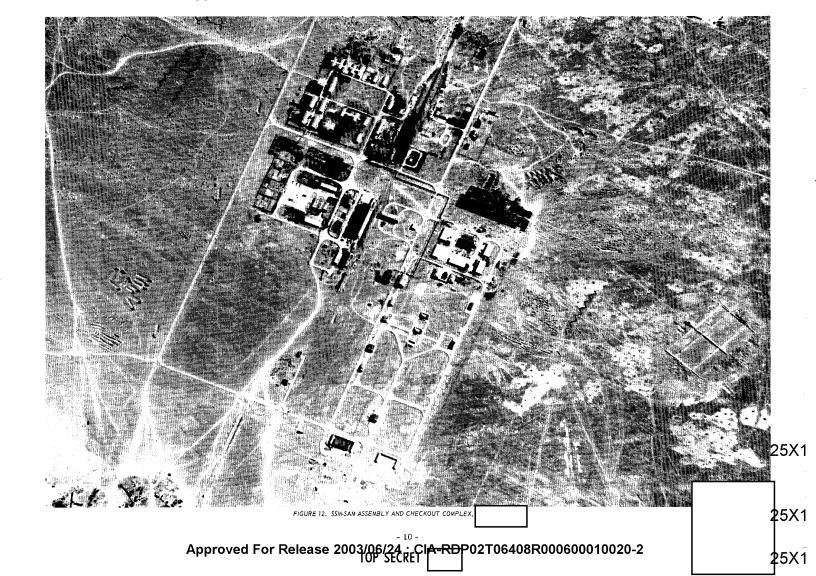
FIGURE 13. SSM-SAM ASSEMBLY AND CHECKOUT COMPLEX.

The SSM-SAM Assembly and Checkout Complex (Figures 11, 12, and 13) is located at 41-06N 100-16E, 7.5 nm northeast of the Main Support Base. It consists of a Housing and Support Area, the SSM Assembly and Checkout Area, and the SAM Assembly and Checkout Area. All areas are served by rail and concrete road and are well lighted. (Lights are not shown for the housing area.)

The Housing and Support Area contains approximately 30 buildings. The northern portion of the area contains barracks, housing, messhalls, and support buildings (items 1-7, Figure 13). On the northern side of the rail line is a rail transfer point and a motor pool (items 8-12) with a grease rack. On the southern side of the rail line is another transfer point with storage buildings (items 13-16) and a liquid unloading and storage facility (items 17-19). Items 17-19 are connected by pipeline. Opposite the pumphouse (item 19) next to the loop road is a fuel pump. The function of the building (item 20) enclosed by the other loop road is undetermined.

A small heatplant (item 25) supplies the northern part of the housing and support area while the large heatplant (item 26) supplies the remainder of the complex. Earthmounded tanks (items 27), a pumphouse (item 28), and a water tower (item 29) are the water supply facilities for the complex. A tank-like structure (item 30) near the pump or valve house has a wedge-shaped cut in it. The object is new since ______ and is similar to one at the Revetted Storage and Handling Area.

The SSM Assembly and Checkout Area is secured and contains approximately 10 buildings and a soccer field. Three rail spurs serve the area and 1 of the spurs enters the assembly and checkout building (item 1). The spur at the western end of the area was extended beyond the fence between

The assembly and checkout building consists of a tall gable-roofed portion and a low flat-roofed portion. The small building next to it (item 2) was extended between

Item 5 is a small, high (approximately 20 to 25 feet) building and its function is undetermined. There is a similar building (item 15) in the SAM Assembly and Checkout Area and another in the Probable Propellant Handling and Storage Area.

Two equipment sheds (items 9) are next to the equipment maintenance building (item 10). Buildings identical to these are found in the SAM Assembly and Checkout Area and in the SSM Housing and Support Area. It is on the large concrete hardstand opposite the equipment and maintenance building that numerous vehicles/pieces of equipment have been observed. A grease rack is on the road opposite the eastern equipment shed.

The northernmost building (item 11) is probably a horizontal engine test cell and is similar to a building at the operational support facility of Chin-hsi Cruise Missile Launch Site. At 1 end is an open extension containing a blast deflector or flame bucket and on 1 side is a shed.

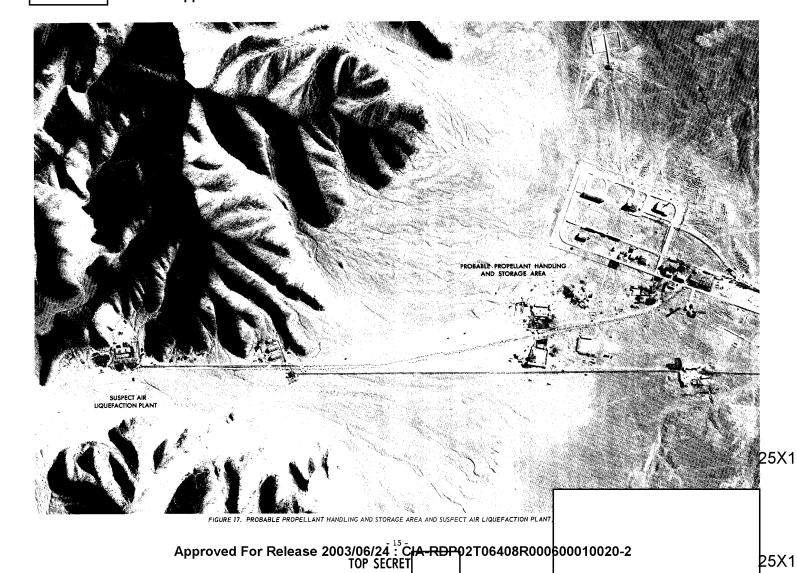
FIGURE 18. PROBABLE PROPELLANT HANDLING AND STORAGE AREA.

road. Since four buildings have been added for a total of approximately 20 buildings, 1 building has been extended, and a platform has been built opposite the new extension. The number of garden plots appears to be approximately the same as it was in	stand. On the other side of the building are 2 liquid unloading columns. Rail cars are often located adjacent to these columns. The next concrete hardstand is opposite 1 unloading column. On coverage 4 unidentified objects are	The suspect plant building (item 15) has vents roof and tall windows along the side. It and an ad building (item 16) both have bilevel roofs with the bp in each case being the higher part. The suspect c tower (item 9) was constructed between
The maintenance section contains 3 single-story bar- racks/storage buildings (items 1-3, Figure 18), 2 storage buildings (items 4 and 5), and a possible heatplant (item 6). One of the barracks/storage buildings was built between	located in the intervening space. It cannot be determined if they are still present. The next building (item 14) is not served by a concrete apron. The next building (item 15) was built between	It replaced a tower which had been structed between The pect cooling tower is connected by pipeline to a wate (item 10). Eight other buildings (items 8, 11-14, 17-1 near the suspect plant building. There is no evide

and 1 of the storage buildings was built between The secured water supply facility contains a pumphouse (item 7), 2 earth-mounded water tanks (items 8),	The next 2 buildings (items 16 and 17) share the same parking apron. Two towers/unloading columns are located opposite them. Item 17 is connected to the next 2 buildings (items 18	cryogenic-type storage tanks and there is no rail line ing the plant area. The small barracks area is east of the suspect building and contains 2 single-story barracks (items
and a water tower (item 9). A water/waste treatment facility is north of the area.	and 19) by an overhead pipeline. The center building (item 18) has a stack or rod on its roof and is not served by a concrete hardstand. The bunkered building (item 19) also	6), a messhall (item 7), and 3 other structures (items A substation with a building (item 1) is east of the barn The new area of unidentified activity is located r

The operations section is well lighted and secured and contains 11 buildings, 3 liquid unloading columns, 4 towers/ unloading columns, and 2 mounds. The largest building in the section (item 10) was extended between and a platform was built opposite the extension.	is not served by a concrete hardstand. It does have 4 entrances, each with a concrete apron, facing the rail line. A flat-roofed building (item 20) approximately 20 or 25 feet high is located near the entrance to the section. It is	east of the plant building. Items 20-22 are probably of ment sheds and item 23 is a heatplant. The functions remaining structures (items 24 and 25) cannot be determined by the control of the plant of
A stack is on the eastern side of the building and 2 towers/ unloading columns are on the western side. The towers/ unloading columns are connected to the building by a con- veyer or pipeline.	similar to 2 buildings in the SSM-SAM Assembly and Check- out Complex. Item 21 is a guardhouse and item 22 is uniden- tified. A building (item 23) is located outside the fence at the

The next building (item 11) is earth banked on the eastern and southern sides and has a bay approximately 30 feet high at its northern end. A mound approximately	northern end of the section. It was built between A possible stack approximately 20 feet in diameter is adjacent to it. The building is next to a road built between

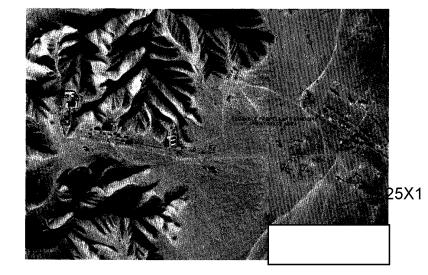
FIGURE 19. SUSPECT AIR LIQUEFACTION PLANT NEAR THE PROBABLE PROPELLANT HANDLING AND STORAGE AREA.

TOP SECRET Approved For Release 2003/06/24 : CIA RDP02T06408R000600010020-2	
PROBABLE PROPELLANT HANDLING AND	30 feet in diameter is south of the building and a mound approximately 20 feet in diameter is northeast of the building.	Suspect Air Liquefaction Plant The previously reported area of unidentified a approximately 1 nm west-northwest of the Probable
STORAGE AREA The Probable Propellant Handling and Storage Area (Figures 17 and 18) is 4.5 nm northeast of the Main Support Base at 41-03N 100-13E. It is served by rail and concrete	The rail-through building (item 12) is flat roofed and is approximately 20 feet high. The building in the northwest corner of the section (item 13) is adjacent to, but not touching, a concrete hard-	pellant Handling and Storage Area can now be identificontaining a suspect air liquefaction plant (Figures 19), a small barracks area, and a new area of unide activity.
