Subject: INVESTIGATION OF ACCIDENT TO U-2F SERIAL NO. 342

INVESTIGATION OF ACCIDENT TO  
U-2F SERIAL NO. 342

SUBJECT: METALLURGICAL ANALYSIS OF SECTIONS OF FAILED WING,  
MODEL U-2, S/N 342

SUBJECT: Chronological Events of Article 342 Accident (Search and Recovery)

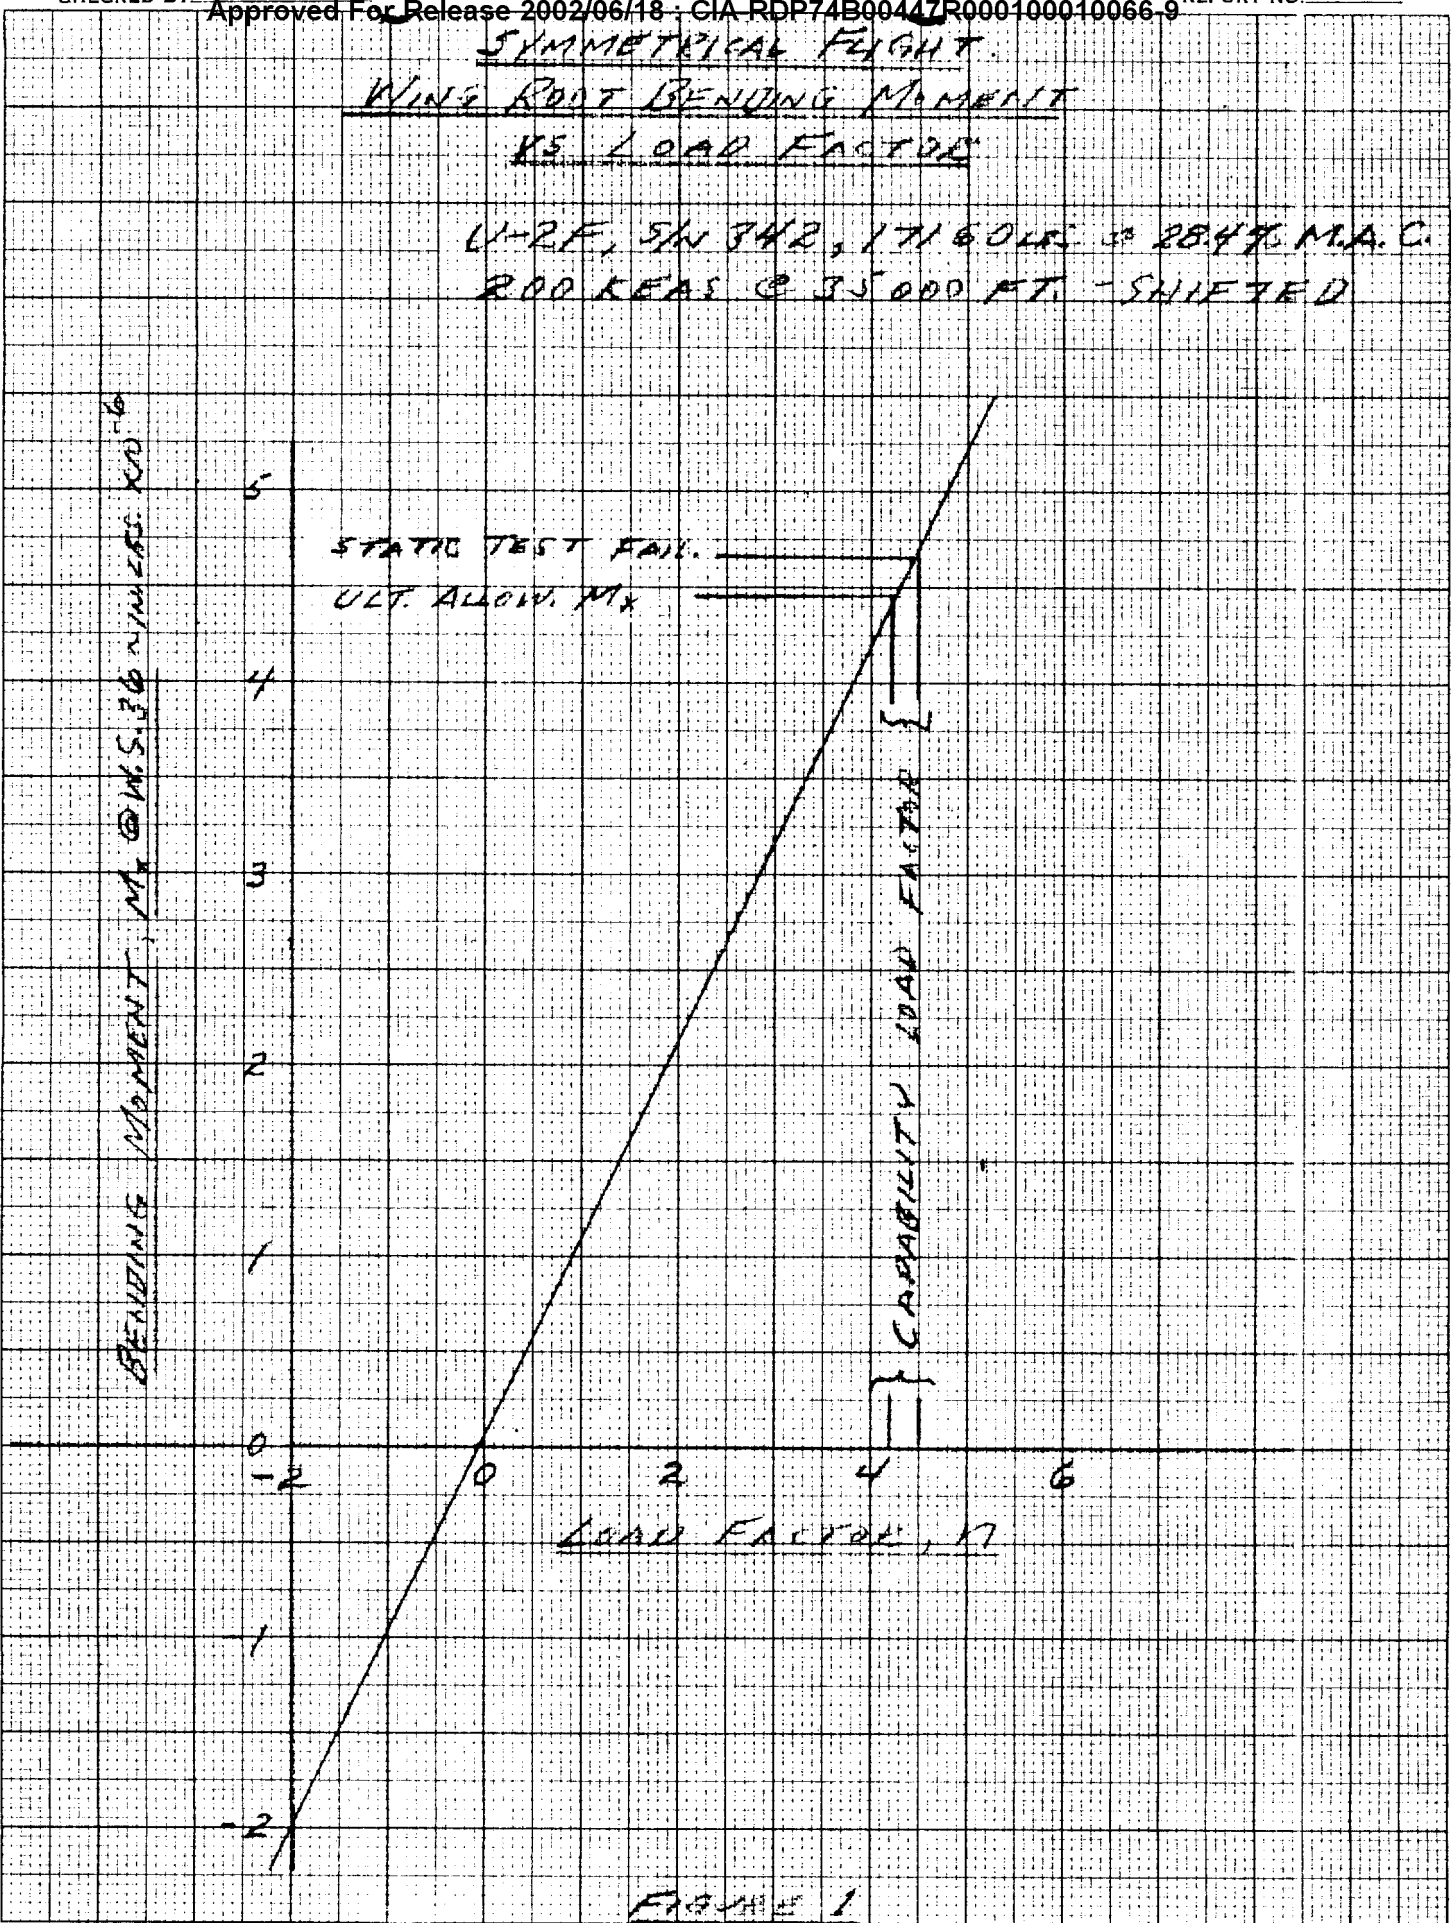
FIGURE 1

SYMMETRICAL FLIGHT  
WING ROOT BENDING MOMENT  
VS. LOAD FACTOR

U-2F, SN 342, 17160LBS @ 284% M.A.C.  
200 KEAS @ 35000 FT. - SHIFTED

STATIC TEST FAIL.  
ULT. ALLOW.  $M_x$

CAPABILITY LOAD FACTOR

Using the specific weights, speeds, altitude etc. at the time of the accident, loads were calculated along the wing as a function of load factor for a symmetrical pull-up maneuver. From this study, it was concluded that the most critical item was up-bending in the wing root section. Figure 1 is a plot of wing root bending moment (W.S. 36) versus load factor. Also shown is the calculated ultimate allowable moment corresponding to a symmetrical pull-up load factor of 4.2 g and the static test failing moment corresponding to a factor of 4.5 g (Ref. LR 10571).

Hence, the capability of the airplane in this particular configuration for a symmetrical pull-up maneuver would be from 4.2 to 4.5 g at failure. If the pull-up was combined with aileron action in roll, the center of gravity load factor would be reduced to 80% of the above or about 3.5 g.

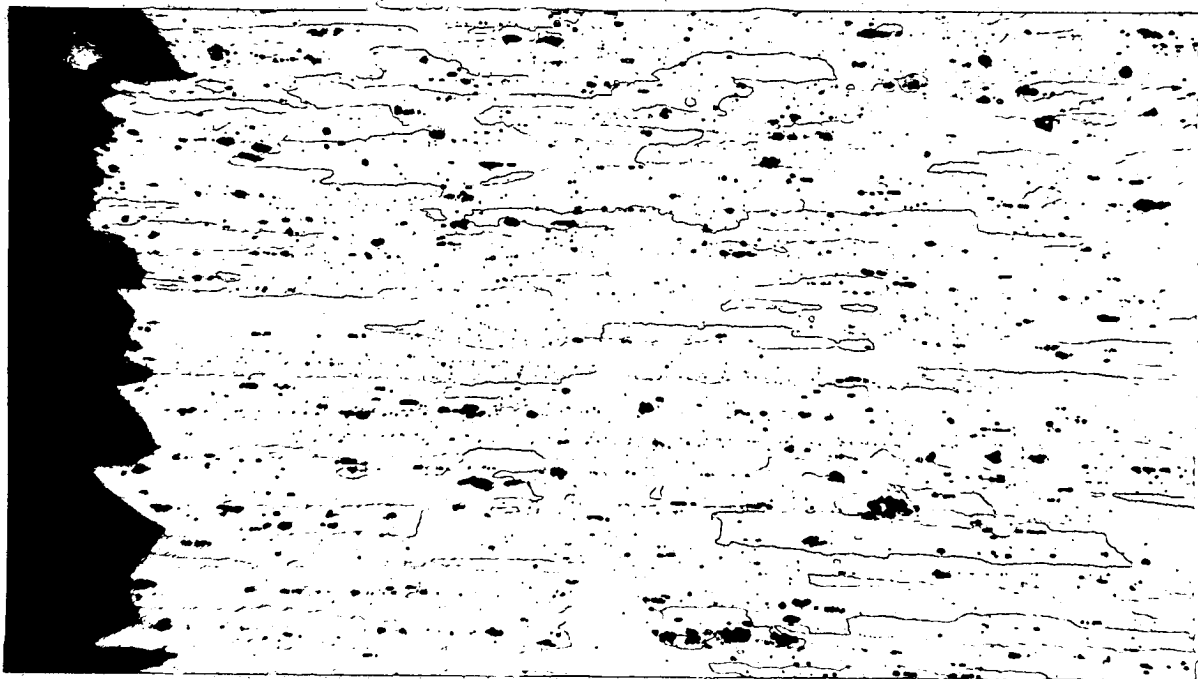
FIG. 6 - MICROGRAPH OF SECTION SHOWN IN FIGURE 5. MICROSTRUCTURE IS NORMAL FOR 7075-T6 SHEET MATERIAL. 200x

Specimen "A" (Figure 1) is a portion of lower skin of left wing at in-board end. Forward (chordwise) portion of primary failure is shown at right in photo. Enlarged view of typical surface of fracture in lower skin is shown in Figure 4. Photo-macrograph of a section cut normal to surface of fracture in skin is shown in Figure 5. This fracture was ductile in nature and resulted from single application of tensile overload. Microstructure (Figure 6) of skin material is normal for 7075-T6 sheet. All fracture surfaces in lower skin were similar in appearance. No evidence of fatigue, stress - corrosion or material defects was found in skin fractures.

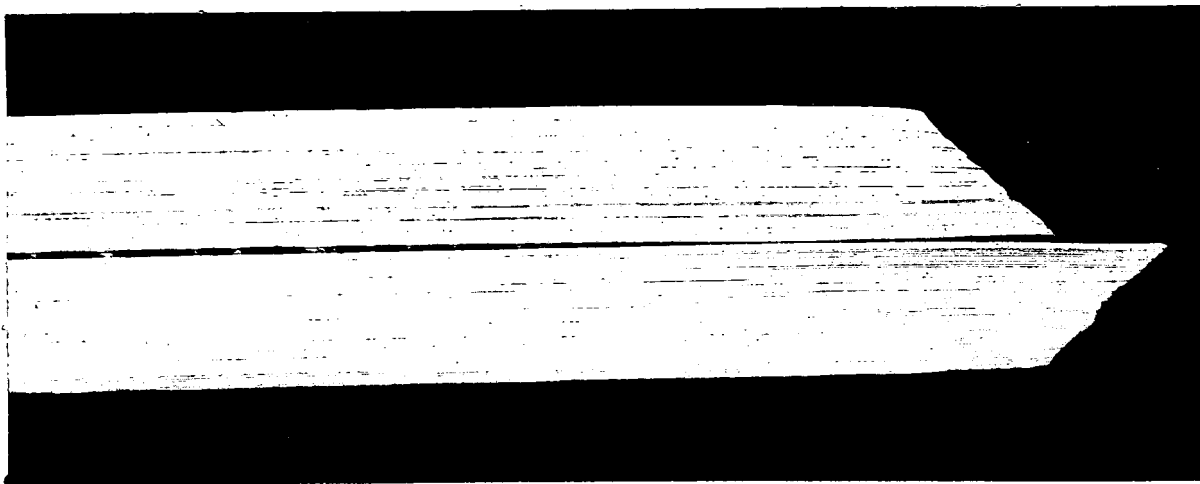
FIG. 8 - MACROGRAPH OF SECTION CUT NORMAL TO FRACTURE ON PLANE A-A IN FIGURE 7. 10X

Enlarged view of fracture in lower skin stiffener is shown in Figure 7. Photo-macrograph of a longitudinal section of stiffener taken normal to surface of fractures is shown in Figure 8. These fractures were also ductile in nature and resulted from single tensile overload. Microstructures shown in Figure 9 are normal for 7075-T6 extruded material. No evidence of fatigue, stress - corrosion or material defects was found in stiffener fractures.

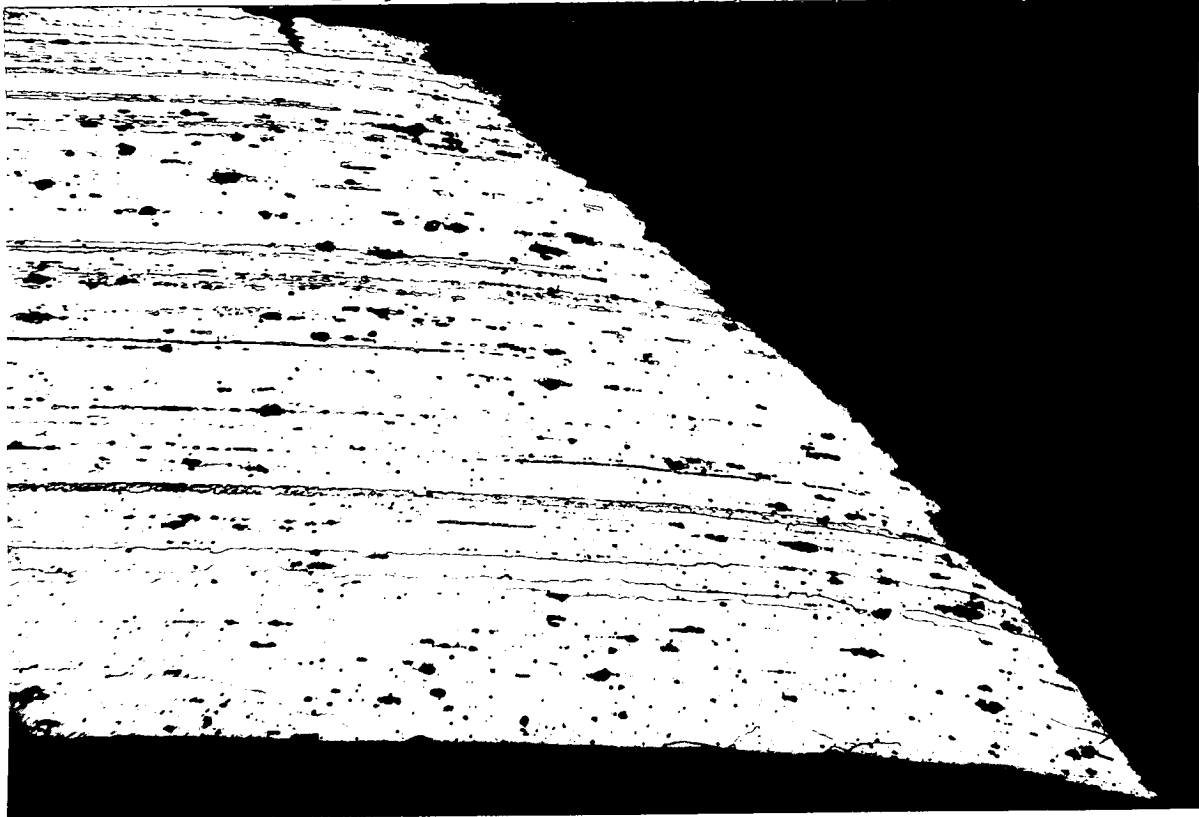
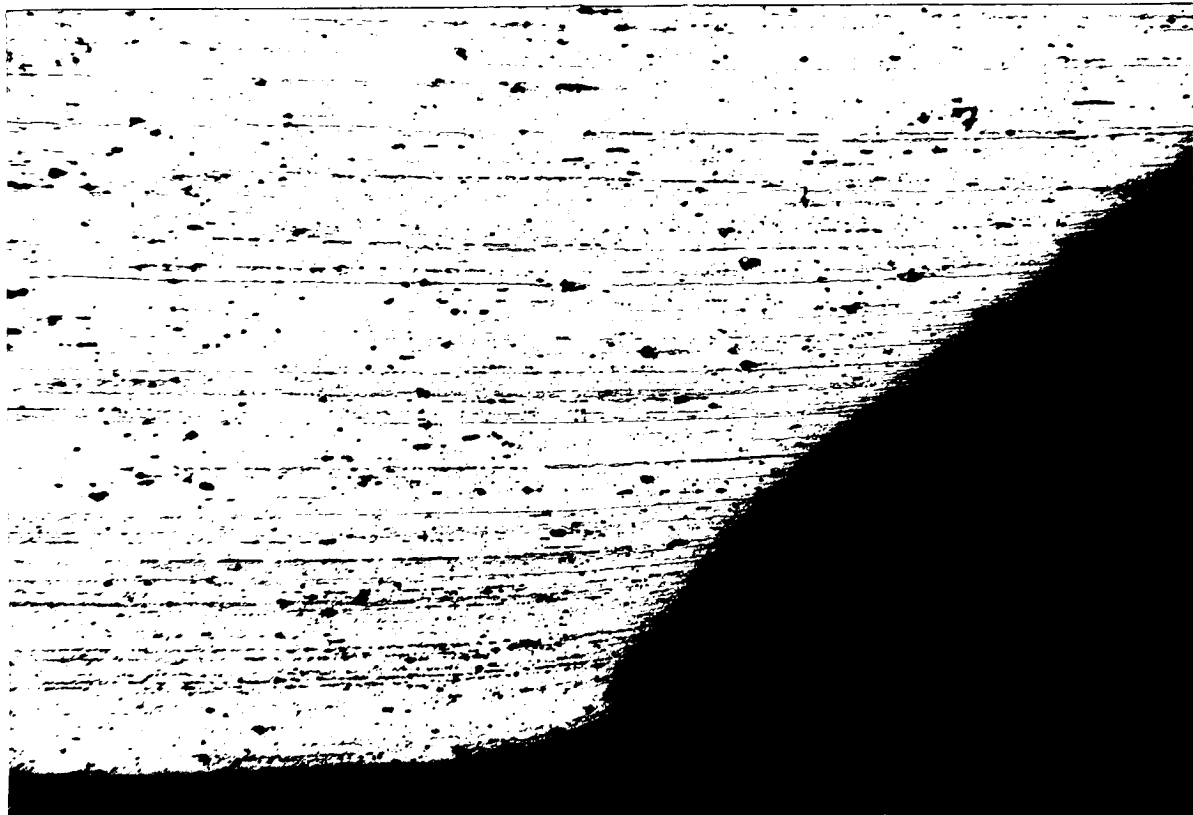
FIG. 9 - MICROGRAPHS OF SECTION SHOWN IN FIGURE 8. MICROSTRUCTURE SHOWN IS NORMAL FOR 7075-T6 EXTRUDED MATERIAL. 200X
