Basic Imagery Interpretation Report

**NATIONAL
PHOTOGRAPHIC
INTERPRETATION
CENTER**

**ACTIVITY AT TYURATAM MTC AND PLESETSK MSC
JULY-DECEMBER 1969**

**STRATEGIC SSM & SPACE FACILITIES
USSR
FEBRUARY 1970**

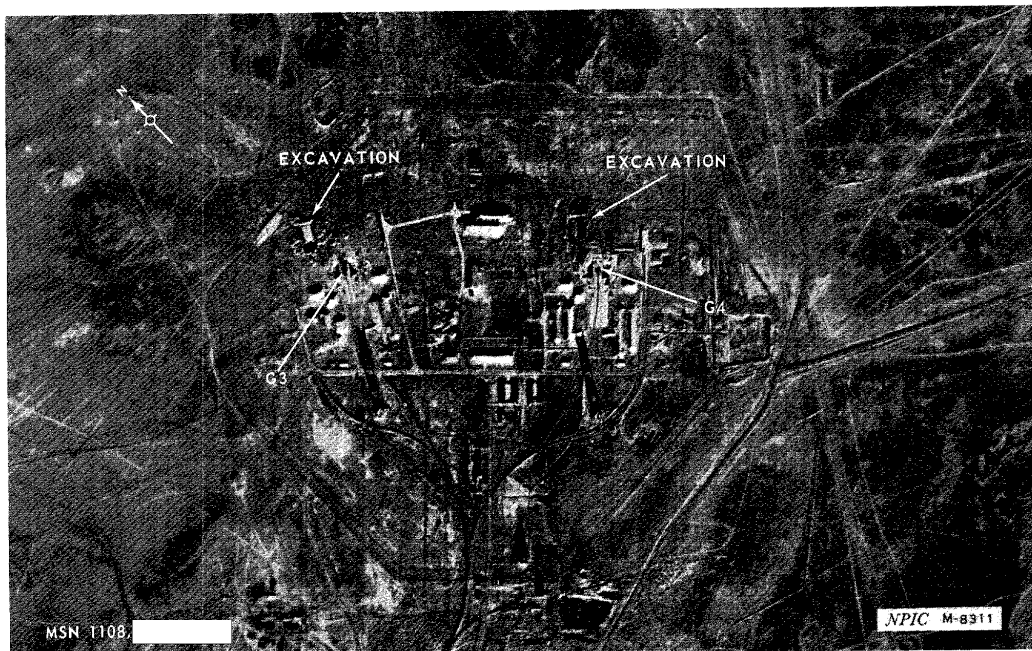
FIGURE 4. LAUNCH AREA G3-G4, TYURATAM LAUNCH COMPLEX G

A second arch-roofed building is under construction at the electronics facility south of launch area G3-G4. The gantry was positioned on G3 on [redacted] and on G4 on [redacted]. On [redacted] a rectangular excavation was observed at the northwest corner of each launch pad and the one at G3 appeared to have a concrete base in it (Figure 4).

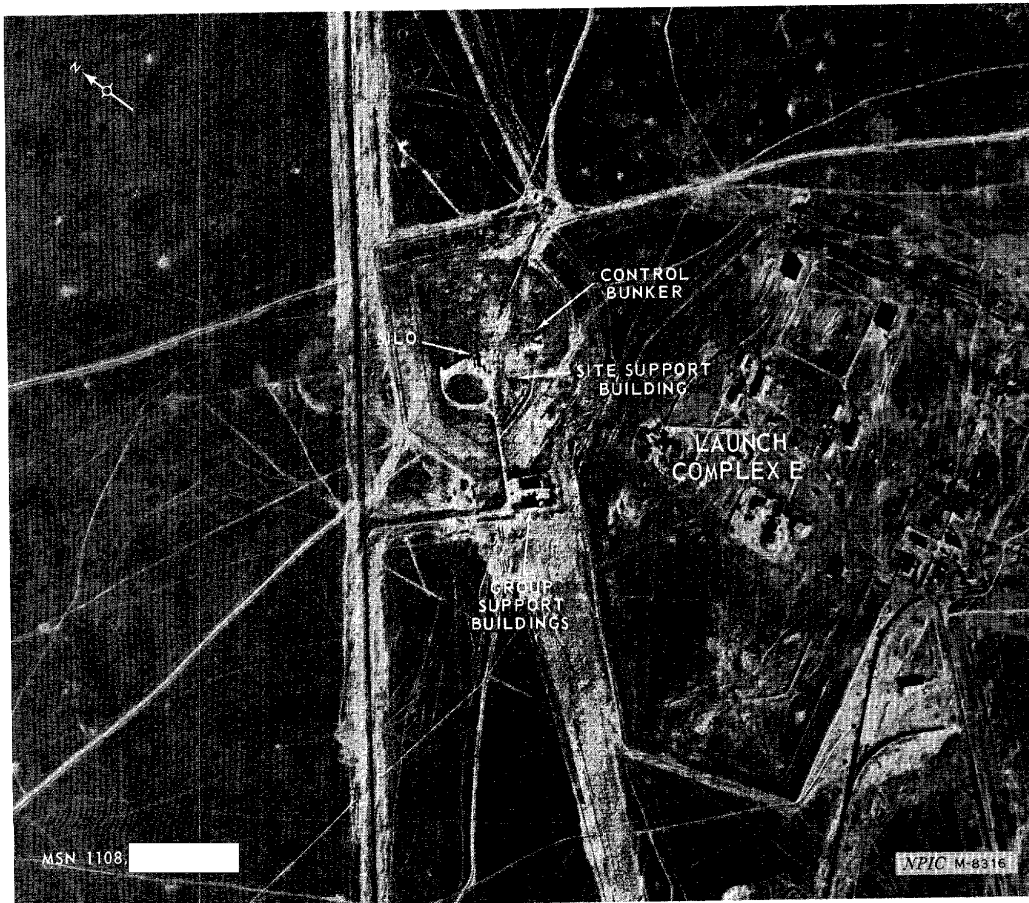
FIGURE 9. CONTROL SITE P3, TYURATAM LAUNCH GROUP P

All six sites of the group continue to exhibit type IIC site characteristics and the sites were probably externally complete in December 1969. Launch site P3 is the control site for the group (Figure 9).

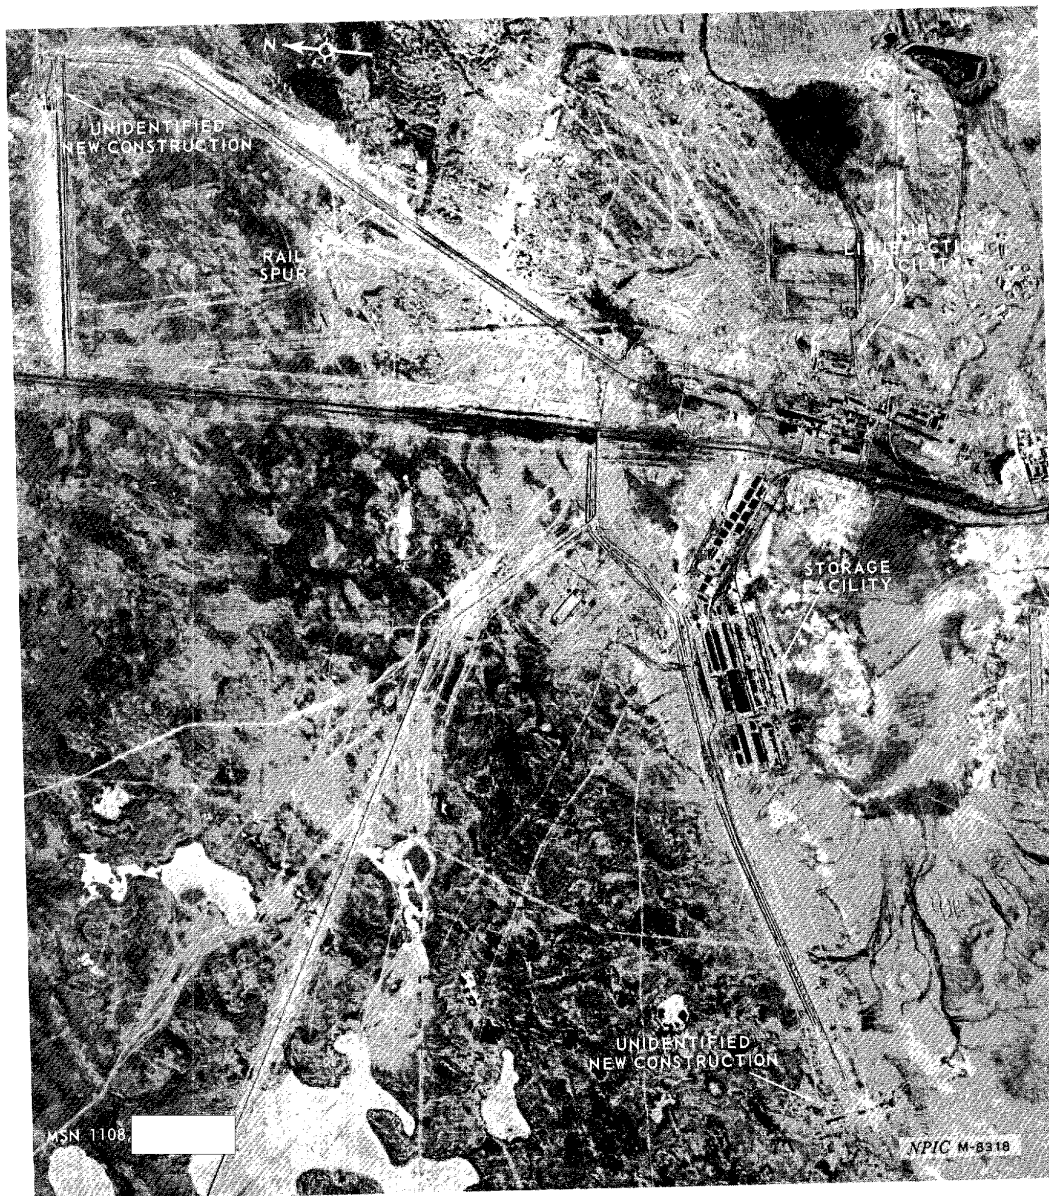
FIGURE 11. SUPPORT FACILITIES ALONG THE MAIN NORTH-SOUTH RANGEHEAD ROAD, TYURATAM MISSILE TEST CENTER

Two areas of unidentified new construction are noted along the main north-south rangehead road (Figure 11). The first of these is approximately 5 nautical miles (nm) north of the air liquefaction facility. A rail spur was extended from the air liquefaction facility to that point, and a road was subsequently constructed from the main north-south rangehead road to the end of the new rail spur.

The second area of new construction is approximately 1 nm west of the storage facility which is opposite the air liquefaction plant and on the west side of the main north-south rangehead road. It consists of a small square structure flanked on its north and south sides by larger rectangular structures that almost appear to be mirror images of each other. A road has been constructed from the storage facility to the new construction.
