PHOTOGRAPHIC INTERPRETATION REPORT

SAM INSTALLATION SERIES

INSTALLATION NAME	GEO COORDS	PUBLICATION DATE	
Unidentified Activity at Nebit-Dag SAM Support Facility USSR	39-28-00N 054-19-55E	July 1966	
	NPIC TARGET NO		
	0338-12B

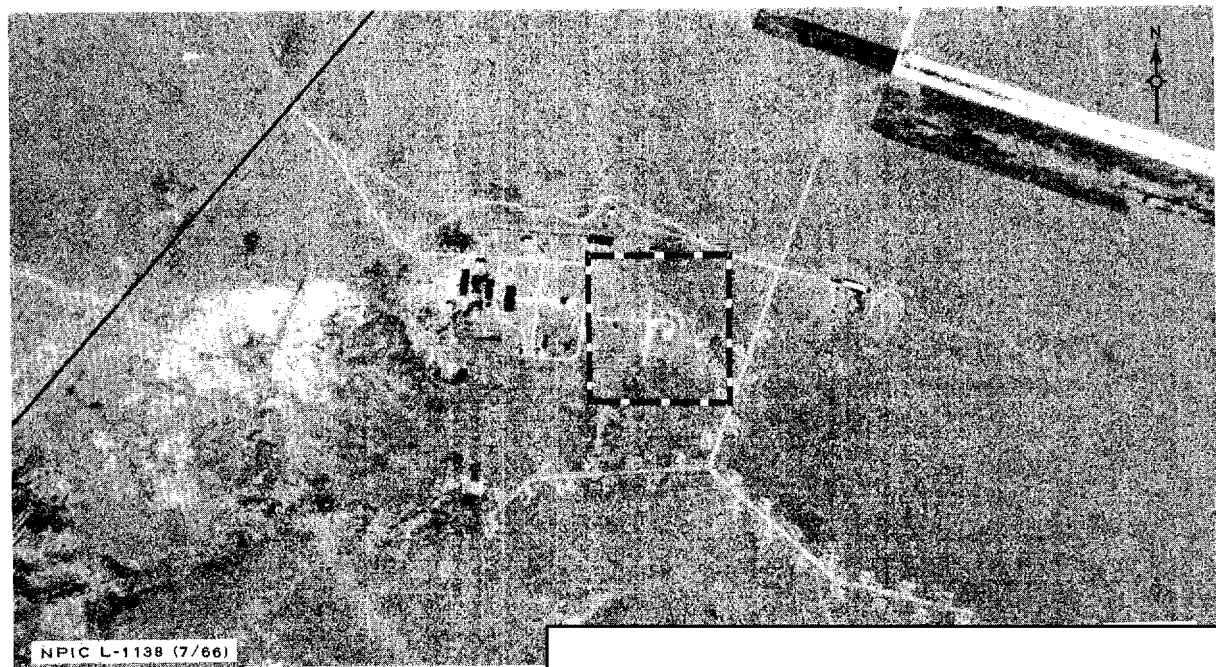
NPIC L-1138 (7/66)

Adjacent to the eastern edge of the Nebit-Dag SAM Support Facility is an area of unidentified activity. In [redacted], the activity consisted of a double security fence which adjoined the fence enclosing the support facility, a small probable security building, and a circular excavation or coring. Six unidentified pieces of equipment were observed in the area. [redacted] [redacted], a possible structure was over the previously noted coring in a shallow linear excavation, which was newly identified at that time.

[redacted] a T-shaped service road and a Ukraina-type revetment are present. Construction status cannot be determined because of poor interpretability and lack of stereo coverage.
