PHOTOGRAPHIC INTELLIGENCE REPORT

CHANGES AND ADDITIONS TO SELECTED

SAM SUPPORT FACILITIES, USSR

CIA/PIR 61114

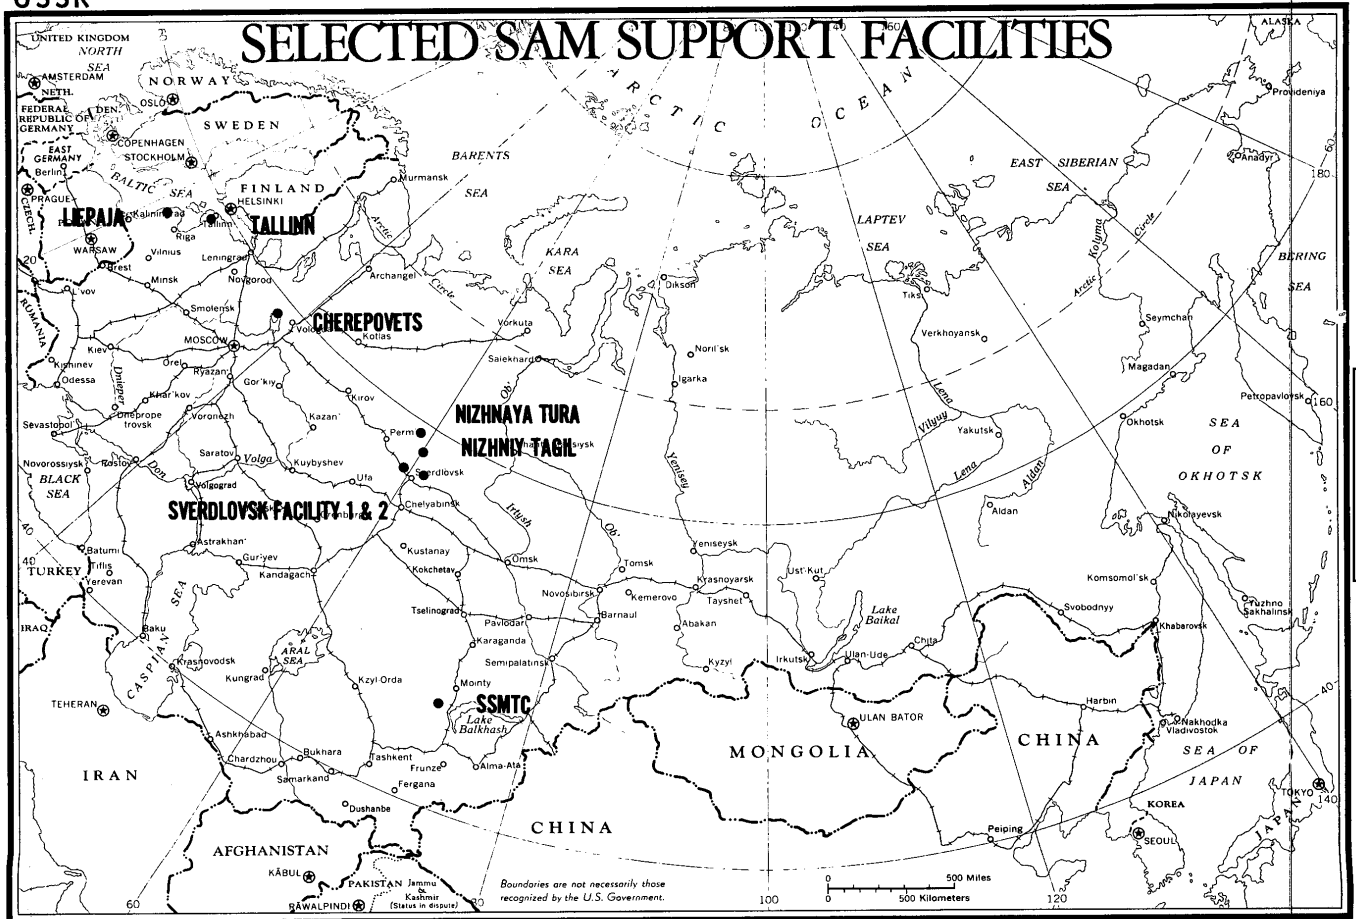
Figure 1

# SELECTED SAM SUPPORT FACILITIES

This report is in response to a CIA requirement requesting an analysis of changes or additions occurring since [redacted] at SAM support facilities located near deployed probable long range SAM launch complexes. The following SAM support facilities, depicted on Figure 1, were analyzed in response to this requirement.

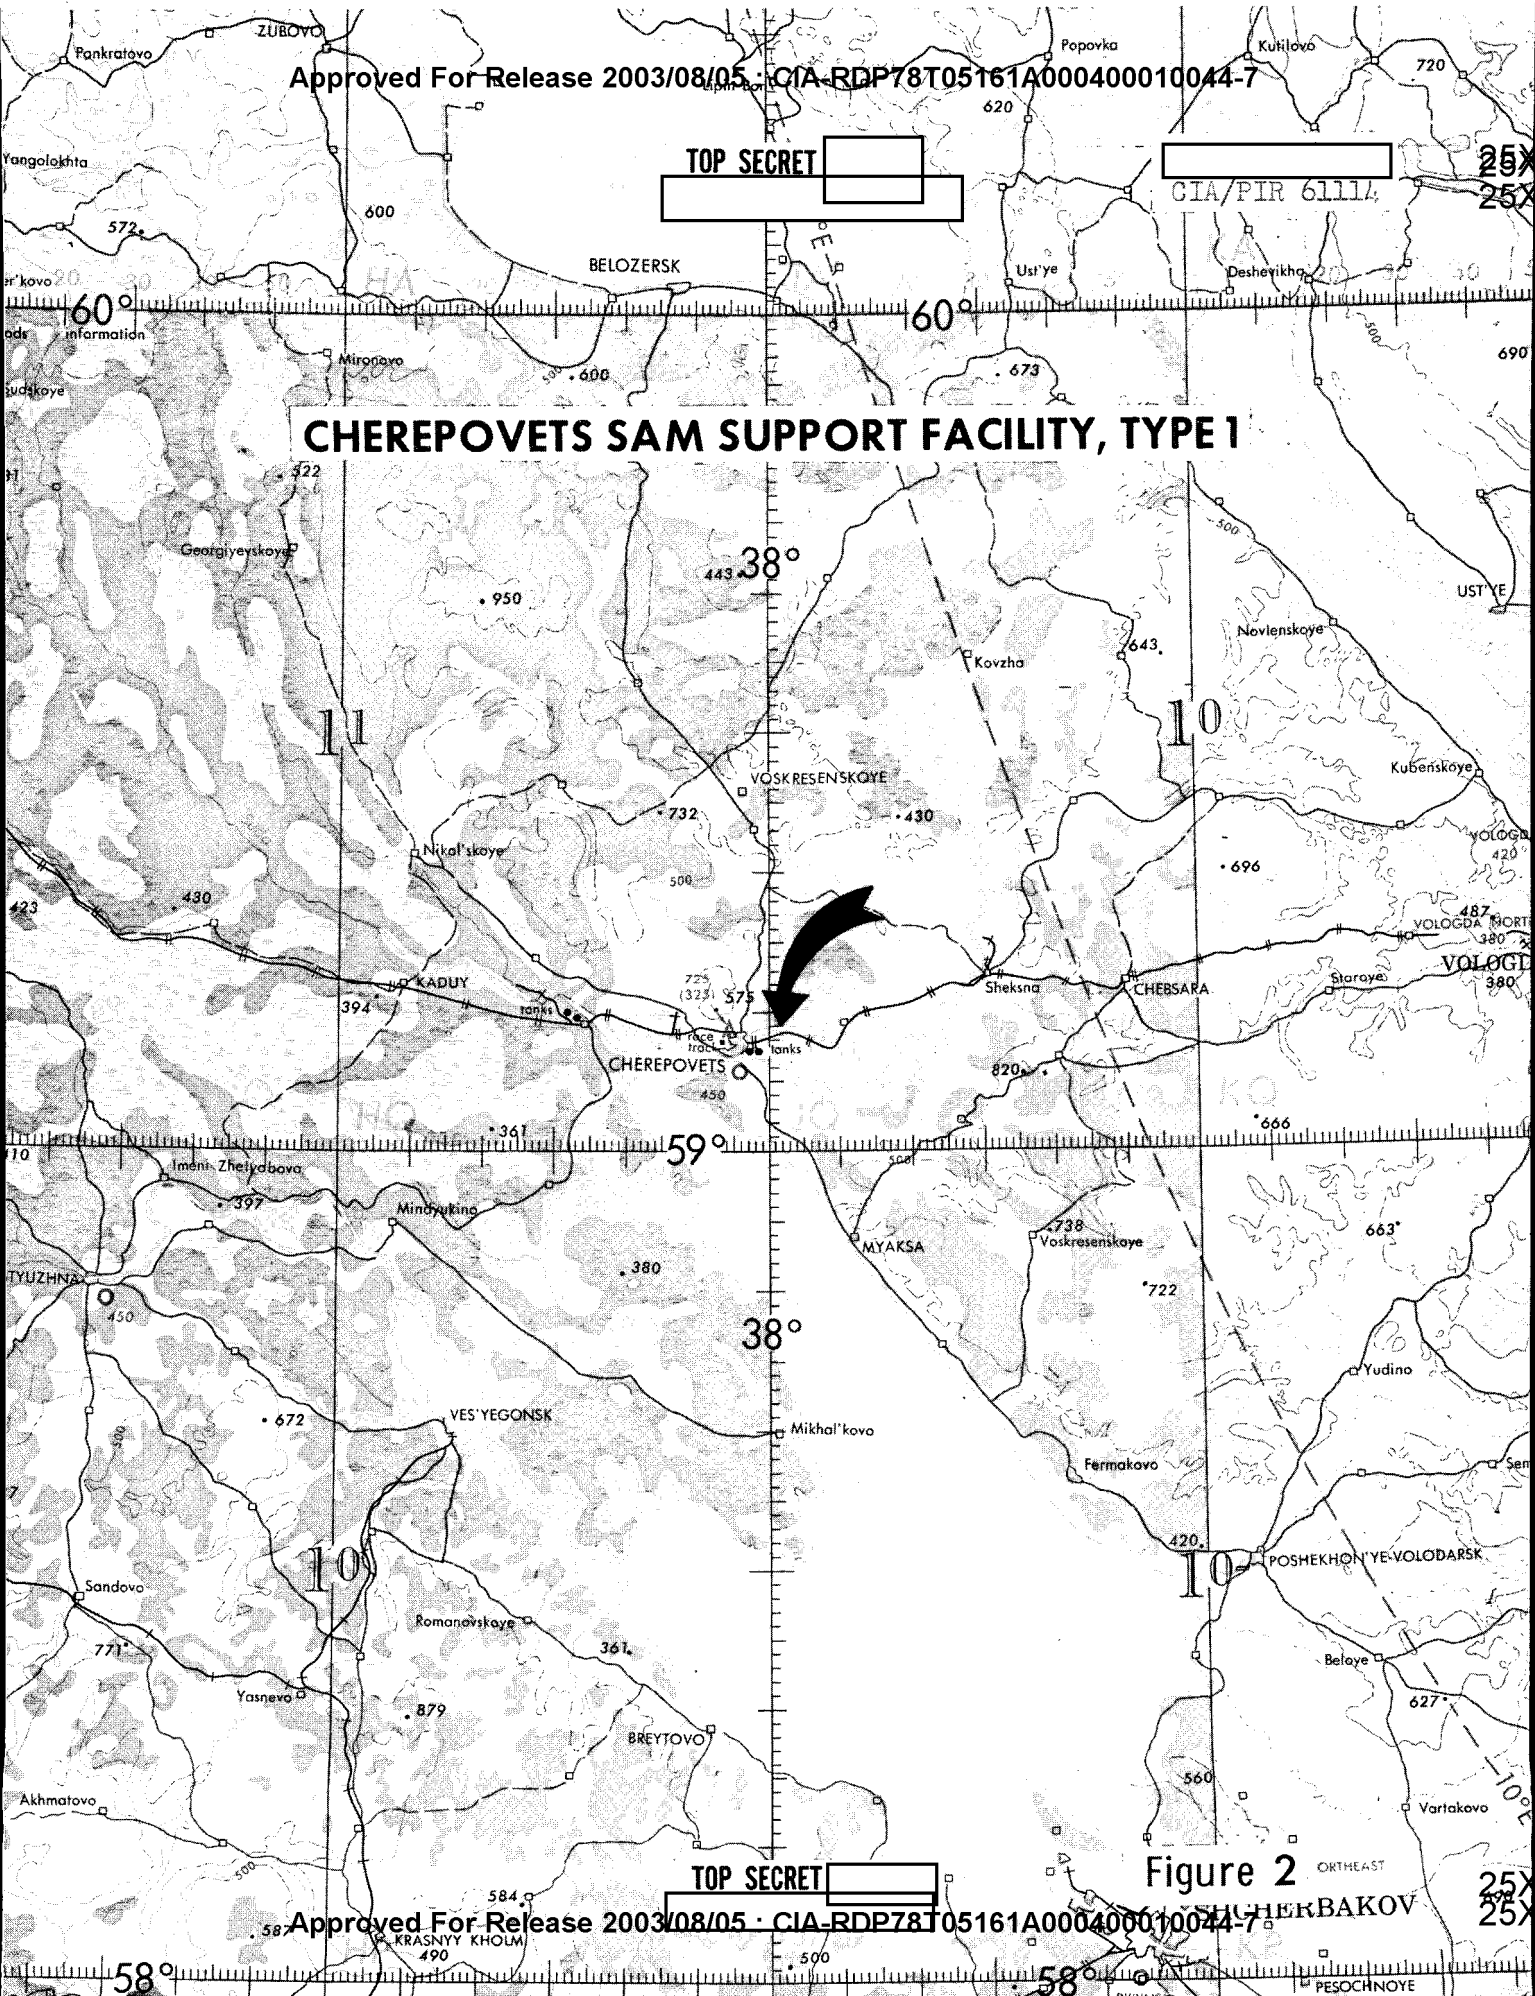
Figure 2

No changes were noted in any of the selected SAM support facilities with the exception of the Cherepovets SAM Support Facility, Type 1 (Figures 2, 3, and 4). The changes involved the construction of six new buildings, a building foundation, and a probable bunker between [redacted]

# CHEREPOVETS SAM SUPPORT FACILITY, TYPE 1

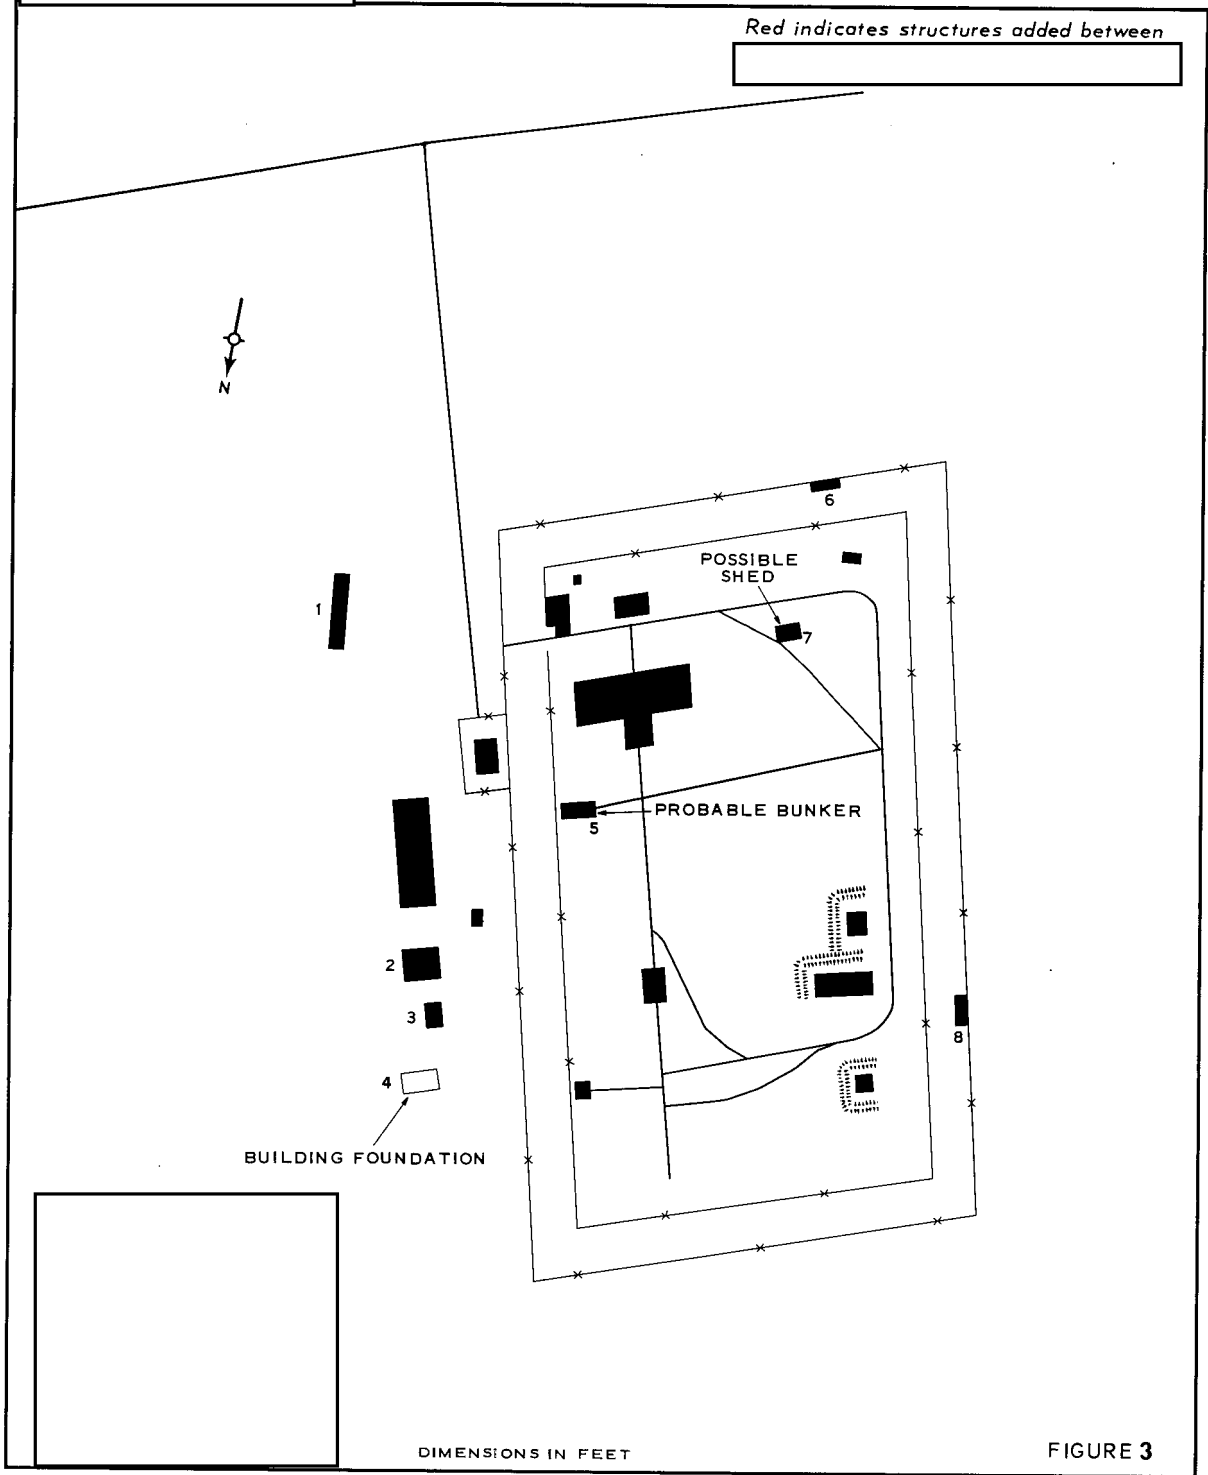
[redacted] No modification to existing structures were noted during the same period. Figure 3 portrays the additions with a color coded line drawing of the facility.

Red indicates structures added between

CHEROPOVETS SAM SUPPORT FACILITY TYPE I  
(DRAWN FROM UNRECTIFIED PHOTOGRAPHY).

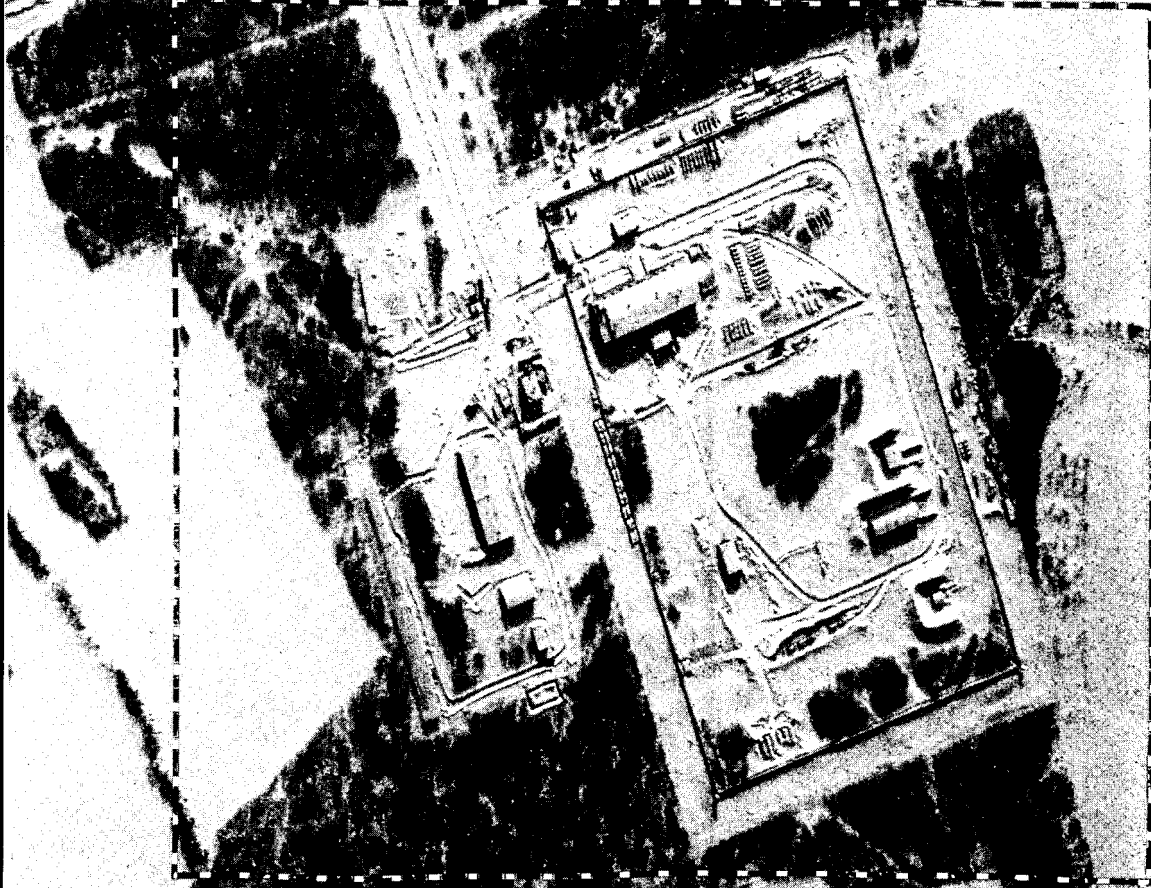
Figure 4

**CHERPOVETS SAM SUPPORT FACILITY, TYPE 1**
