PHOTOGRAPHIC INTELLIGENCE REPORT

MUNITIONS STORAGE SITE NEAR
HUANG-PEI, CHINA

CIA/PIR 63026

DATE JAN 1966

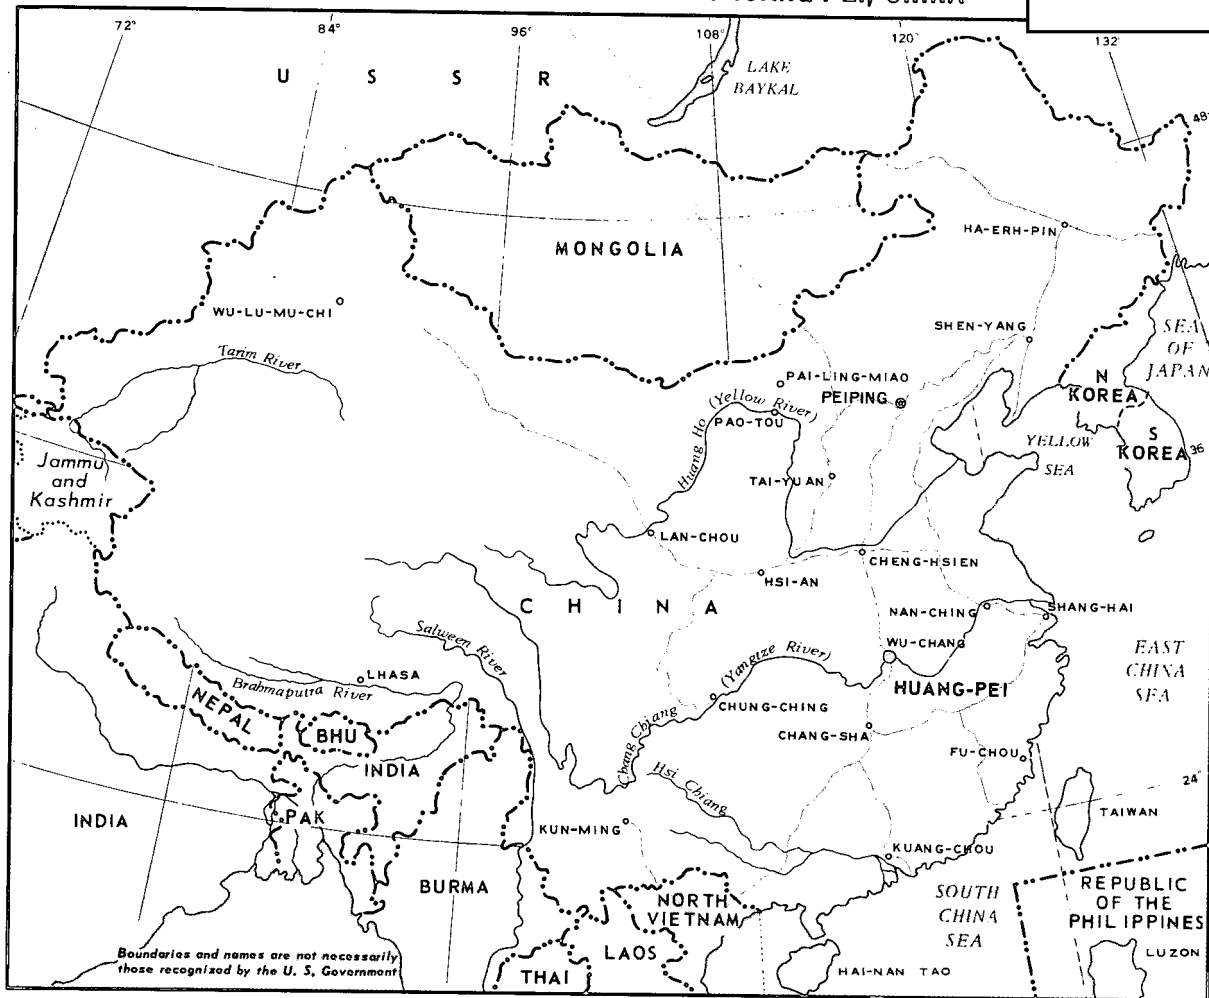
FIGURE 1.

COMOR NO: [REDACTED]
 BE NO: [REDACTED]
 COORDS: 30-48N 114-19E
 NPIC TARGET NO: 0493-38K1
 DATE OF INFO: [REDACTED]

is located at 30-48N 114-19E, 5 nautical miles (nm) SW of Huang-pei and 15 nm north of Wu-han (Hankow), China (Figure 1). The site is road served; rail service is available at a siding 1 nm to the west.

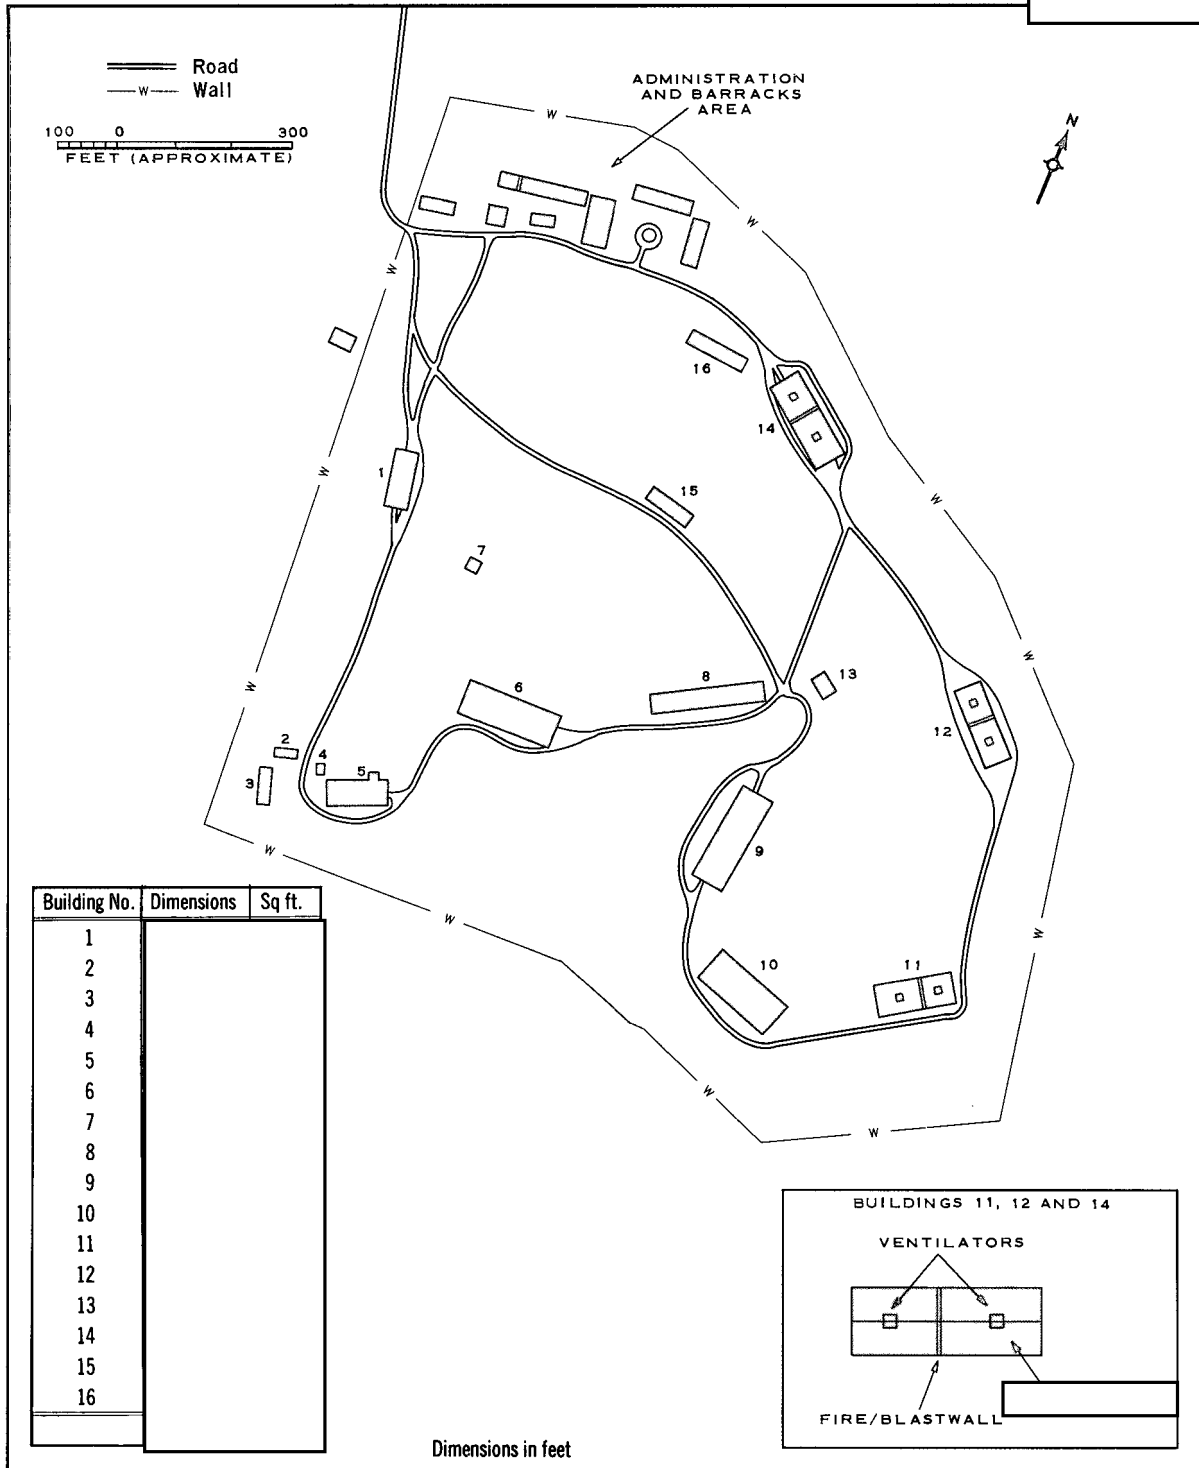
FIGURE 3. MUNITIONS STORAGE SITE NEAR HUANG-PEI, CHINA.

Storage facilities at the site include 13 warehouses and 3 small storage/service buildings (Buildings 2, 4 and 7, Figure 3). Three of the warehouses (Buildings 11, 12 and 14, Figure 3) are of particular interest. These buildings are divided into 2 unequal sections by a fire or blast wall. Ventilators are visible on the roofs, and separate access to each section is provided by entryways at both ends of the buildings.

Small piles of white material, suggestive of a decontaminant, can be seen near Buildings 10 and 15.
