CIA/PIR-67265

CIA IMAGERY ANALYSIS DIVISION

POSSIBLE TACTICAL SURFACE-TO-SURFACE MISSILE SUPPORT FACILITY UZHGOROD, USSR (48 36N-022 21E)

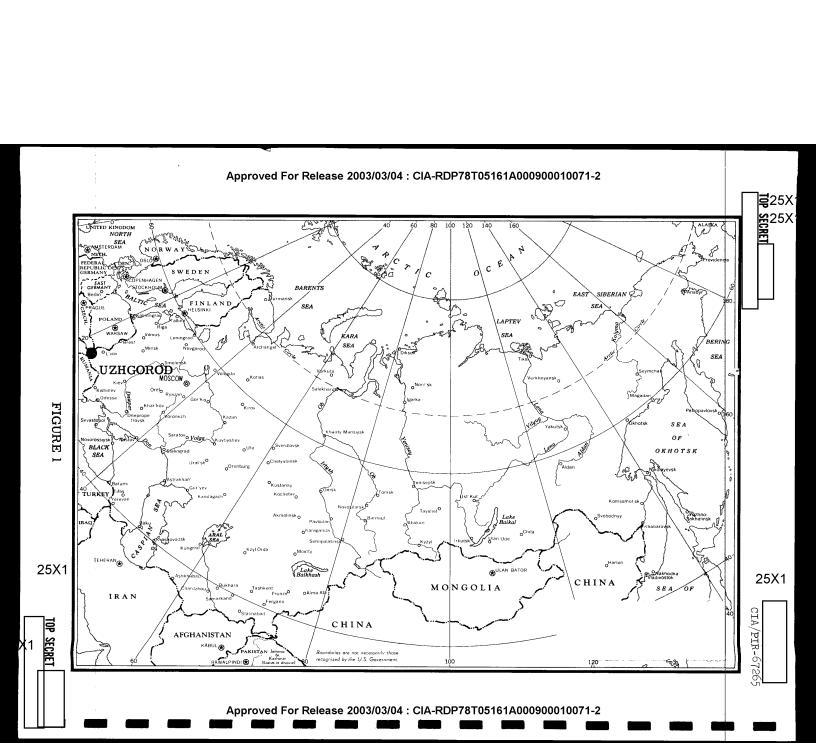
I	L		CIA/PI	.
25X1	CIA IMAGE	RY ANALYSIS DIVISION	0114/11	11-0 20)
X1	PF	REFACE		
located 3 nm within an amm	ole surface-to-surface east of Uzhgorod ^l . T unition depot which h	The possible supp	ort facility is lo	is
checkout area building were structed from		cle/equipment she	ds, and a maintena A rail spur was	nce con- en
	photography.			
		,		
				·
* 1. Th Am 52	e installation is lis munition Depot Dravce E.	ted in the Bombi,	ng Encyclopedia as located at 48 36	
Am	munition Depot Dravce E.	sted in the Bombi
