NPIC/R-301/63 December 1963

PHOTOGRAPHIC INTERPRETATION REPORT

COMPARISON OF SAM GUIDANCE RADARS AT OSTROV NARGIN, MYS SET-NAVOLOK, AND MOSCOW/FILI AIRFIELD, USSR

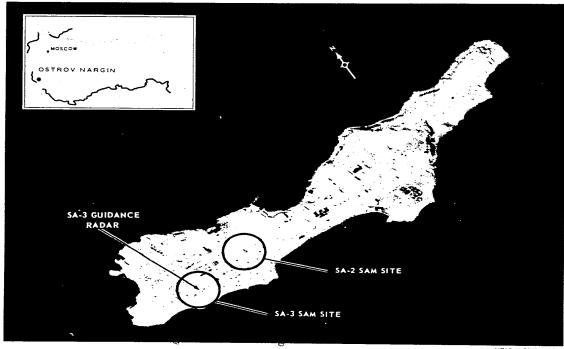
FIGURE 1. SA-3 GUIDANCE RADAR, OSTROV NARGIN, AUGUST 1963.

The SA-3 guidance radar at Ostrov Nargin (Figures 1-4) consists of five different components mounted on a chassis, as illustrated in Figure 5. The back-to-back circular section (Figure 5, item I) is attached to the rear of the chassis by a lattice-type mast and may have the capability of being raised or lowered. A cut cylindrical section (item C) is mounted on top of the chassis and appears to have the capability to revolve. Two cut paraboloids (item B), one with a feed and one without, are located on top of the chassis over two troughs (item A). One trough is horizontal and parallel to the front of the chassis; the other is also horizontal, but attached to the side of the chassis. At the base of the chassis, under the latter trough, is a stacked circular section (item G).

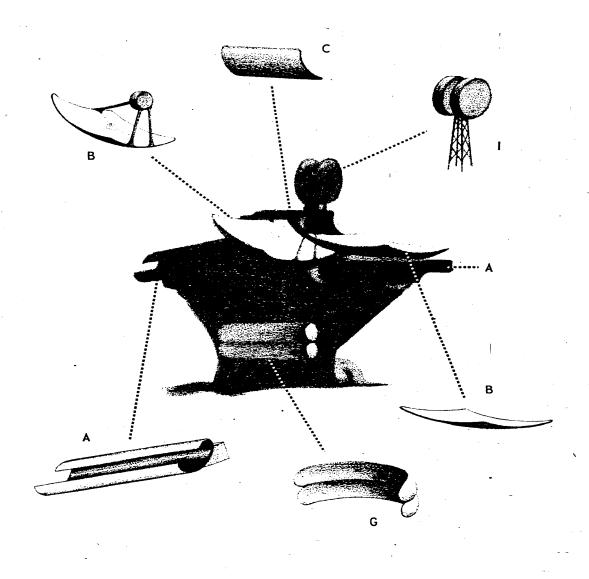
FIGURE 5. CONCEPT OF GUIDANCE RADAR COMPONENTS, OSTROV NARGIN, OBSERVED ON JUNE 1963 PHOTOGRAPHY.

Item (Figs 5 & 10)	Component	Ostrov Nargin	Mys Set-Navolok	Moscow/Fili Airfield
A	Trough	Present	Present	Present
В	Cut paraboloid section	Present	Present	Present
С	Cut cylindrical section	Present	Not visible	Present
D	Peel	Not visible	Present	Present
E	Feed	Not visible	Present	Not visible
F	Single circular section	Not visible	Present	Not visible
G	Stacked circular section	Present	Present	Not visible
н	Unidentified object	Not visible	Present	Not visible
I	Back-to-back circular section	Present	Not visible	Not visible

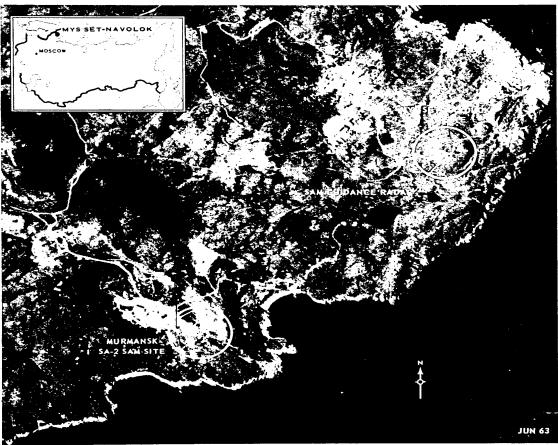
FIGURE 6. LOCATION OF SAM GUIDANCE RADAR, MYS SET-NAVOLOK, JUNE 1963.

The SAM guidance radar at Mys Set-Navolok (Figures 6-9) consists of seven different components mounted on a heavy lattice mast, as illustrated in Figure 10. A chassis mounted on top of the mast holds four of the compo-

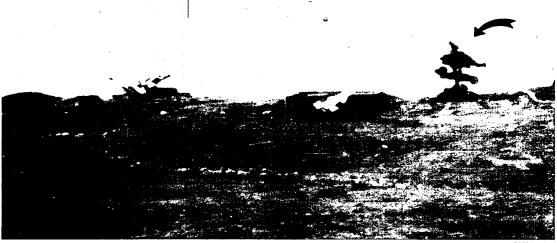
FIGURE 9. SAM GUIDANCE RADAR, MYS SET-NAVOLOK, AUGUST 1963.

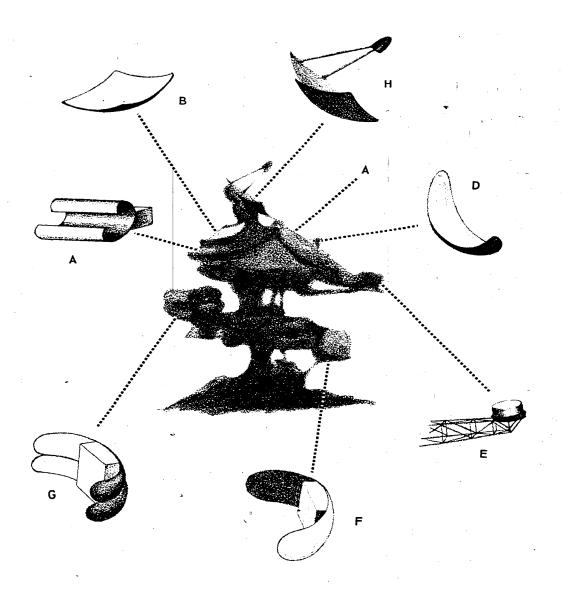
FIGURE 10. CONCEPT OF GUIDANCE RADAR COMPONENTS, MYS SET-NAVOLOK, OBSERVED ON AUGUST 1963 PHOTOGRAPHY.

nents (Figure 10, items A, B, D, and H). An unidentified component (item H) with a small feed is mounted topmost on the chassis. Below this component is a cut paraboloid (item B) attached to the chassis just above a trough

(item A), which is horizontal and mounted on the chassis in a manner similar to that of the sidemounted trough at Ostrov Nargin. Another trough (item A) appears to be located on the other side of the chassis and slanted at a 45degree angle to the ground. A peel (item D) is situated on the far side of the chassis. Halfway up the mast that holds the chassis are two

lattice-type arms. At the end of one arm is a single circular section-type component (item F), and at the end of the other arm is a stacked circular section-type component (item G). An independently mounted feed (item E) is attached to the mast above the two lattice-type arms. This feed may have the capability of being raised and lowered.

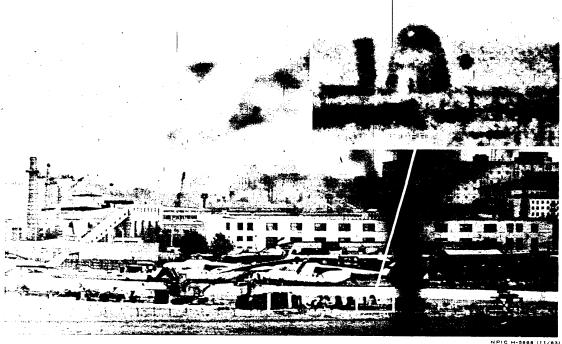
FIGURE 12. PEEL-TYPE REFLECTOR OBSERVED AT MOSCOW/FILI AIRFIELD RADAR ASSEMBLY AREA, OCTOBER 1963.

The four different guidance radar components at the Moscow/Fili Airfield radar assembly area are mounted on two different chassis, which are in the process of being assembled (Figures 11 and 12). Two troughs (Figure 5, item A) are visible mounted on one chassis, and a cut paraboloid (item B) can be seen mounted on the second chassis. A cut

cylindrical section (item C) is on the ground between the two chassis. To the right of the second chassis a canvas-covered peel (item D) is lying on the ground. The troughs measure in length, the cut paraboloid feet in width and feet in chord, and the cut cylindrical section feet in length.
