TCS No. 1282/64-KH IB No. 87/64 17 February 1964 Copy

SUBJECT : Helwan, UAR (Egypt) Aircraft Industry

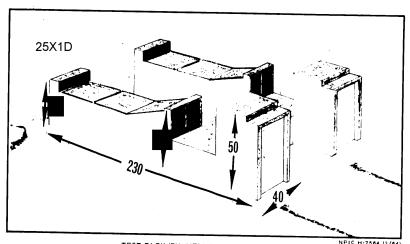
(CIA/PID/IB-P-271/64) - New test facilities (NPIC H-7564) highlight the extensive expansion activity that took place during the interval of photographic coverage. These two new test facilities, one still under construction the date of this coverage, are very large compared to other test facilities through-out the world and it is believed that they will be used to test an entire weapons system i.e. engine, airframe, control surfaces ect. The large hangar and the two small hangars located on the southwest edge of the complex have probably been converted to storage buildings because the apron has been torm up for some unidentified construction. Other new structures include: one research building, four warehouses, two motor pool sheds, and a POL storage tank. The large fabrication building is very near completion and the machine shop/workshop mentioned in paragraph j has been completed.

TEST FACILITY, HELWAN AIRFIELD, EGYPT.
