ATTACHMENT TO L-2029
07 OCTOBER 1966
PAGE 1

STATUS OF ROUTE 92
PANHANDLE AREA, LAOS

STATUS OF ROUTE 92

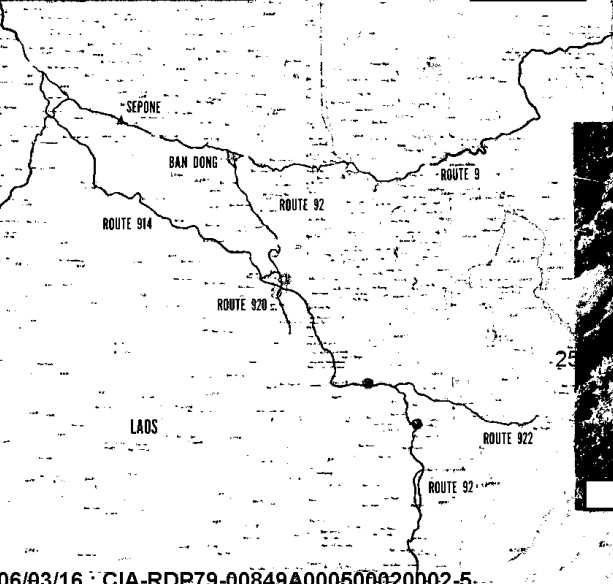
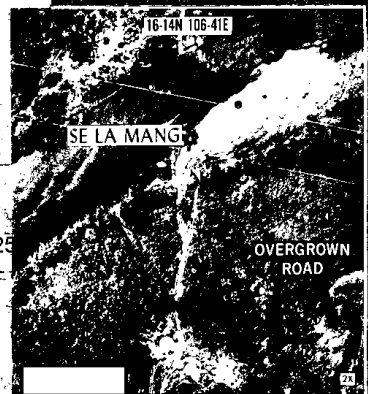
PHOTOGRAPHY REVEALS THAT THE INTERDICTION POINT AT 1626N 10629E (UTM XD592190), 0.5 NM NORTH OF THE ROUTE 914 JUNCTION, HAS NEITHER BEEN BY-PASSED NOR REPAIRED SINCE FIRST OBSERVED ON PHOTOGRAPHY OF [REDACTED] 25X1

[REDACTED] ANOTHER INTERDICTION POINT AT 1617N 10637E (UTM XD731029), 2.4 NM WEST OF ROUTE 92/922 JUNCTION, HAS NOT BEEN BY-PASSED. THE OBSERVED SECTION OF ROUTE 92, INCLUDING THE ROUTE 914 JUNCTION, IS IN POOR CONDITION AND SHOWS NO EVIDENCE OF VEHICULAR TRAFFIC. THE SECTION OBSERVED SOUTH OF ROUTE 922 IS OVERGROWN.
