**Ground Force
Facilities**

Basic Imagery Interpretation Report

Kai-yuan Army Barracks South AL-3

China

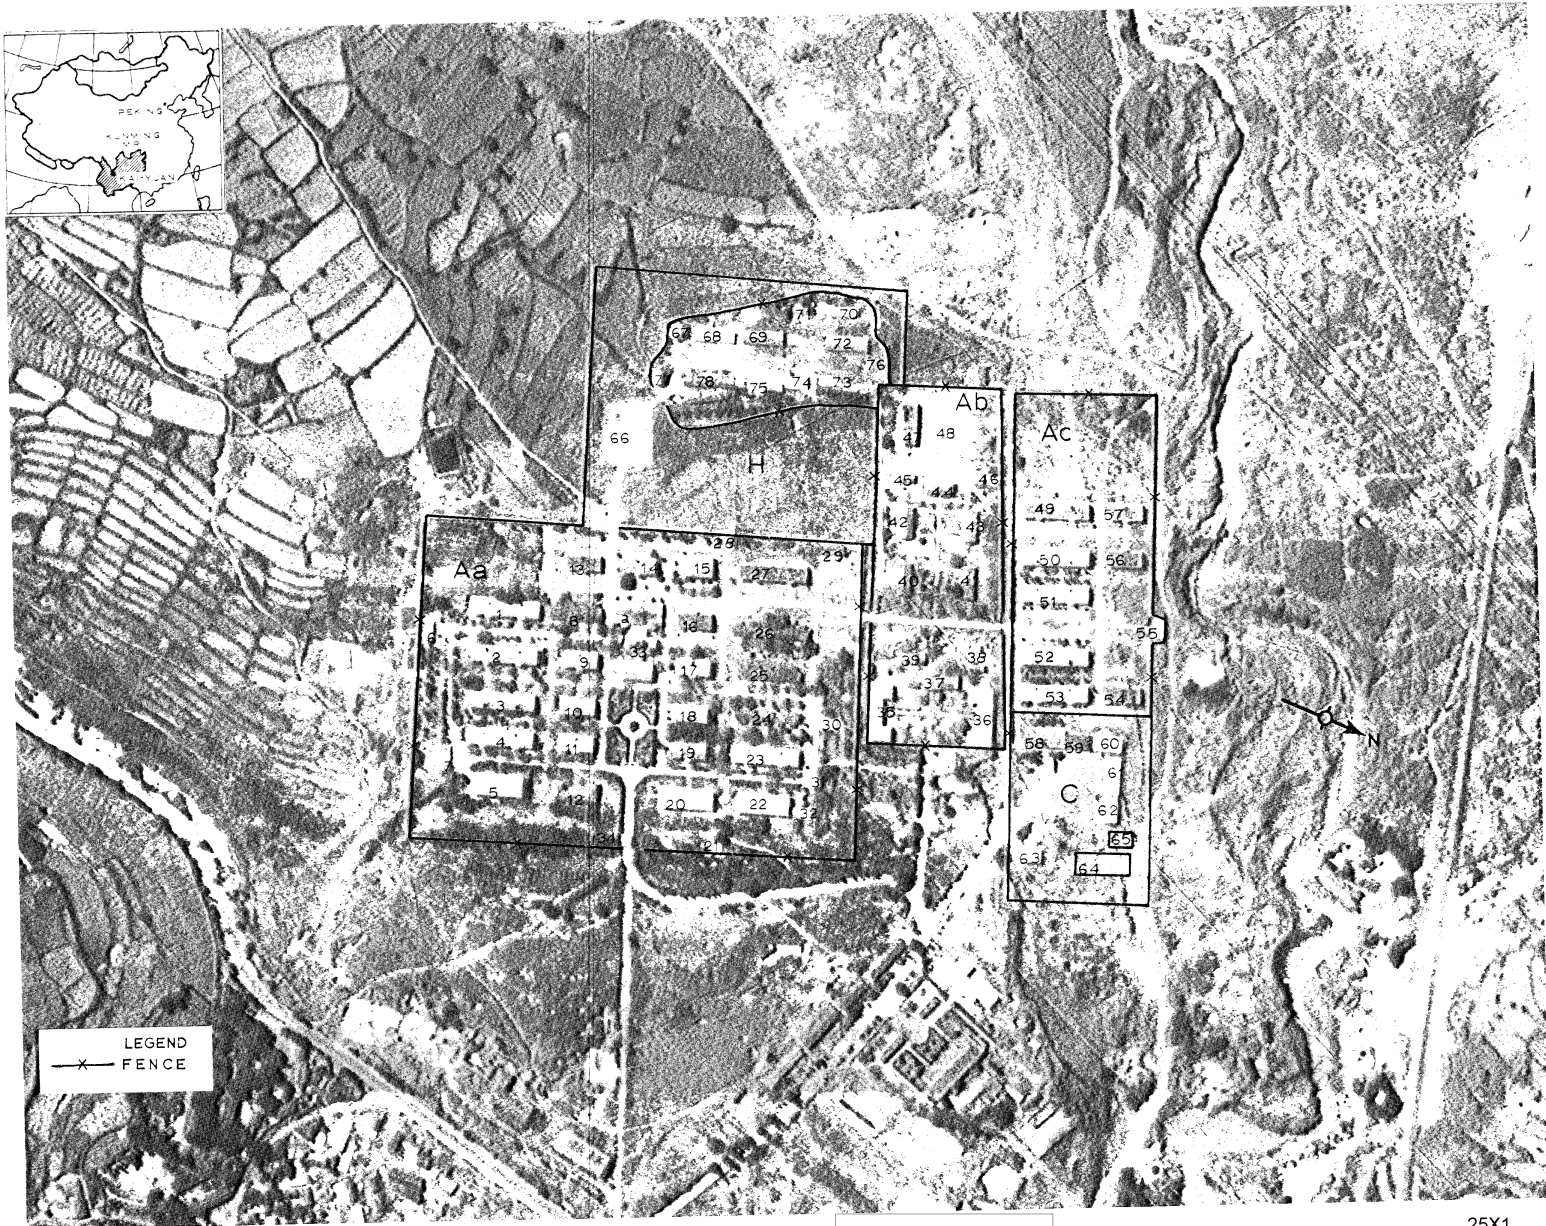
KAI-YUAN ARMY BARRACKS SOUTH AL-3

FUNCTIONAL AREAS AND FACILITIES* DIMENSIONS (FT)** SUBTOTAL SQUARE FEET

11 Probable barracks (1-4,23) (9-11,17-19)	5 6

24,150	25X1
7 Barracks/support buildings (26) (27) (24,25) (8) (13,16)	2 2		15,330.....39,480	
1 Messhall (33)				
1 Administration building (12)				
6 Latrines (6,7,21,28,30,31)				
6 Support buildings (5,14,15, 20,22,32)				
1 Agricultural storage building (29)				
1 Probable guard house (34)

5 Possible quarters (40-44)	5- 63 x 30		9,450	
1 Administration building (37)				
2 Administration/support buildings (35,36)				
3 Latrines (38,45,46)				
2 Support buildings (39,47)				
1 Basketball court (48)

4 Barracks (50-53)

25X1	
4 Barracks/support buildings (49) (54,56,57)				6,210.....	25X1
1 Latrine (55)

7 Probable general storage buildings (64) (58) (61) (59,60) (62) (63)	2

5,520	25X1
1 Support building (65)			3,280	
			3,480	25X1
			1,715	
		17,890	25X1

8 Animal sheds (68,69,72-76,78)				
4 Support buildings (67,70,71,77)				
2 Basketball courts (66)
