Highways in the NOVY JICIN area

Highways south-west of PARDUBICE

Map Ref: PARDUBICE, Czechoslovakia

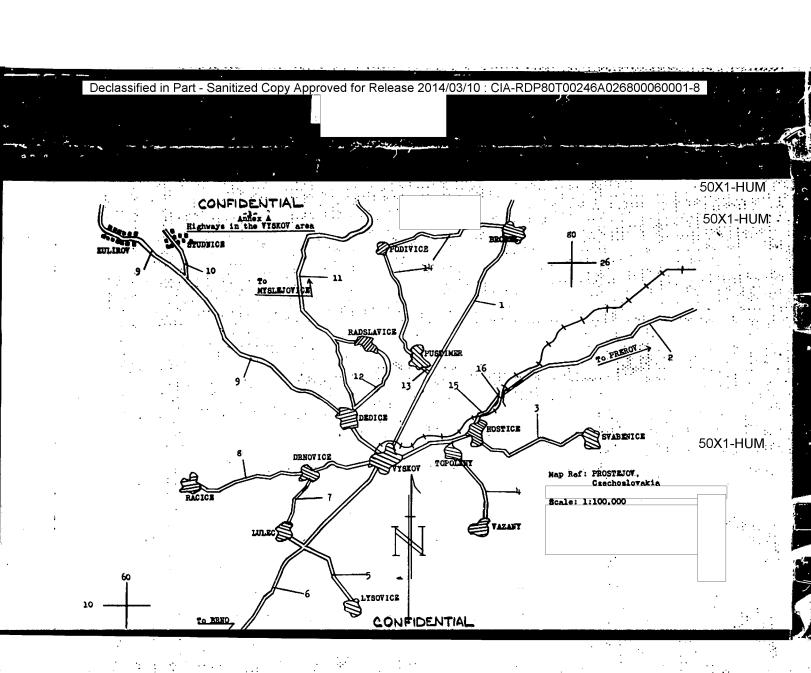
5UX1-HUIVI
	CONFIDENTIAL
	=4=
	Annex Á:
ena co	50X1-HUM
1.	Cobble stone surfaced state highway, in good condition.
2.	Asphalt surfaced state highway, in good condition.

3.	Rolled gravel surfaced district highway, in fairly good condition.  50X1-H
	Rolled gravel surfaced district highway. in very poor condition. 50X1-H
5.	Rolled gravel surfaced district highway, in fairly good condition.

6.	State highway. For details on this highway connecting VYSKOV with BRNO see Annex G. 50X1-HUM
7.	Rolled gravel surfaced district highway, in good condition. Both sides of this highway had a row of trees.

9. 10. 11. 12. 13. 14. 15.	DRNOVICE was asphalt surfaced, while the section from DRNOVICE to RACICE was rolled gravel surfaced. Both sections of this highway were in good condition.  District highway. The section of this highway between VYSKOV and DEDICE was cobble stone surfaced. Prior to 1952 this was a rolled gravel surfaced highway. From DEDICE to KULIROV this highway was rolled gravel surfaced. Both sections of this highway were in good condition.  Rolled gravel surfaced district highway, in very poor condition.  Rolled gravel surfaced district highway, in very poor condition. Trees were planted on both sides of this highway.  Rolled gravel surfaced district highway, in poor condition. Trees were planted on both sides of this highway.  Rolled gravel surfaced district highway, in poor condition. Trees were planted on both sides of this highway.  Rolled gravel surfaced district highway, in poor condition.  Grade crossing.  Railroad underpass, approximately 7 m long, 9 m wide and 3.50 m high.  50X1-HUM
