### RAIL ACTIVITY

## THANH HOA/VINH RAIL LINE, NORTH VIETNAM

RAIL ACTIVITY  
QUI VINH, NORTH VIETNAM  
1916N 10542E

THIS BRIEFING BOARD DEPICTS RAIL ACTIVITY ON THE THANH HOA/VINH RAIL LINE IN THE VICINITY OF QUI VINH.

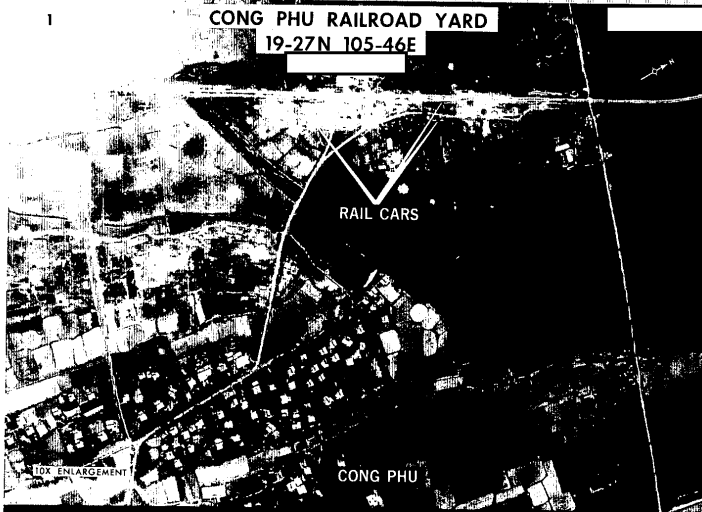
[REDACTED] REVEALS THAT THE RAIL LINE AT QUI VINH IS SERVICEABLE DESPITE AIR STRIKES AGAINST THE QUI VINH RAILROAD YARD AND VICINITY. SIXTY-EIGHT PIECES OF ROLLING STOCK ARE OBSERVED AT THE RAILROAD YARD AND A PREVIOUSLY DESTROYED TRAIN IS OBSERVED JUST WEST OF THE YARD. QUI VINH RAILROAD BRIDGE NORTH OVER STREAM [REDACTED], QUI VINH RAILROAD BRIDGE 2 OVER SONG HOANG MAI [REDACTED]), AND QUI VINH RAILROAD BRIDGE 3 OVER SONG HOANG MAI [REDACTED] APPEAR SERVICEABLE, QUI VINH RAILROAD BRIDGE 1 OVER SONG HOANG MAI [REDACTED] IS UNSERVICEABLE. A NEW BY-PASS UNDER CONSTRUCTION, WHICH WILL CROSS THE SONG HOANG MAI (RIVER) THREE HUNDRED METERS NORTH OF THE DESTROYED BRIDGE, IS NOT YET COMPLETED. AT LEAST TWO OCCUPIED AAA SITES ARE OBSERVED IN THE AREA.

A PREVIOUSLY REPORTED RAIL SPUR, LOCATED ONE NM EAST-NORTHEAST OF QUI VINH, CONTAINS SEVERAL UNIDENTIFIED PIECES OF ROLLING STOCK. A NEWLY LAID SPUR EXTENDING FROM THIS SPUR CONTAINS AT LEAST SIX PROBABLE FLANGE-WHEELED CARGO TRUCKS.
