COUNTRY Germany, Soviet Zone

SUBJECT Technical Examination of East German Semi-Conductor, Diodes and Transistors

DATE DISTR. 7 April 1959

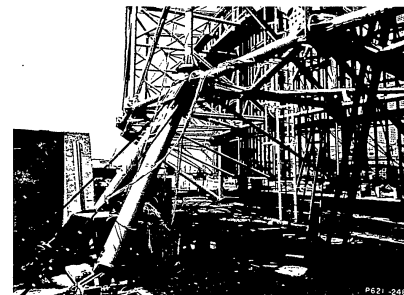
Fig. 71-2. Reflector rear support leg showing strain gage wiring terminating of instrument panel.

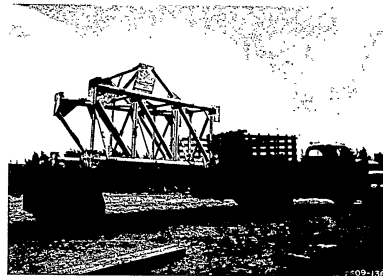
Fig. 71-21. Spider support arm loaded upside down, showing holes in mounting flanges, and brackets for survival locks.

Two of the three identical trusses were then shipped directly to the site (Fig. 71-21); the third was returned to the test pad at Garden City for load, deflection and stress level testing by Lincoln Laboratory personnel.

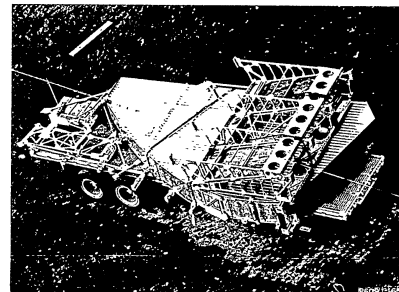
Fig. 71-22. Hog horn, upper supports, rear support and pivot arms as shipped from the fabricator required special road escorts because of 15-foot width.

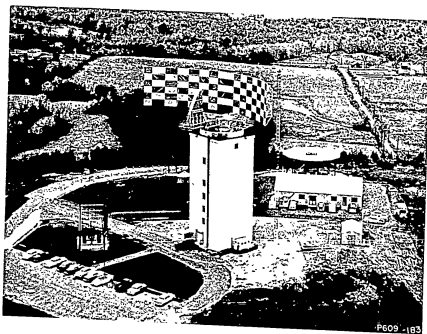
Fig. 71-65. Aerial view of completed antenna and tower during operation at 5 rpm.

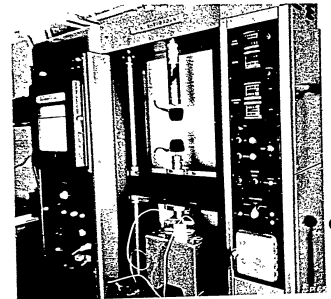
Fig. 76-43. Instron tester with fixtures for tensile test.

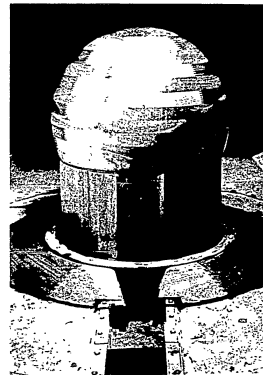
Fig. 76-49. Wind tunnel model of spherical, tower-mounted radome.

The radomes tested are 1/24 scale models of 55-foot-diameter radomes. They are made of polished mahogany of 27.5-inch diameter. The distance from the center of the sphere to the top of the base is 5.728 inches. The base is a regular 12-sided prism with a height of 12.0 inches. Photographs of the models are shown in Figs. 76-49 and 76-50.

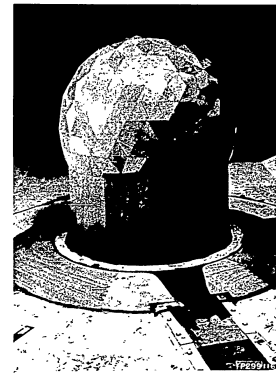
Fig. 76-50. Wind tunnel model of spherical, faceted, tower-mounted radome.
