BUILDING CONSTRUCTION ON PERMAFROST
IN THE USSR

REPORT NO. 98

Air Information Division, Structural Engineering Section

April 1959

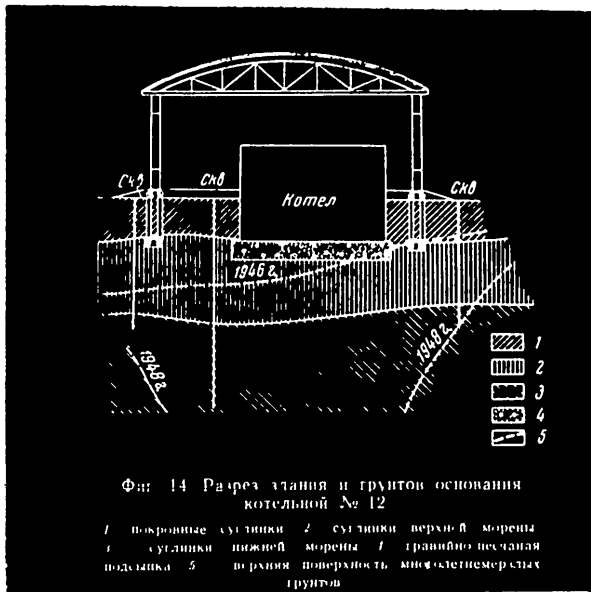
PLATE 16

Boiler House No. 12, Sanitation Plant
 Section Through the Structure and the Foundation Bearing Layer. Ckb denotes bore hole

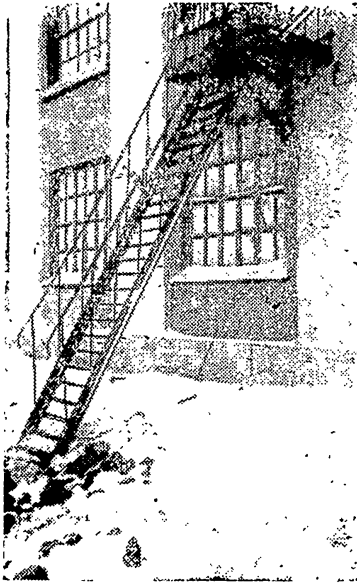
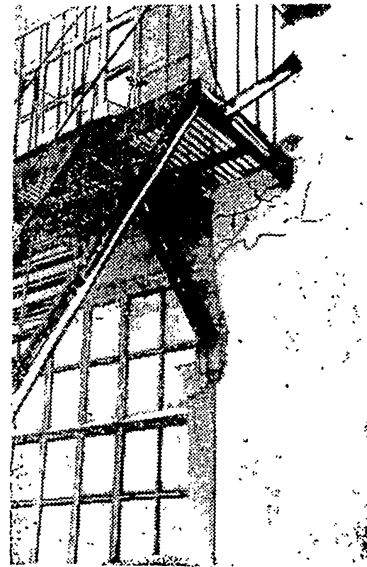
PLATE 22

Wall Deformed by a Rigidly Joined Fire Escape
Heaved by its Shallow Foundation.

DEFORMATION OF VORKUTA BUILDINGS AND ITS CAUSES
EFFECTS ON A BUILDING OF HEAVING OF A SHALLOW FOUNDATION
Source: N. I. Saltykov. Building Foundations in the Bol'shezemel'skaya Tundra Region.
(Akademiya Nauk SSSR. Trudy Instituta Merzlotovedenia im. V.A. Obrucheva,
Vol. IV, 1944) p. 181

3. Absence of splash aprons around the buildings (see Plate 22) and laying out yards and passages between the buildings at a level higher than that of sidewalks or leveled ground by the walls of buildings. This arrangement allows surface waters to penetrate freely to the footings; thawing of the soil, uneven settlement, and deformation follow. Sixteen such cases were registered.

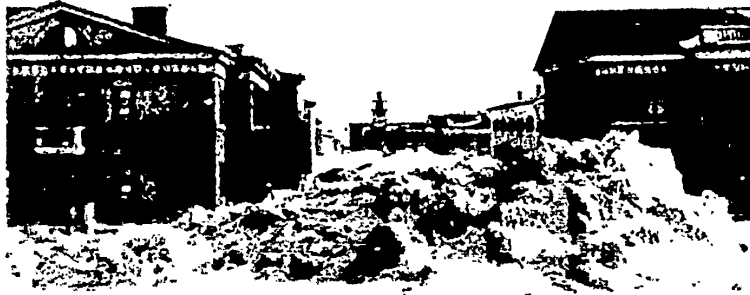
Fig. 1. Snowdrifts in a Street Running at Right Angles to the Direction of Prevailing Winds.

Recent information shows that the layout of some parts of Noril'sk was not altogether well conceived. Presumably the planners lost sight of the direction of prevailing winter winds when some streets were laid out in the windward part of town. Streets running at right angles to the direction of wind at times became impassable because of snow drifts. (Plate 48 a, Fig. 1). In places, snow fences are used to protect buildings (Plate 48 a, Fig. 2).

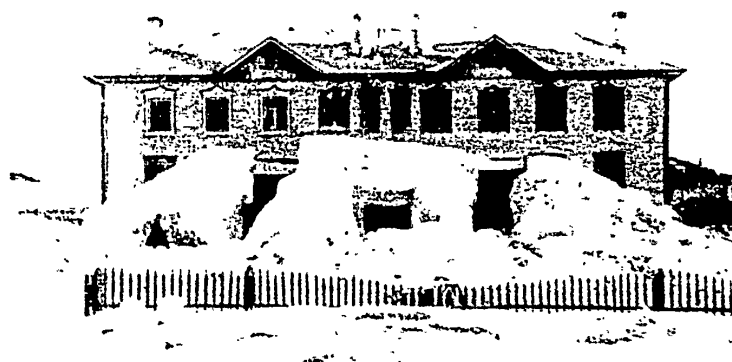
Source: Arkhitektura SSSR, No. 1, 1959, p. 15
Plate 56 a

Snowdrift on Lee Side of a Building Erected
at Right Angles to Prevailing Wind

(The building is presumably of wood)

Long polar nights with low temperatures and snow storms (Plate 56 a).
