SURFACE CHANGE DURING WARM-FORMING

By Jack Houck

February 5, 1982

Metallurgical Analysis by Victor Kerlins

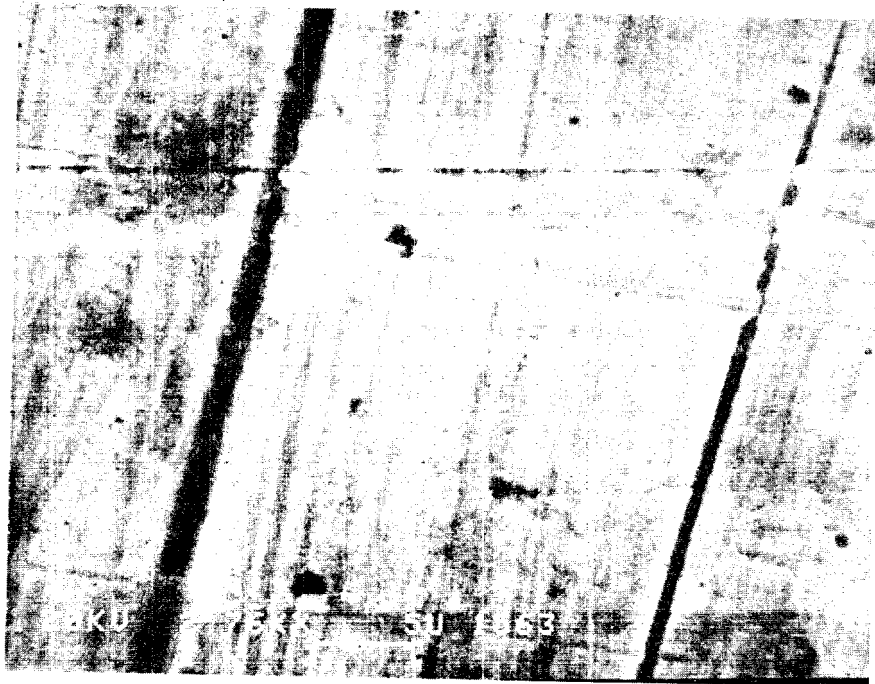
Figure 16. Surface of Control Rod, Area A (2.76KX)

section being removed.) Figure 13 shows the surface of the control rod section magnified 14.3 times. Figure 14 shows the same section magnified 98 times. Further magnification (520 times) of that same section is shown in Figure 15. Points A and B are defined in Figure 15 by the arrows on the margin. Magnification of point A to 2.76 times is shown in Figure 16. Similarly, magnification of point B to 2.78K times is shown in Figure 17. These photographs of another portion of the control rod surface are essentially identical to those previously shown in Figures 2 through 6. The surface of the straight section removed from the warm-formed rod, magnified 14.3 times, is shown in Figure 18. Figure 19 shows that same section magnified 97 times. Further magnification (520 times) is shown in Figure 20. New points A and B are defined by the arrows shown in the margin on Figure 20. Further magnification of point A is shown in Figure 21, magnified 2.78K times. Similarly a magnification of 2.78K times of point B is shown in Figure 22. It can be seen that the surface of the straight portion of the warm-formed rod is very similar to the surface of the bent portion shown in Figures 7 through 11. Thus, the SEM shows that the same type of surface pitting occurred over the entire warm-formed rod.
