PHOTOGRAPHIC INTERPRETATION REPORT

[REDACTED]  
CONSTRUCTION  
TECHNIQUES AND  
PROCEDURES  
ASSOCIATED WITH  
THE TYPE IIID ICBM  
LAUNCH SILO

**CONSTRUCTION TECHNIQUES  
AND PROCEDURES  
ASSOCIATED WITH  
THE TYPE IIID ICBM LAUNCH SILO**

OCTOBER 1966

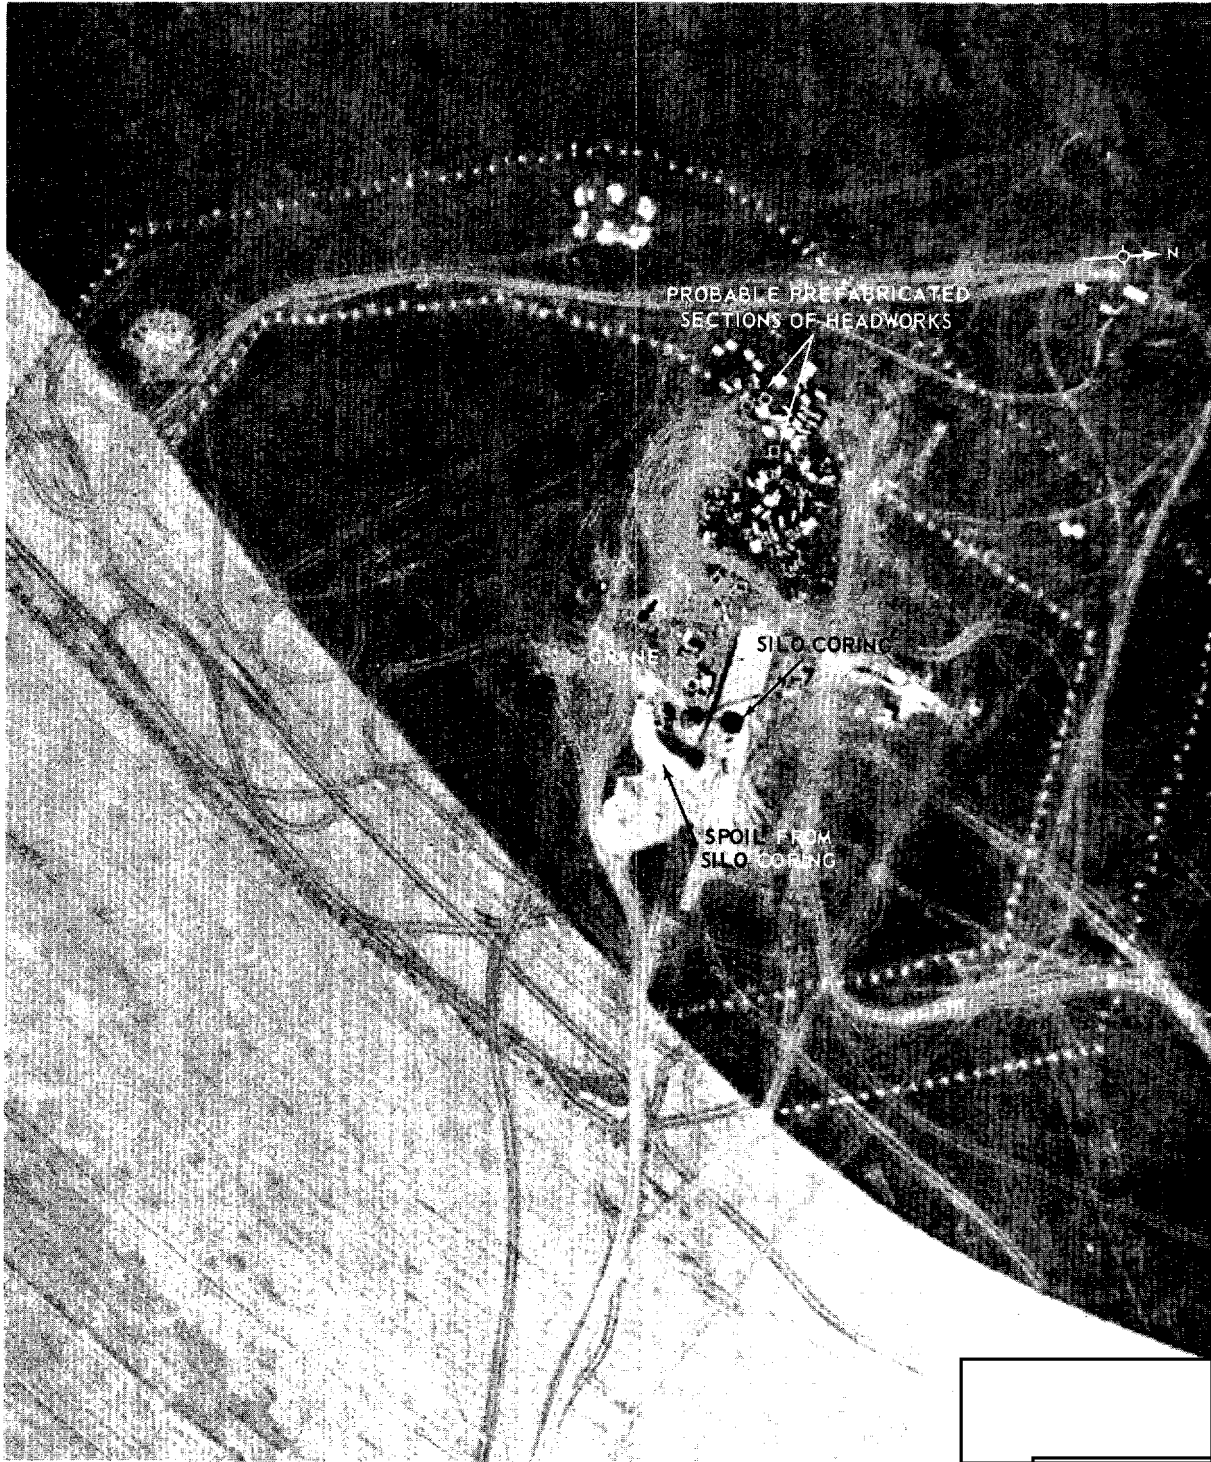
FIGURE 1. SILO CONSTRUCTION AT LAUNCH SITE 70, OLOVYANNAYA ICBM COMPLEX.

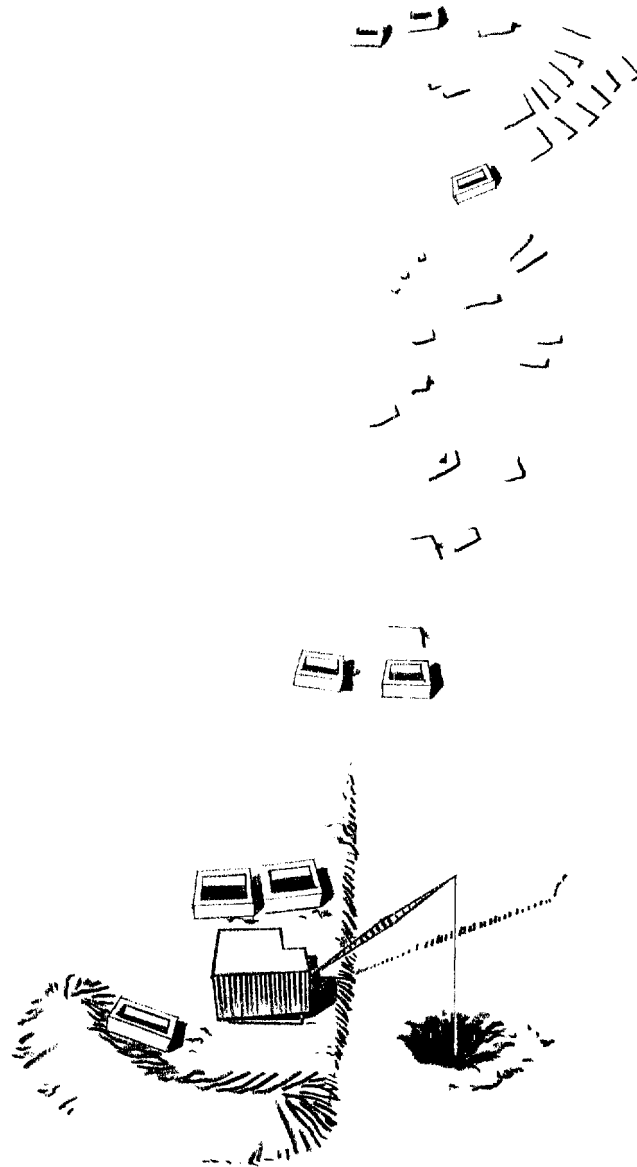
FIGURE 2. ARTIST'S CONCEPT OF SILO CORING BEING EXCAVATED AT SITE 70, OLOVYANNAYA.

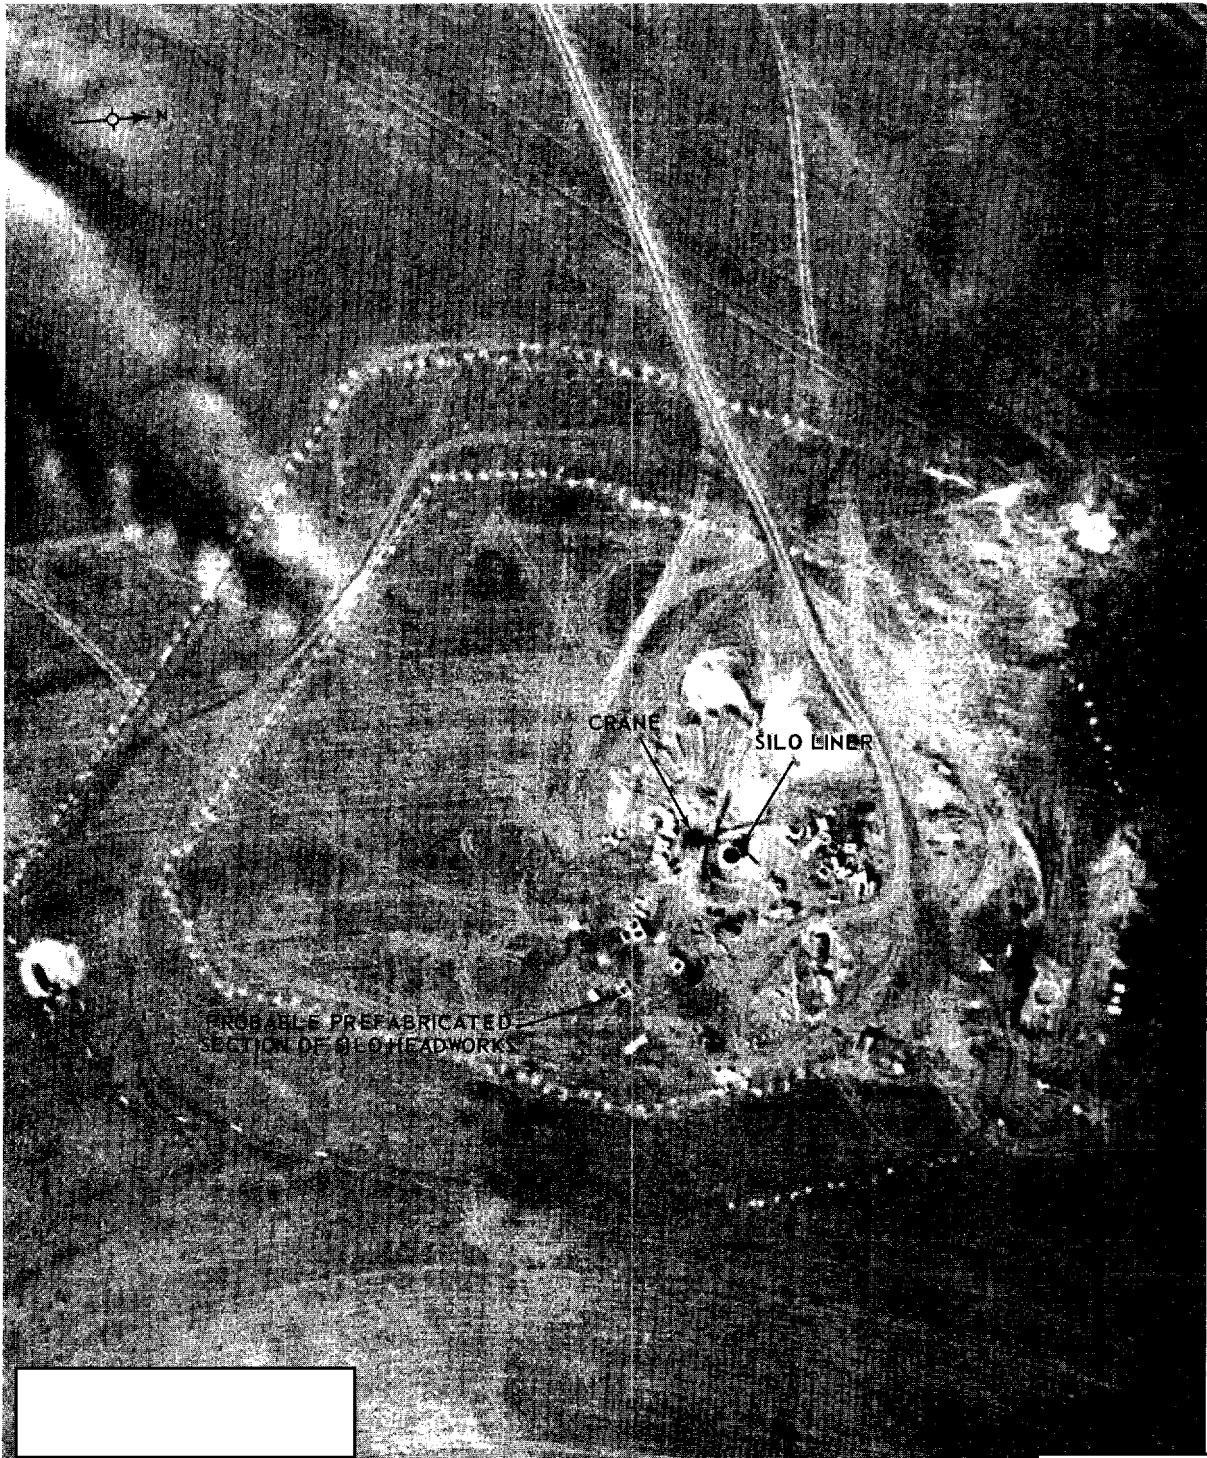
FIGURE 3. SILO CONSTRUCTION AT LAUNCH SITE 79, OLOVYANNAYA.

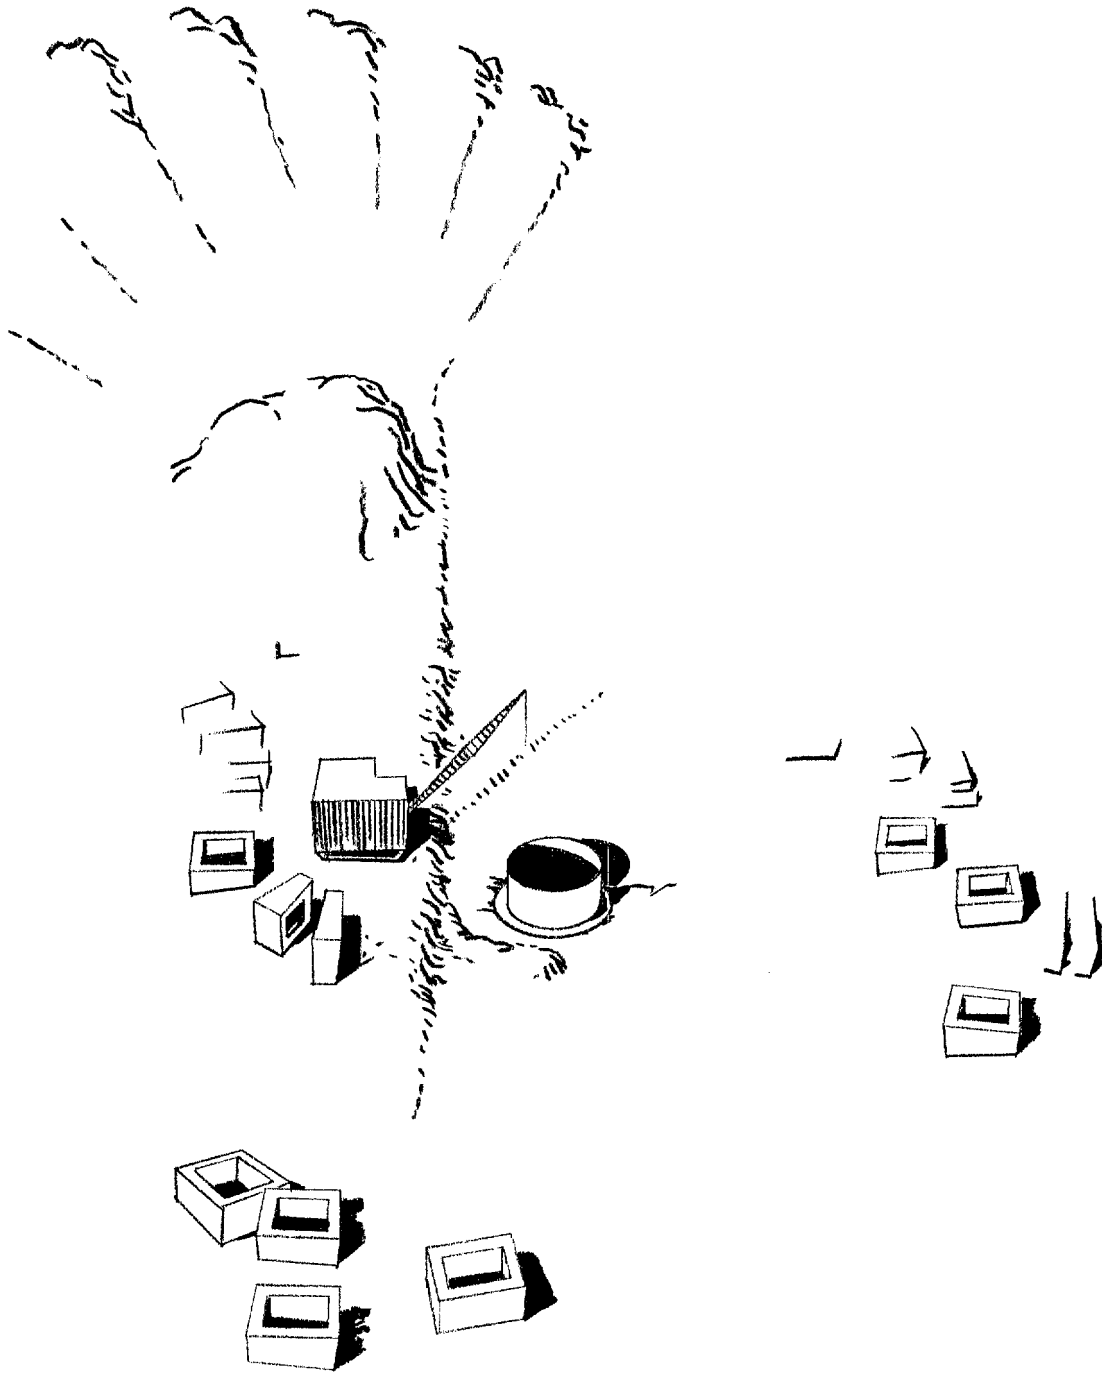
FIGURE 4. ARTIST'S CONCEPT OF EMPLACED SILO LINER AT SITE 79, OLOVYANNAYA.

The square objects have been observed in the railhead and storage area at the Olovyannaya ICBM Complex. They were stacked on the ground and on a flatcar [redacted]. At Launch Site 66, at Olovyannaya, a Type IIID silo liner was identified, for the first time, [redacted]. The liner was upright and protruding from the silo coring. No evidence of concrete forms was observed in the area; however, the square objects were stacked beside a crane which was working over the silo. At Launch Site 70, Olovyannaya (Figures 1 and 2), [redacted] revealed a silo coring being excavated by a crane. Numerous square objects were visible in the vicinity of the site. There was no evidence of a silo headworks. On the same mission an emplaced silo liner was visible at Site 79, Olovyannaya (Figures 3 and 4). A crane was working over the liner and the square objects were scattered about the silo excavation. Construction of the silo headworks had not started. The mission further revealed that the silo head-

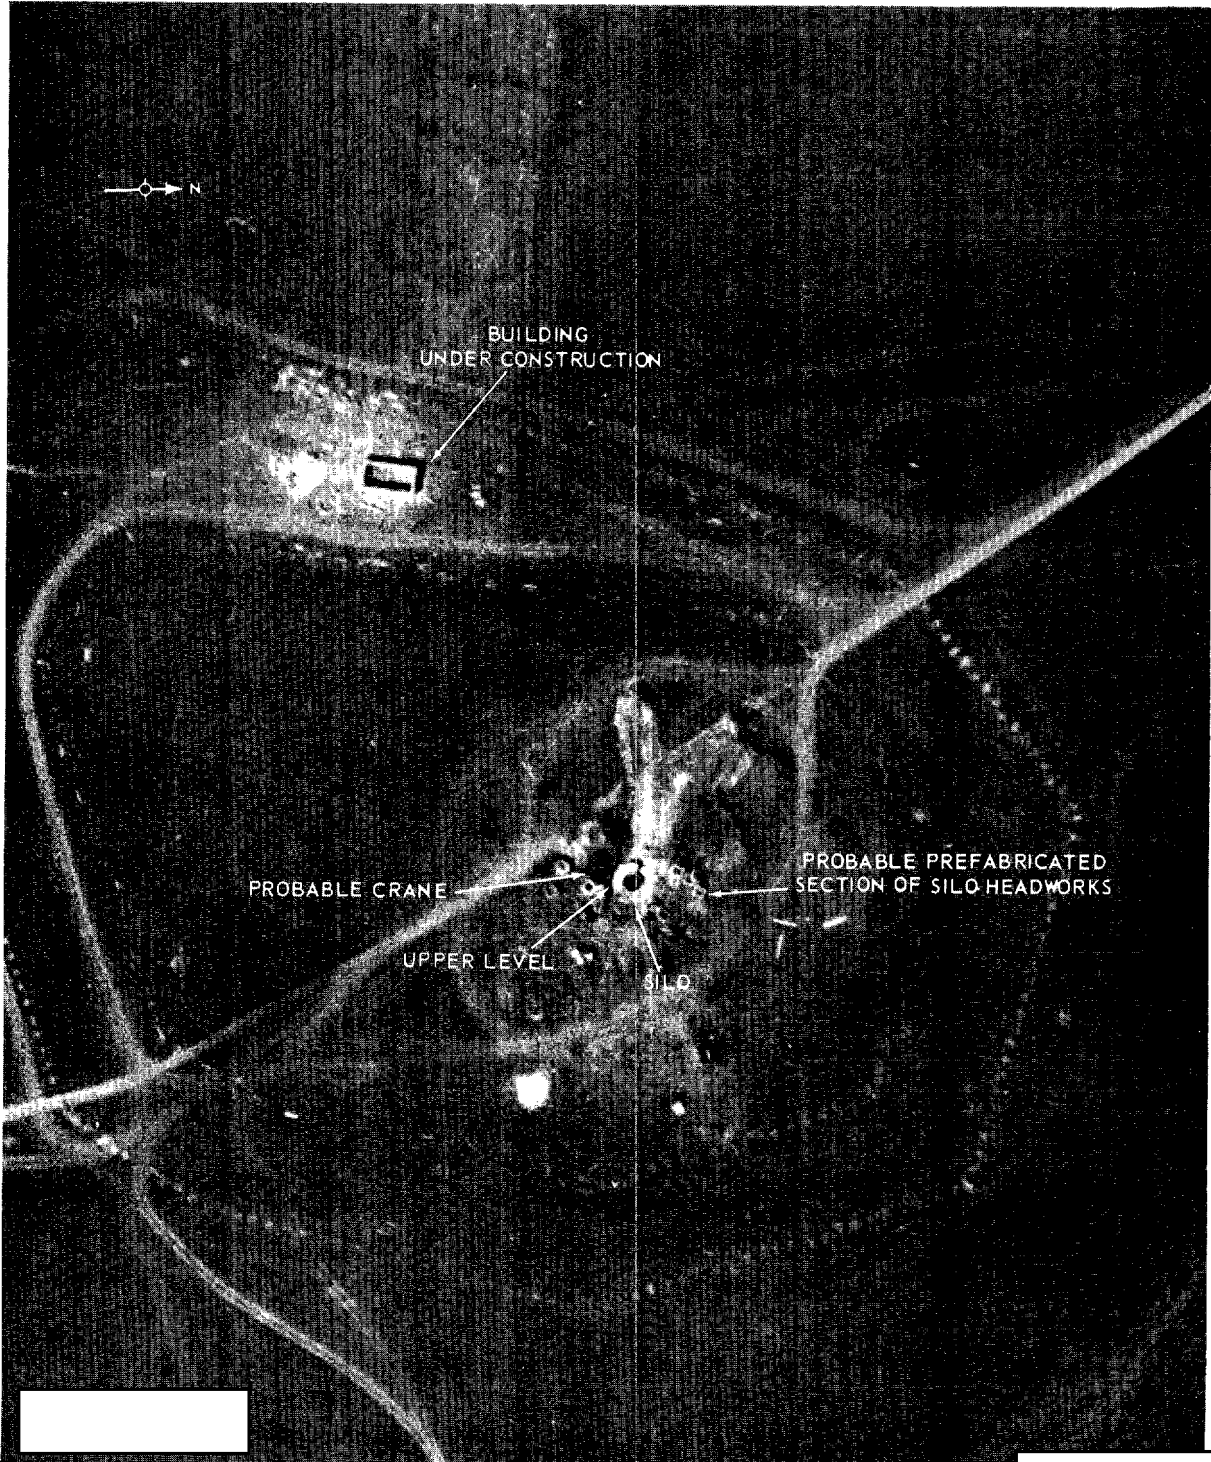
FIGURE 5. SILO CONSTRUCTION AT LAUNCH SITE 72, OLOVYANNAYA.

works at Site 72 (Figures 5 and 6) was under construction and that it probably consisted of 2 levels, one being only partially complete. Six square objects were visible around the silo, and a probable crane was on the south lip of the silo excavation.

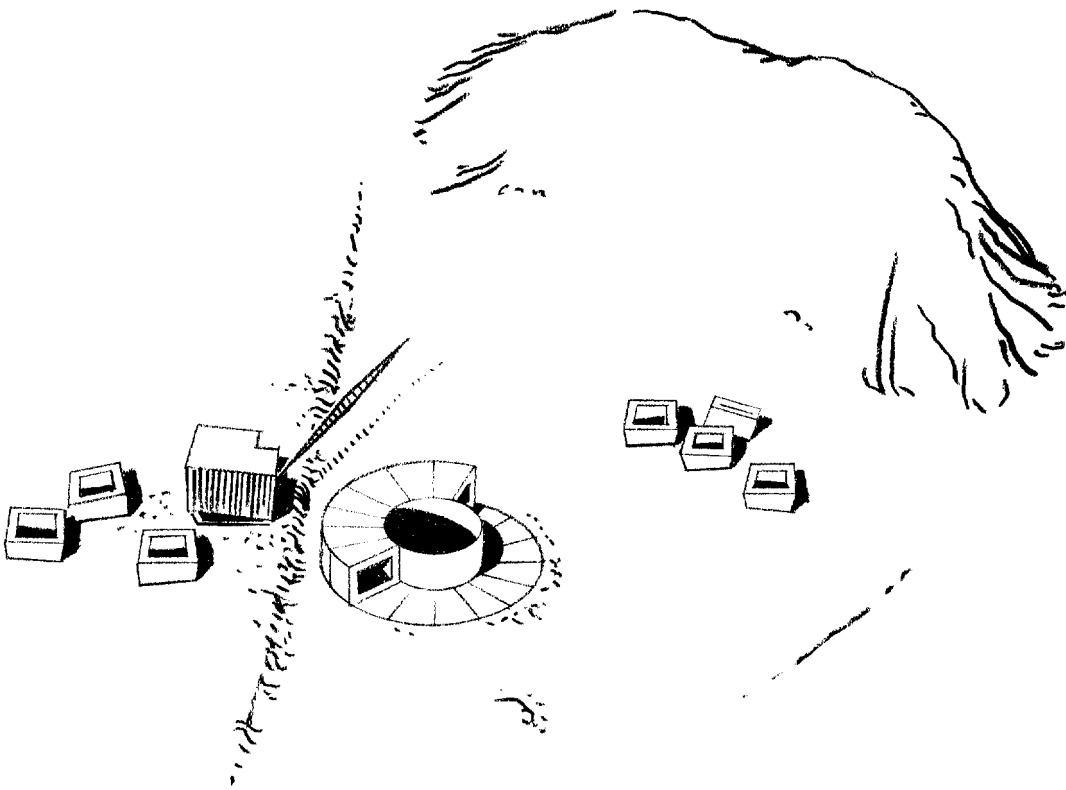
FIGURE 6. ARTIST'S CONCEPT OF SILO HEADWORKS UNDER CONSTRUCTION AT SITE 72, OLOVYANNAYA.

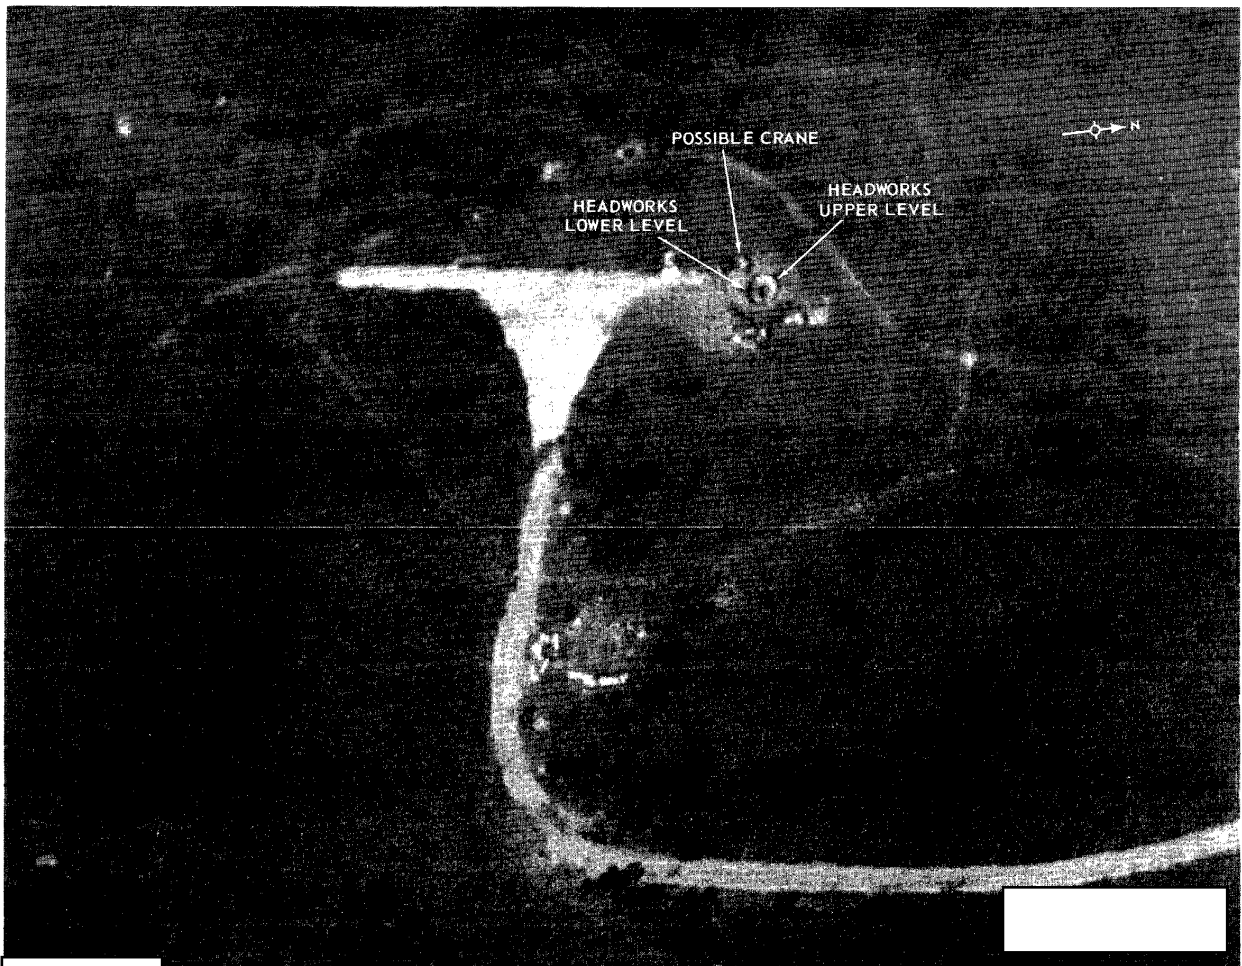
FIGURE 7. SILO CONSTRUCTION AT LAUNCH SITE 21, SVOBODNYI ICBM COMPLEX.

[redacted] coverage [redacted] of the Svobodnyy ICBM Complex revealed at Site 21 a silo headworks under construction (Figures 7 and 8) which is definitely in 2 levels. It appears that the top level is about half completed, with lines which indicate that it is composed of sections. A possible crane is on the lip of the silo excavation. Possible square objects are visible in the vicinity of the silo.

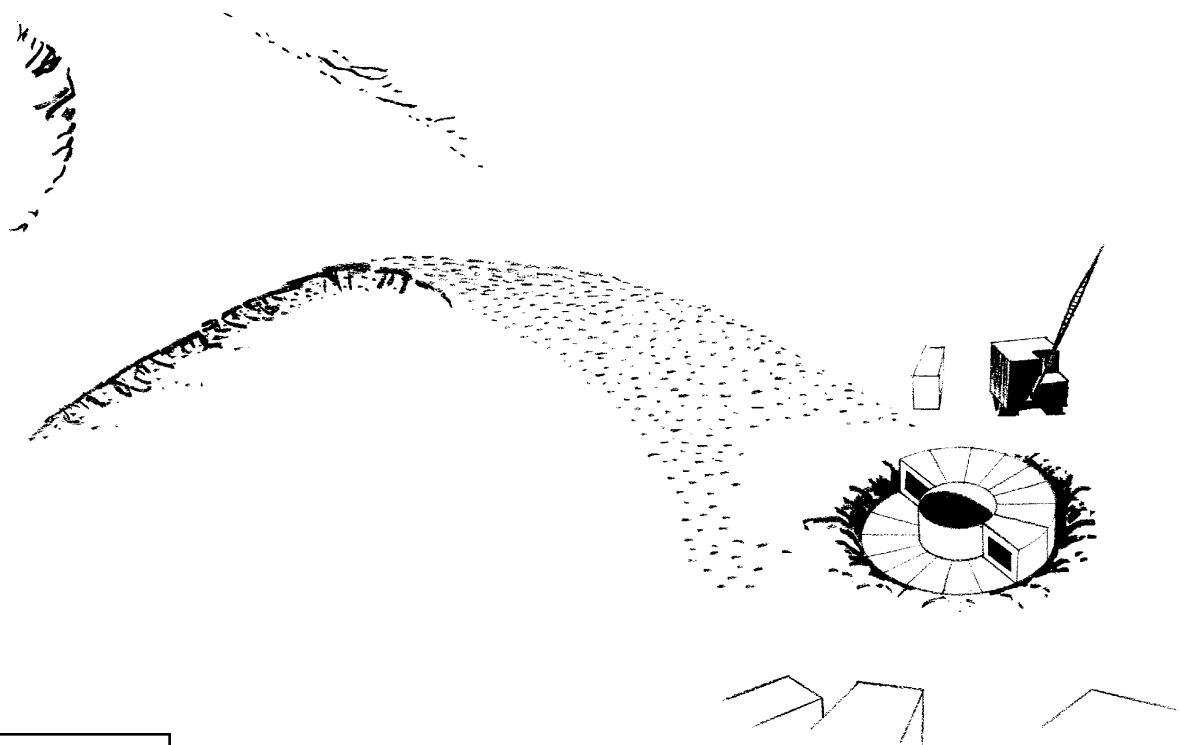
FIGURE 8. ARTIST'S CONCEPT OF SILO HEADWORKS UNDER CONSTRUCTION AT SITE 21 SVGBODNY.

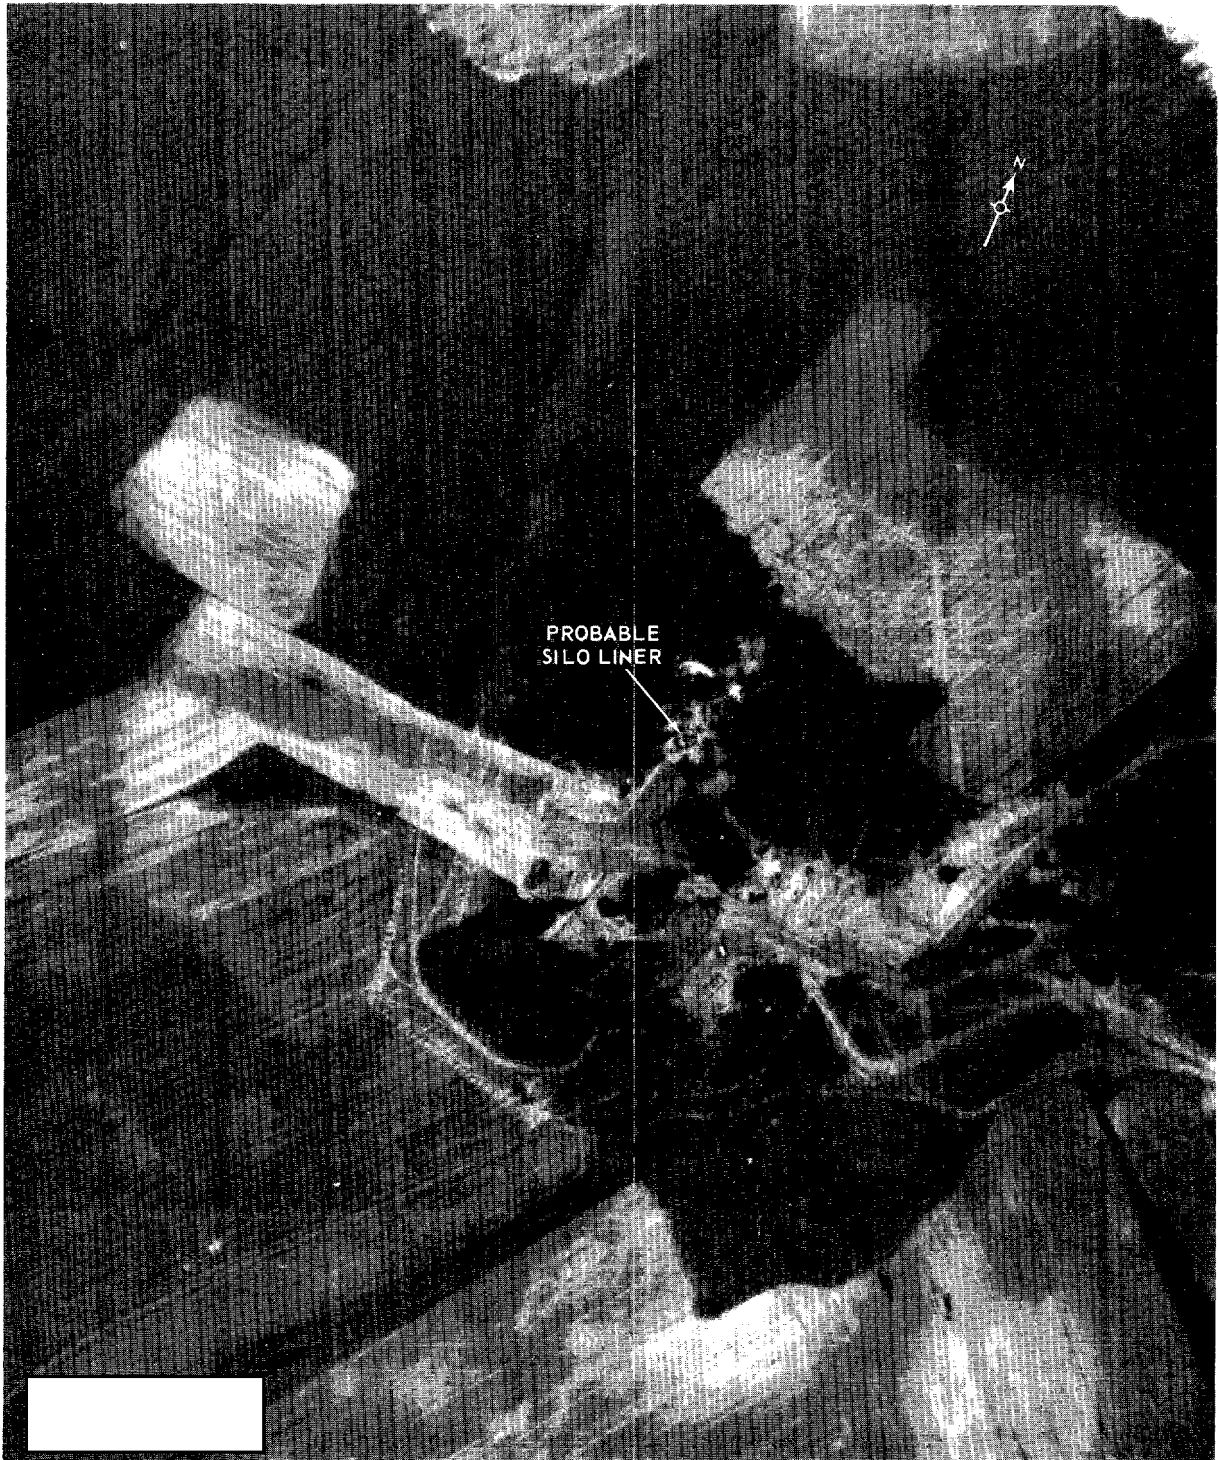
FIGURE 9. SILO CONSTRUCTION AT LAUNCH SITE 9, KOSTROMA ICBM COMPLEX.

[redacted] Kostroma ICBM Complex revealed what is probably an emplaced silo liner in the silo excavation at Site 9 (Figure 9). Dark, tapered lines radiate from the liner to the side of the silo excavation and may indicate sections missing from the first level of the silo headworks. Neither a crane nor the square objects were visible on this fair-interpretability photography.

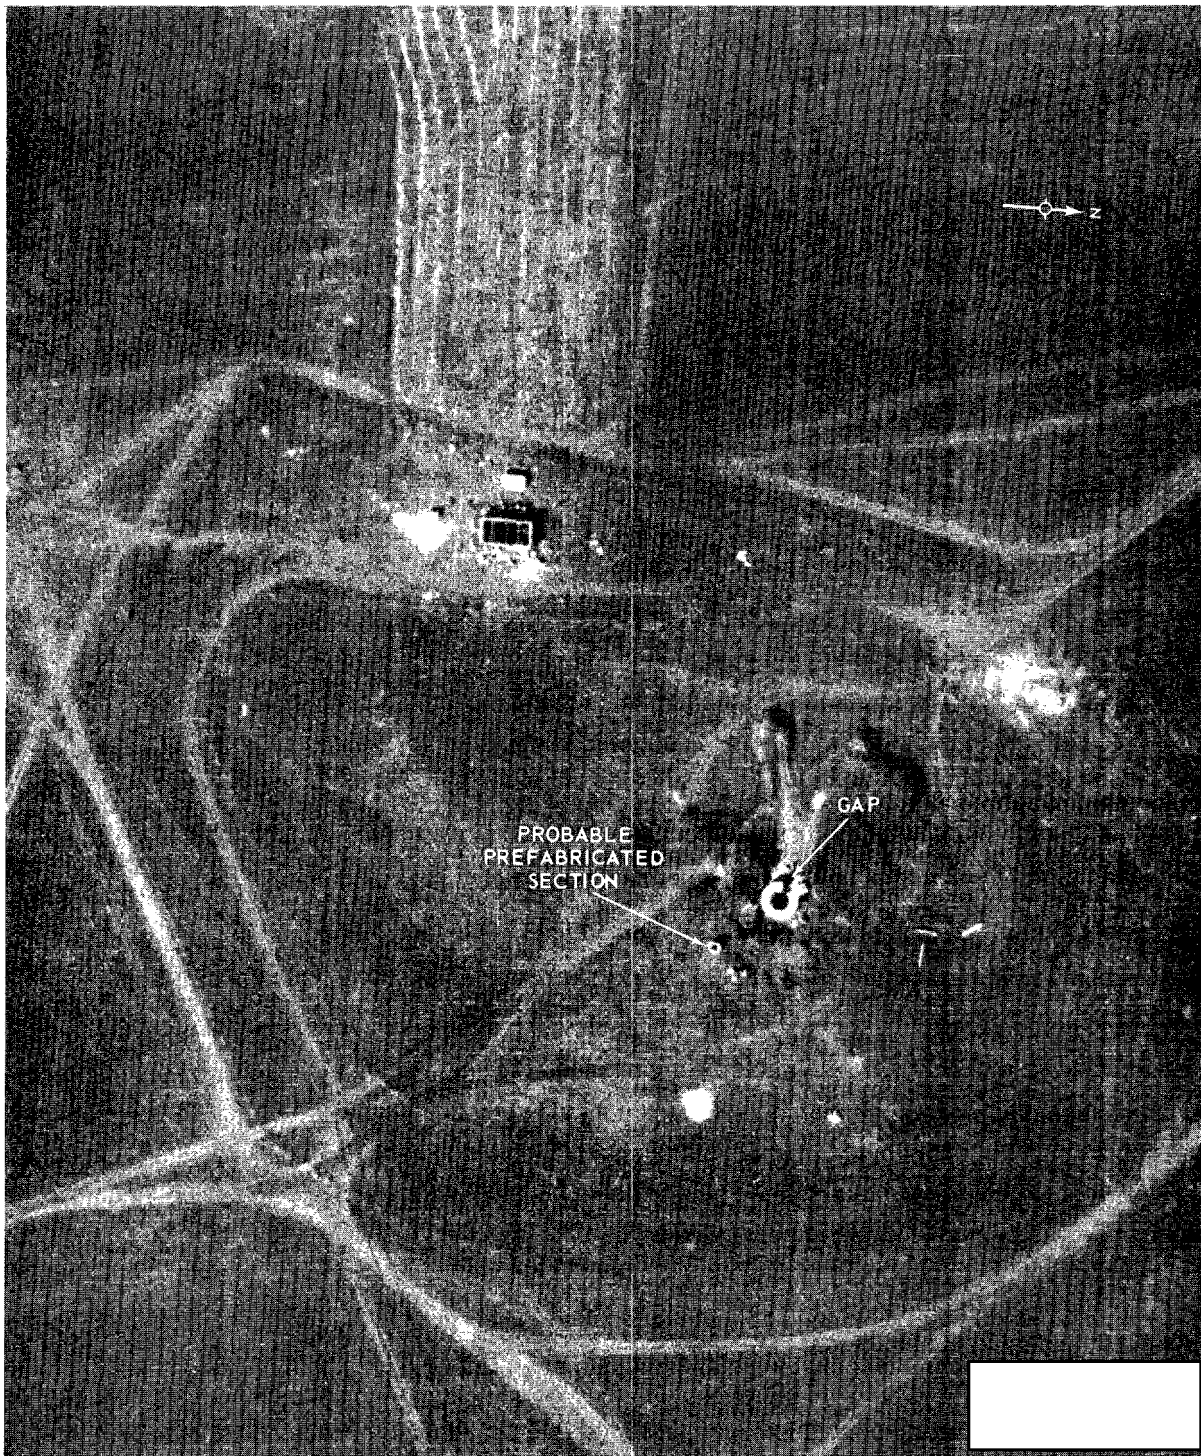
FIGURE 10. SILO CONSTRUCTION AT SITE 72, OLOVYANNAYA.

A wedge-shaped gap is visible in the silo headworks at Site 72, Olovyannaya (Figure 10), [redacted]. One square, hollow object is visible approximately 50 feet southeast of the silo. The silo liner is visible in the headworks.
