HH-43B
AIRCRAFT ACCIDENT

SUBJ: H-43 ACCIDENT

HISTORY OF FLIGHT

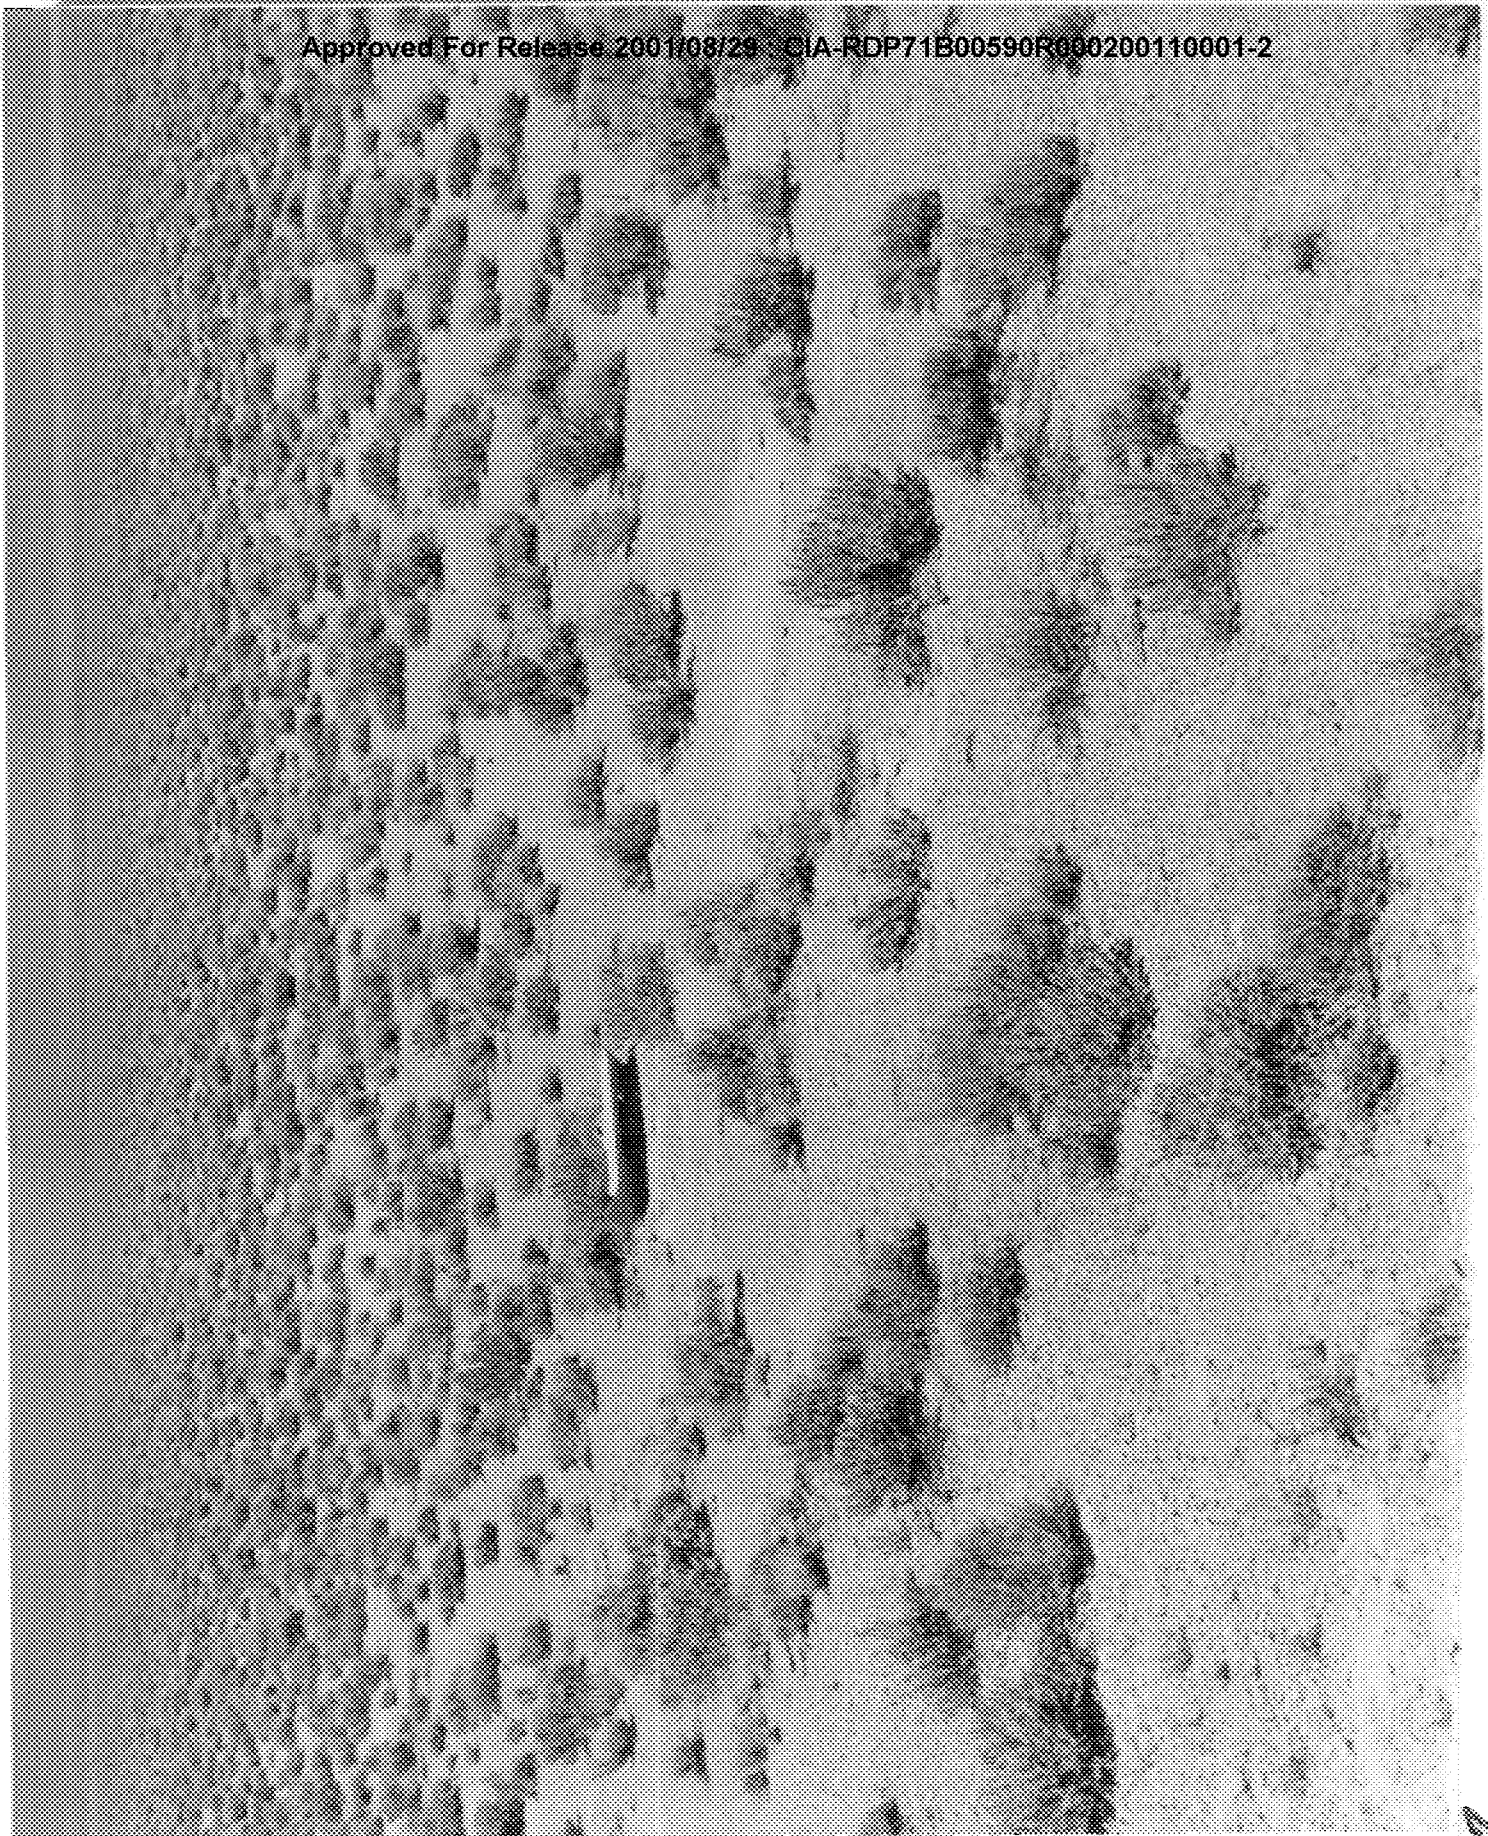
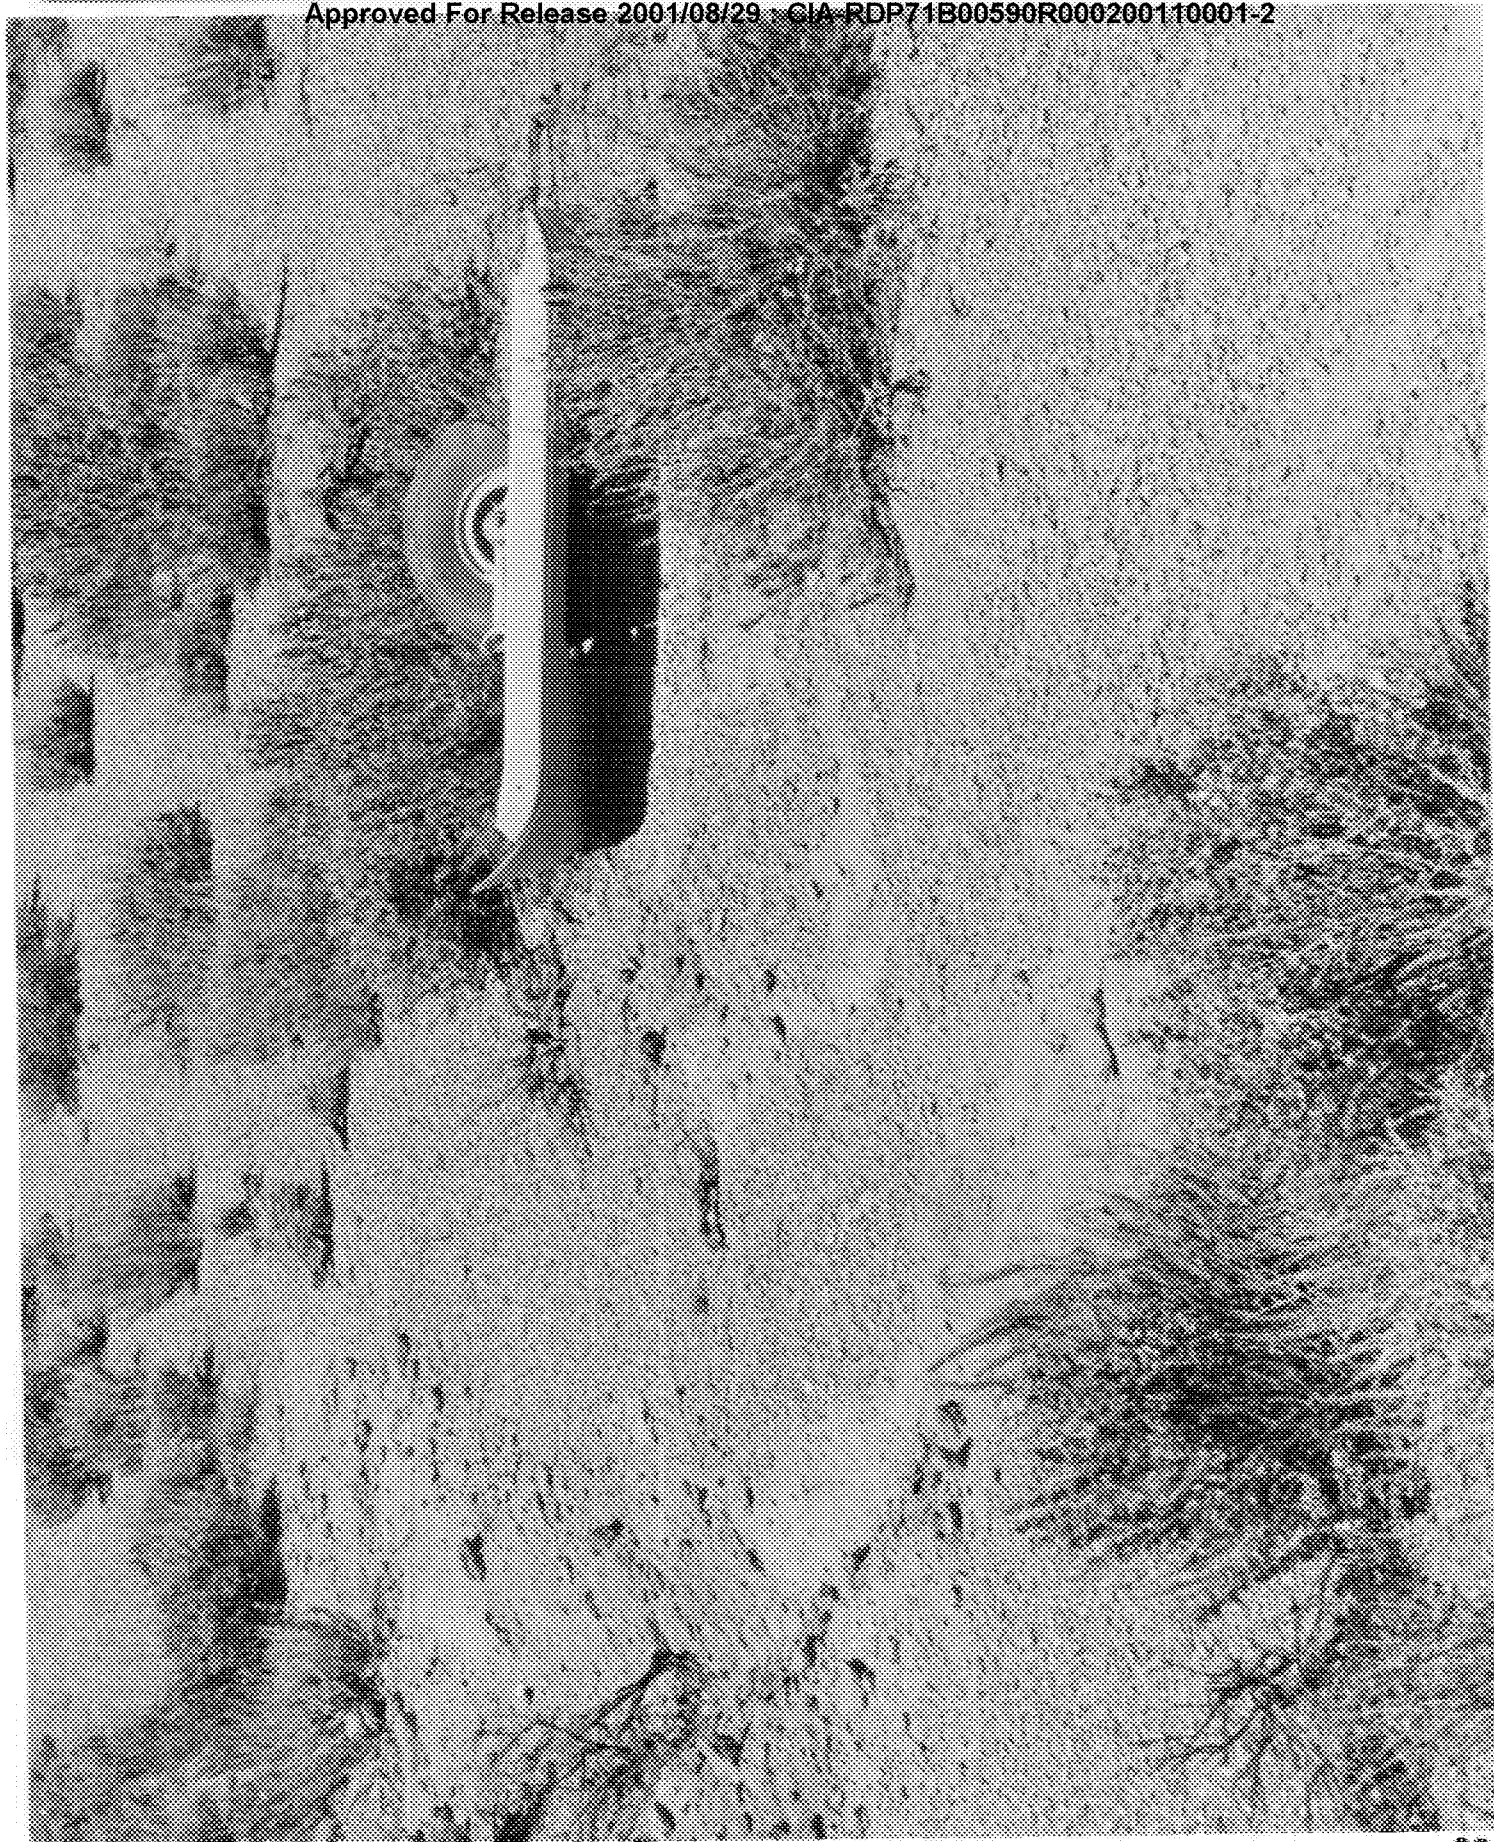
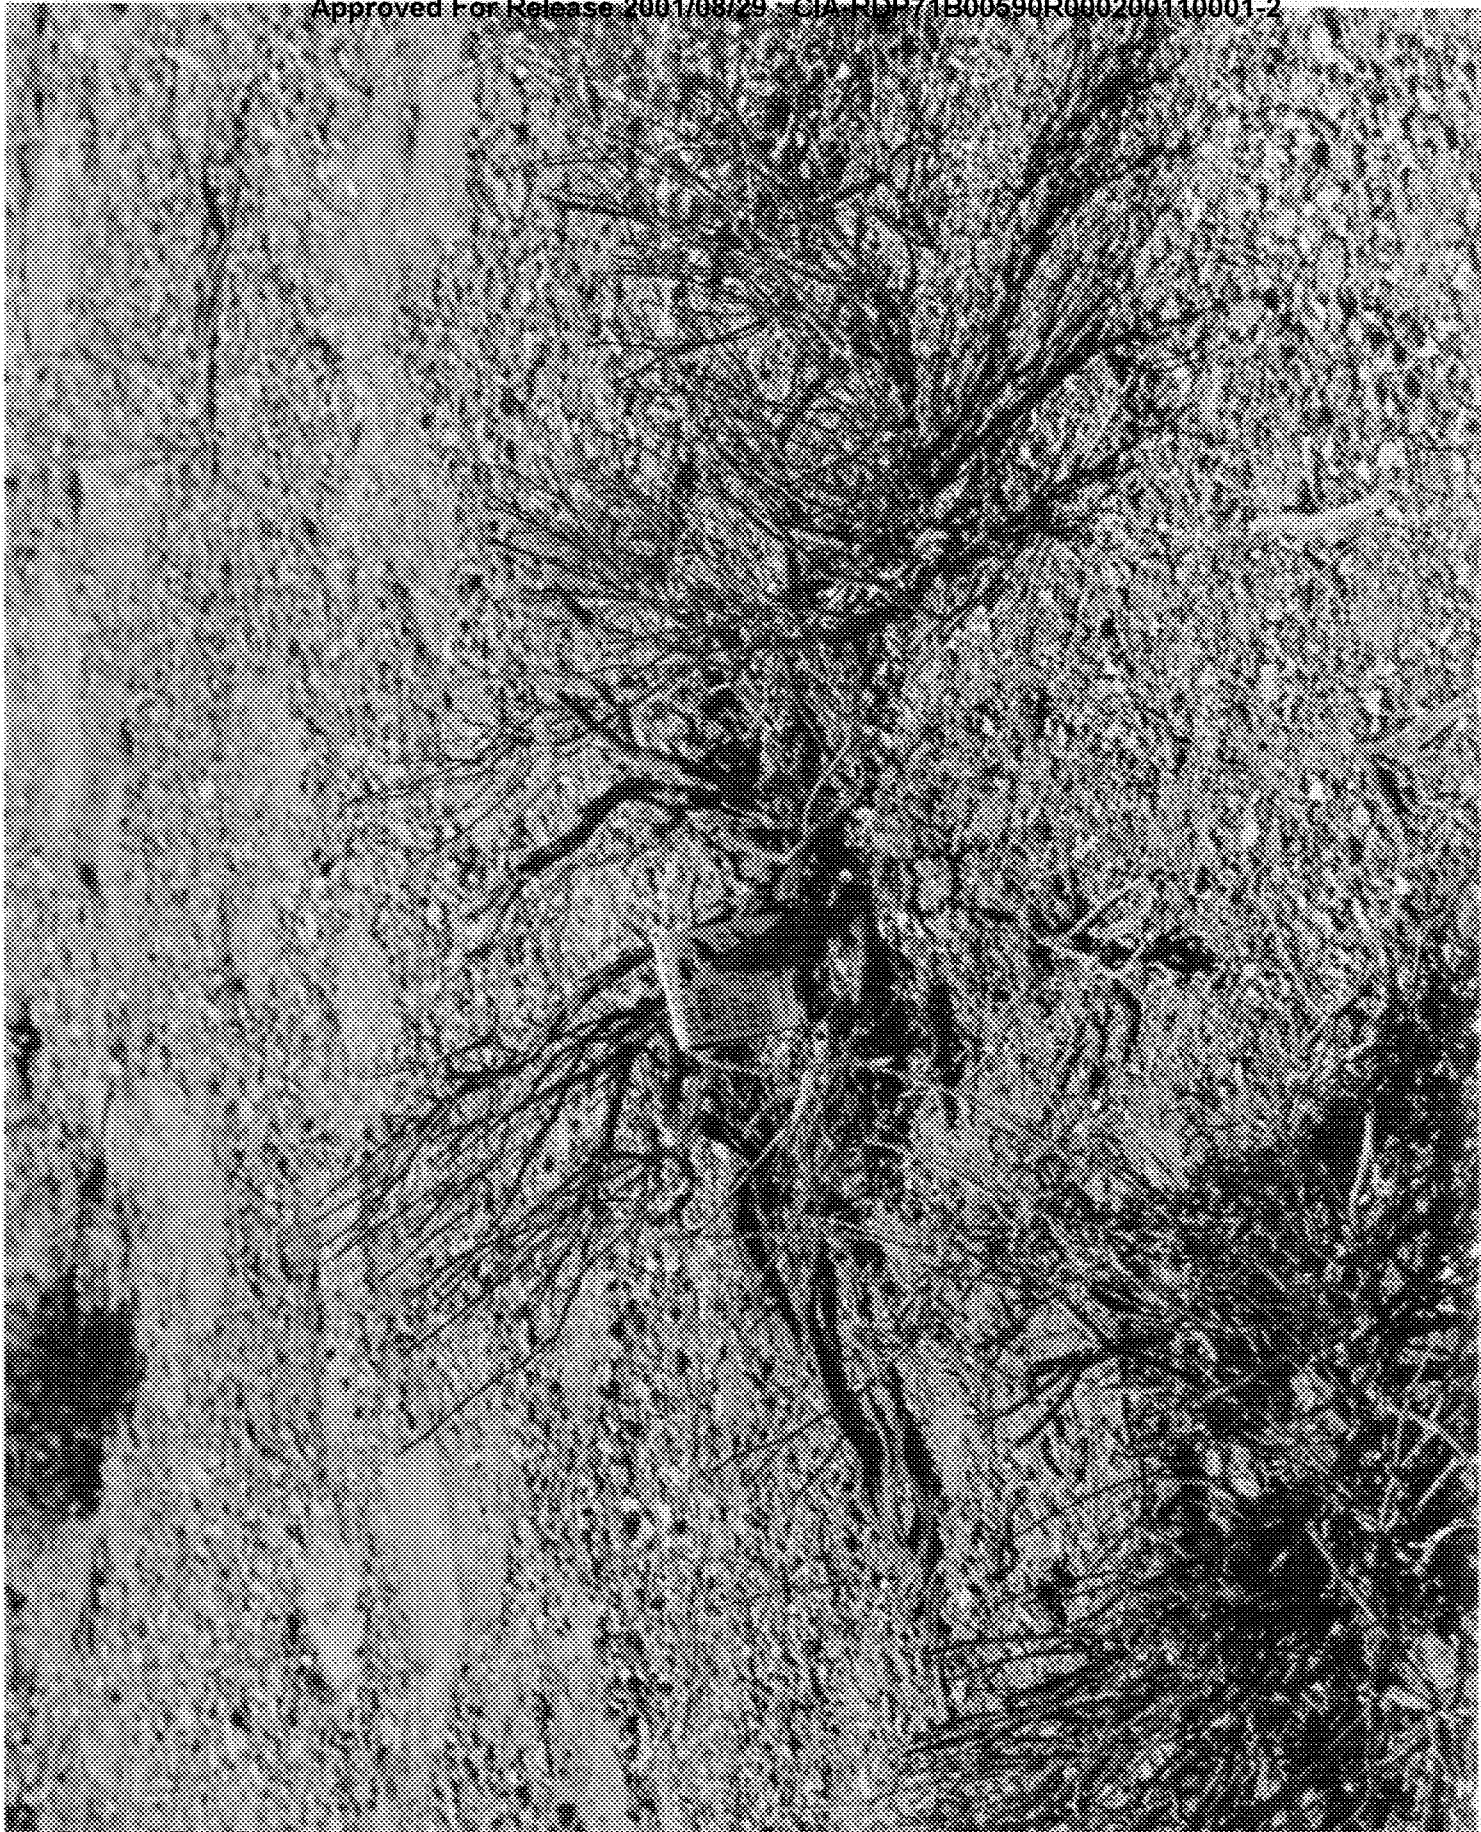
1. HORIZONTAL STABILIZER DAMAGE
2. AFT CABIN, BOTTOM OF FUSELAGE, AND RIGHT MAIN GEAR DAMAGE
3. LEFT AUXILIARY GEAR DAMAGE
4. LEFT MAIN GEAR DAMAGE
5. RIGHT AUXILIARY GEAR DAMAGE
6. RIGHT MAIN GEAR DAMAGE
7. IMPACT AREA, DIRECTION OF TRAVEL RIGHT TO LEFT
8. CLOSE UP OF RIGHT AUXILIARY GEAR IMPACT AREA. GOUGE ON LEFT SIDE IS WHERE THE BROKEN STRUT DUG INTO THE GROUND.
9. SAGEBRUSH CUT OFF BY ROTOR BLADES DURING RECOVERY. MATCHBOOK COVER INDICATES RELATIVE SIZE.
