PHOTOGRAPHIC INTERPRETATION REPORT

SOVIET MILITARY ORDER OF BATTLE BALTIC MD

MILITARY INSTALLATION
(57-24N 021-34E)
VENTSPILS, LATVIYSKAYA SSR, USSR
BAL TIC MD

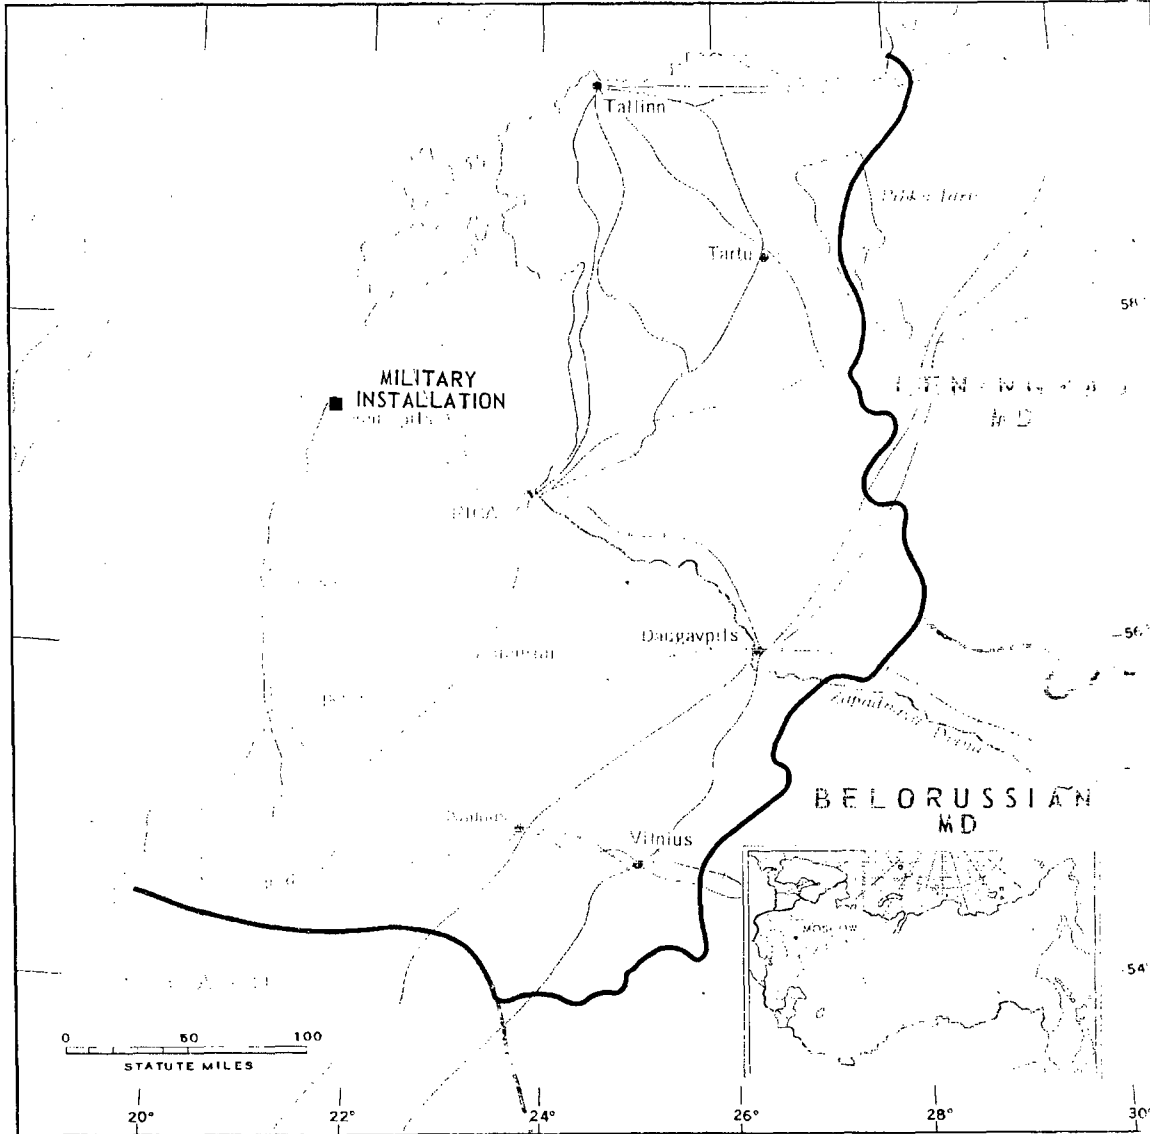
FIGURE 1. LOCATION OF MILITARY INSTALLATION.

A military installation is located on the northeast edge of Ventspils on the Baltic Sea. The installation is approximately 3 kilometers (km) northwest of a railroad bridge and adjacent to a commercial quay (Figure 1).

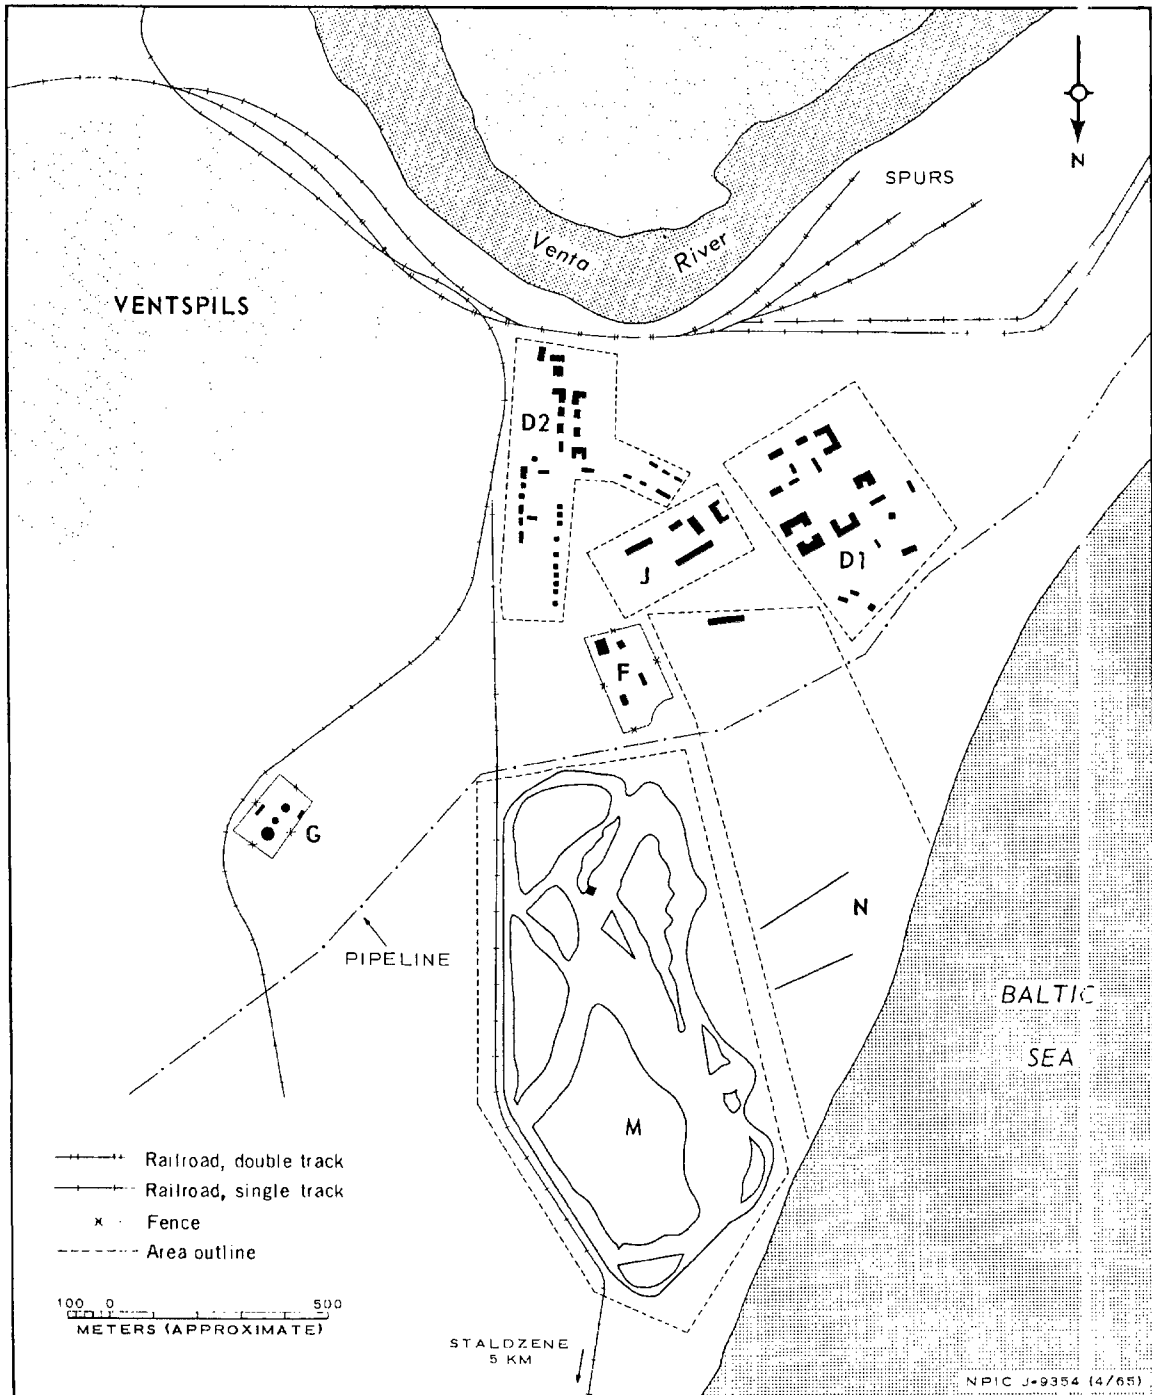
FIGURE 3. MILITARY INSTALLATION. Sketch compiled from Mission Report, June 1964.

The installation covers approximately 500 acres and contains: 2 housing/administration areas with a total of 22 barracks/administration buildings, 22 possible dependents quarters, 5 storage buildings, 7 support buildings, a motor pool with 3 vehicle storage/maintenance buildings, an ammunition storage area with 4 storage buildings, a driver-training course, and an armor range (Figures 2 and 3). A POL storage

Area M contains an irregular driver-train-

ing course with a control building and probable obstacles.
