PHOTOGRAPHIC INTERPRETATION REPORT

# SOUTHEAST ASIA ACTIVITY REPORT

# SELECTED TRANSPORTATION AND INFILTRATION COMPENDIUM ROAD STUDY, ROUTE 7

NPIC/R-128/67 JULY 1967

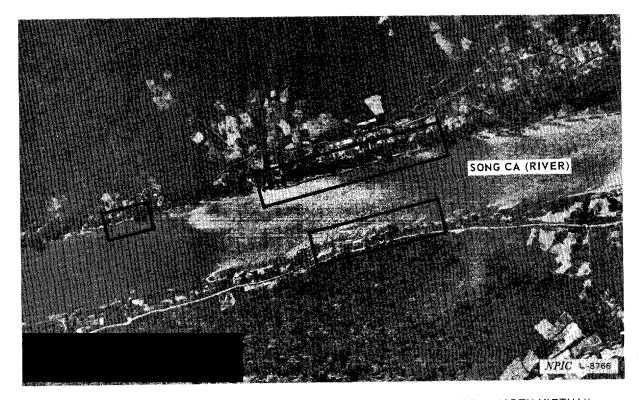
FIGURE 1. MOORED SAMPANS (29 TOTAL), KHE BO TRANSSHIPMENT AREA, NORTH VIETNAM

from Route 7 along the west bank of the Song Ca (river) with foot trails covering the remaining distance to the water. Up to 30 25X1D have been observed moored along both sampans river banks. (Figure 1) Truck Park, VG663182; Access road with several short parking slots. 4. Truck Park, VG637193; Series of single parking lanes. Possible Rest and Refuel Area, VG626190; Vehicle tracks through abandoned village of Ban Tam Bong. Parking slots immediately south of village with vehicle tracks south along stream. 6. Truck Park, VG594209; Single parking lane. Truck Park, VG591204; Single parking lane extending around hill. Truck Park, VG545230; Series of short parking lanes on each side of Route 7. Truck Park, VG531243; Interconnecting single parking lanes. 10. Probable Storage/Support Area; VG511249; At least 3 partially concealed buildings and trail network under tree canopy at termini of two access roads. (Figure 2) 11. Possible Support Area, VG519263; 4 partially concealed huts being maintained at edge of abandoned village site. (Figure 3) Truck Park, VG481278; Three short parking lanes. 12. Vehicle Support Facility, VG386303; Four buildings and several 13. short parking lanes (Figure 8) 14. Truck Park, VG322307; Single Parking lane. Truck Park, VG302333; Single parking lane. 15. Truck Park, VG286370; Series of short parking lanes on each side 16. of Route 7. 17. Truck Park, VG224400; Single parking lane (Figure 10). Truck Park, VG210396; Single parking lane. 18. Truck Park, VG200409; Single parking lane. 19. 20. 25X1D Truck Park, VG191417; Single-Loop parking lane.

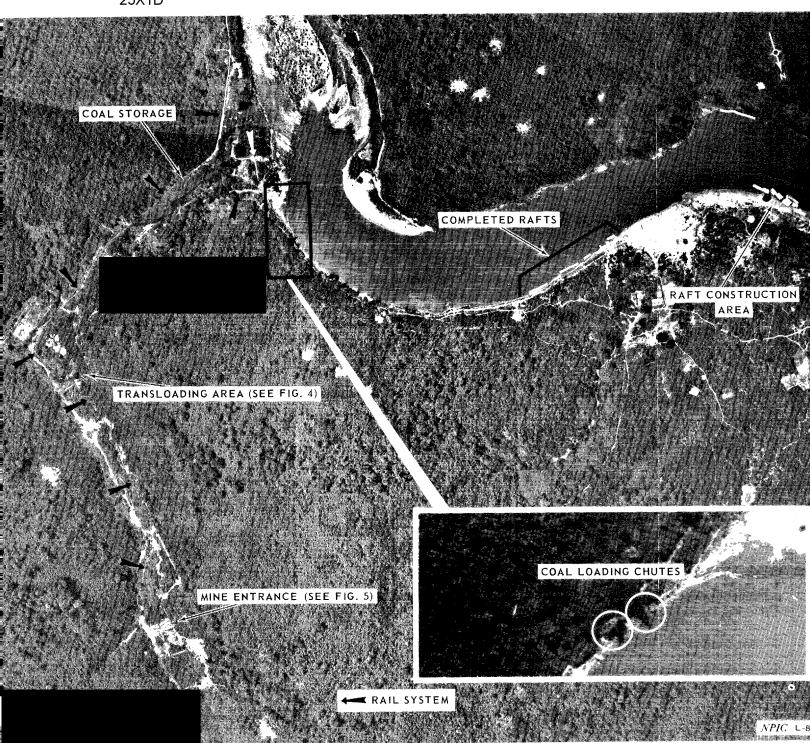
FIGURE 6. COAL MINE, BAN XA MU, NORTH VIETNAM

- 25X1D 1. Lignite Coal Mine, Located on the east bank of the Song Ca (River) north of Route 7, this small horizontal-shaft mining operation utilizes two entrances, one of which incorporates a double transloading transportation system between extraction and the stockpile. This rail system also extends between the stockpiles to two coal loading chutes on the bank of the river. Raft construction is observed adjacent to the mine on the same river bank. Upon construction the rafts are coal loaded and apparently floated downstream toward Vinh. (Figures 4-7)
- 25X1D 2. Transshipment Area, An access road extends

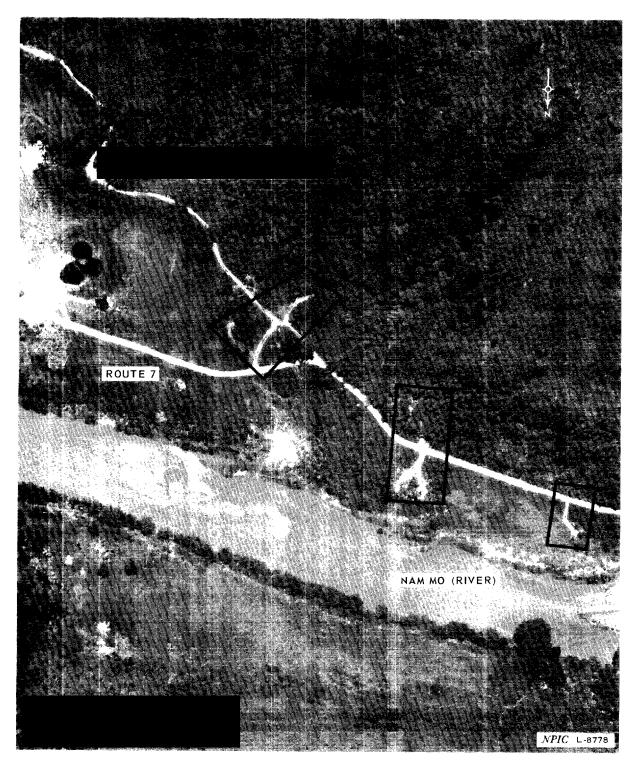
FIGURE 11. SINGLE LANE TRUCK PARKS, ROUTE 7, NORTH VIETNAM

Truck Park, VG185418; Short parking lanes on each side of Route 21. 22. 7 (Figure 11) 23. 25X1D

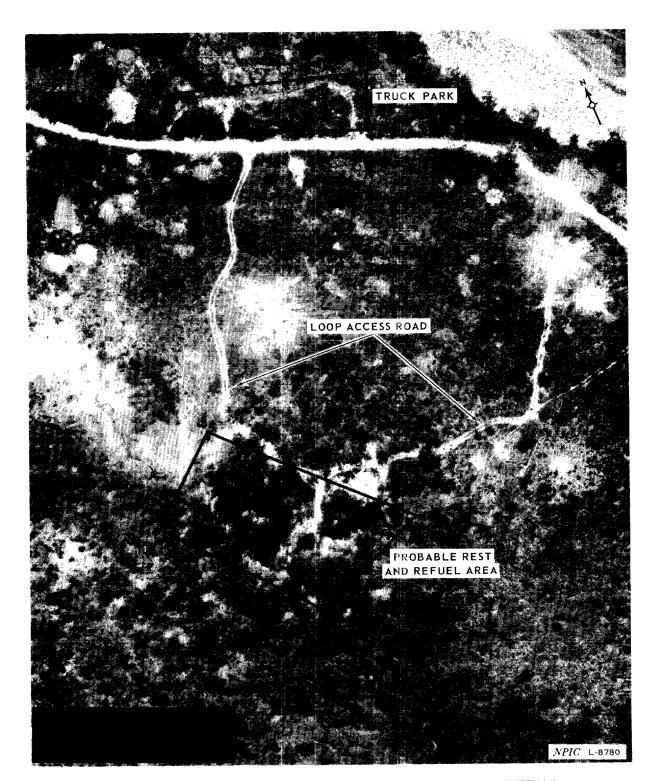
LIGURE 13. PROBABLE REST AND REFUEL AREA, HOUTE 7, NORTH VIETNAM

24. Probable Rest and Refuel/Area, VG148431; Well-used loop road south of Route 7 through the rest area. Single parking loop north of Route 7 (Figure 13)

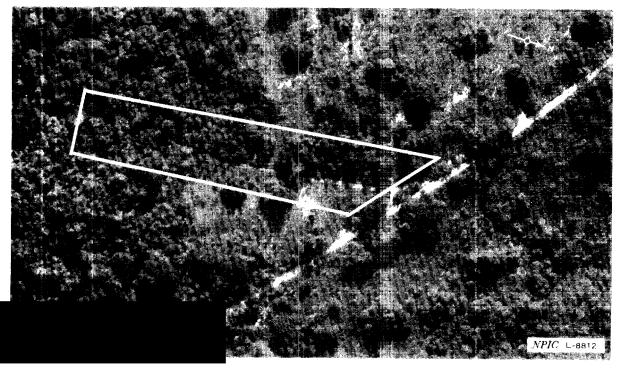
FIGURE 24. SINGLE LANE TRUCK PARK, HOUTET, LAOS

- Truck Park, UG538672; Single parking lane (Figure 24). 51.
- Truck Park, UG536677; Single parking lane. 52.

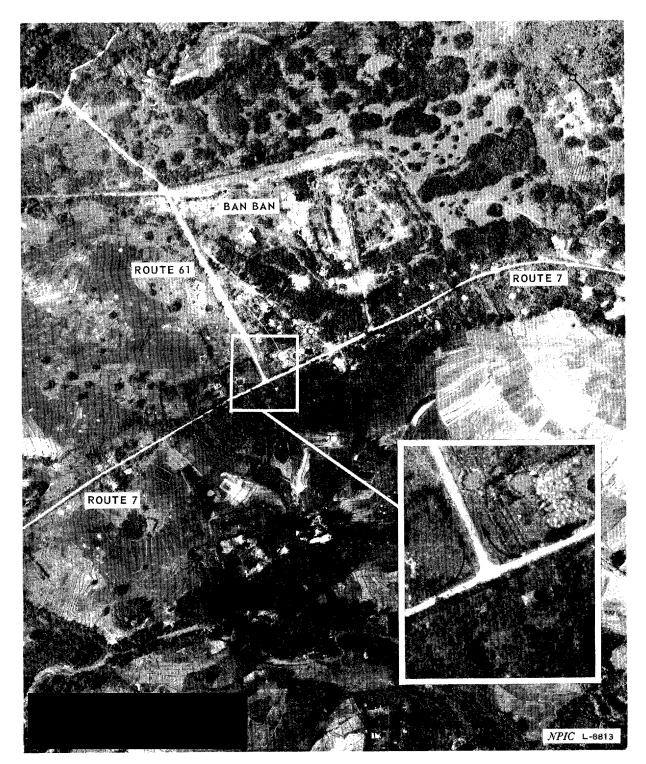
FIGURE 25. JUNCTION OF ROUTES 7 AND 61, BAN BAN, LAOS

Fifty-four facilities are dispersed along the road segment and their relatively small size indicates that they are used primarily in support of through traffic -- traffic which appears equally divided between continuing west from Ban Ban on Route 7 and proceeding north on Route 61 (Figure 25). No major storage facilities have been identified other than at Nong Het (Figure 18) and this area evidences a very low level of activity. Although unrelated to the vehicular movement along Route 7, the lignite coal mine at the eastern extremity of the study is included because of its location adjacent to the Route and its interest in general (Figures 4-7).
