PHOTOGRAPHIC INTELLIGENCE REPORT

NAN-NING AMMUNITION DEPOT NORTHEAST, CHINA

CIA/PIR 63051

DATE JUNE 1966

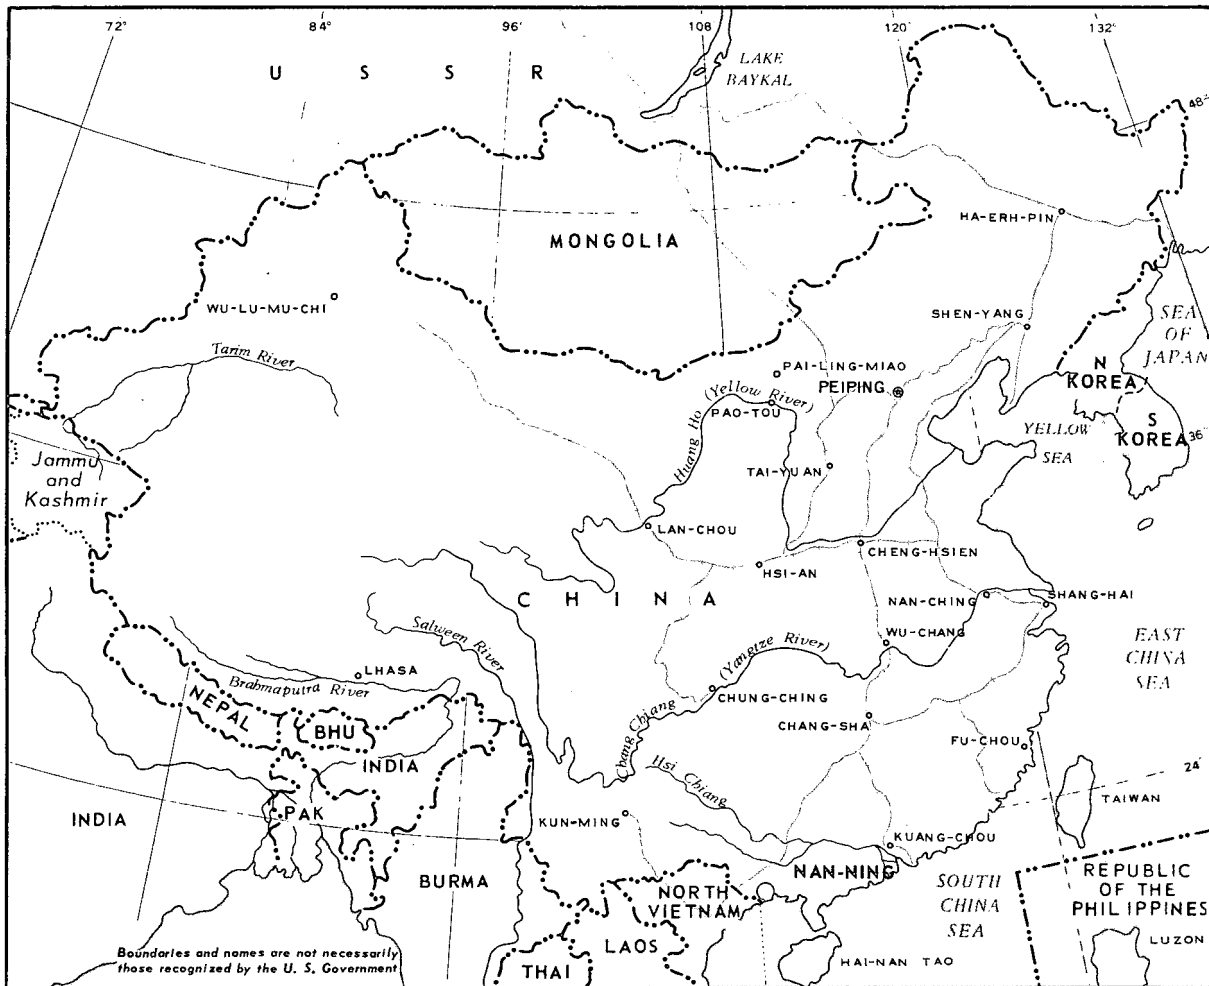
FIGURE 1.

A previously identified munitions storage site is located at 22-50N 108-22E, 3.5 nautical miles northeast of Nan-ning, China (Figure 1). The site is road served only.

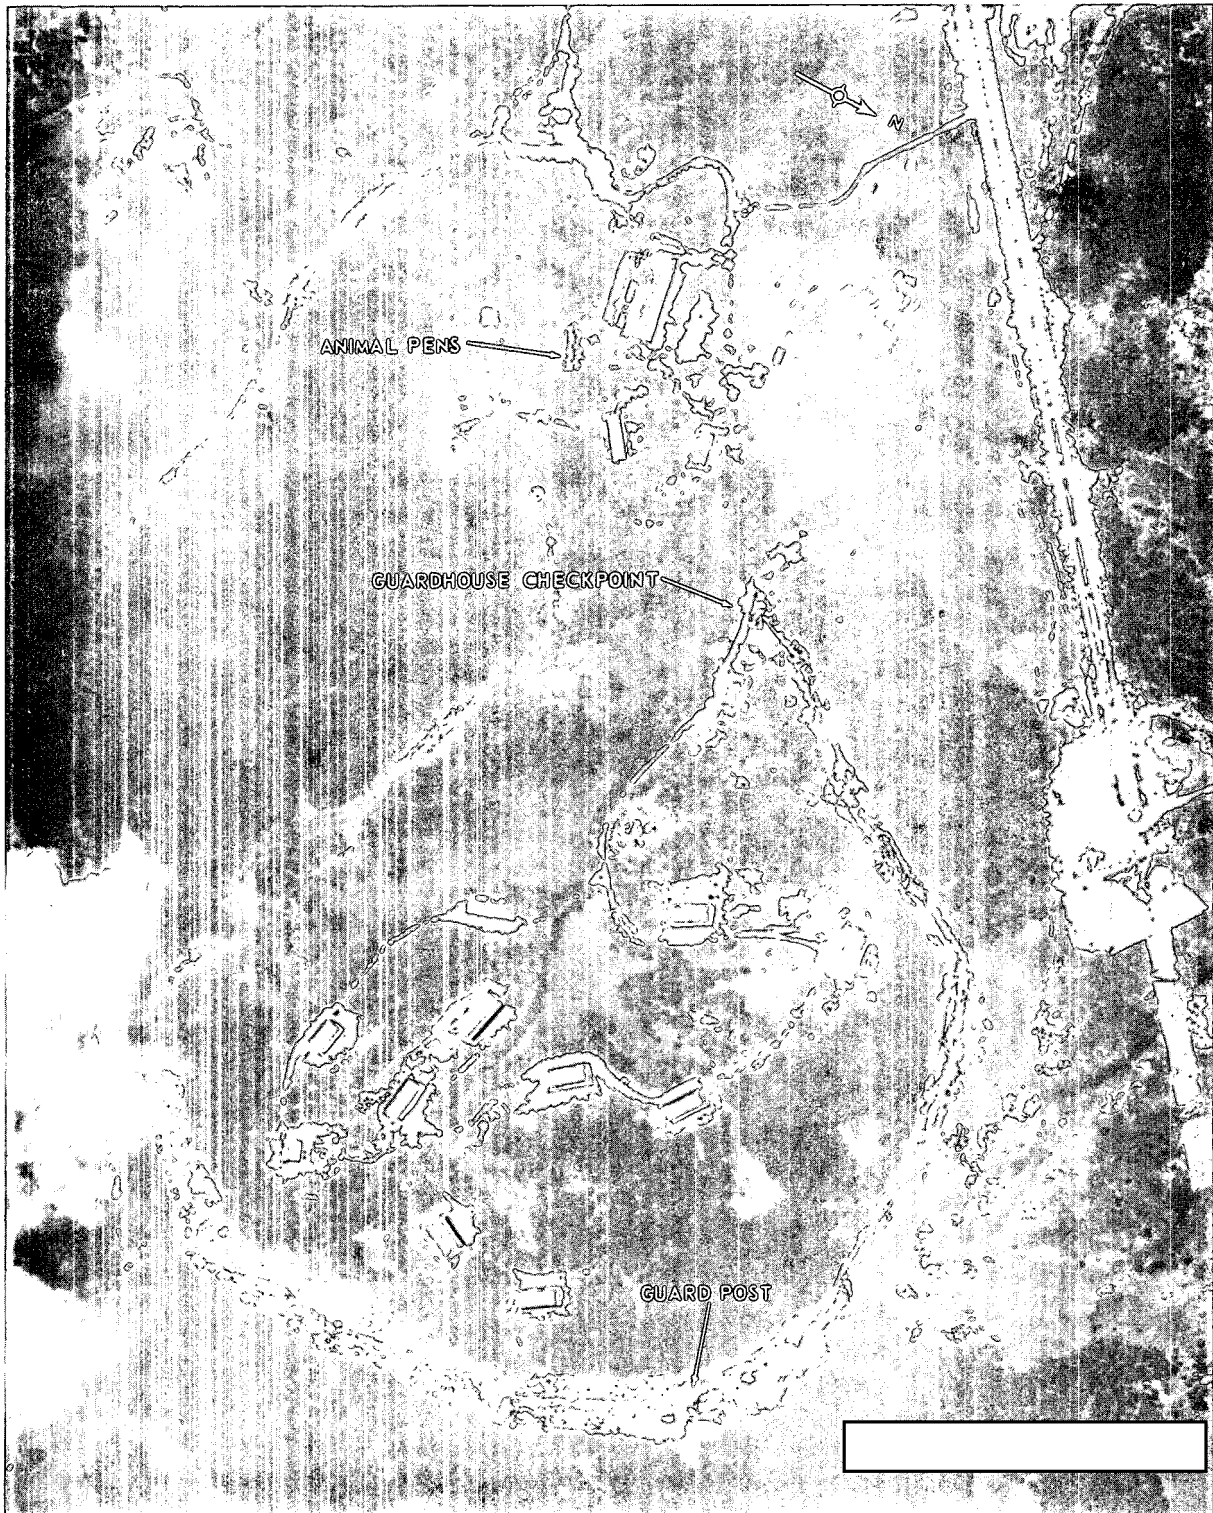
FIGURE 2. NAN-NING AMMUNITION DEPOT NE, CHINA

The storage area is secured by a single fence located within a cleared strip which varies in width from about 50 to 150 feet. A guardhouse/checkpoint is located at the entrance to the storage area. A small building serving as a guard post is located at a high point just outside the fence in the eastern portion of the site (Figure 2). Patrol paths are visible around the entire perimeter of the storage area.

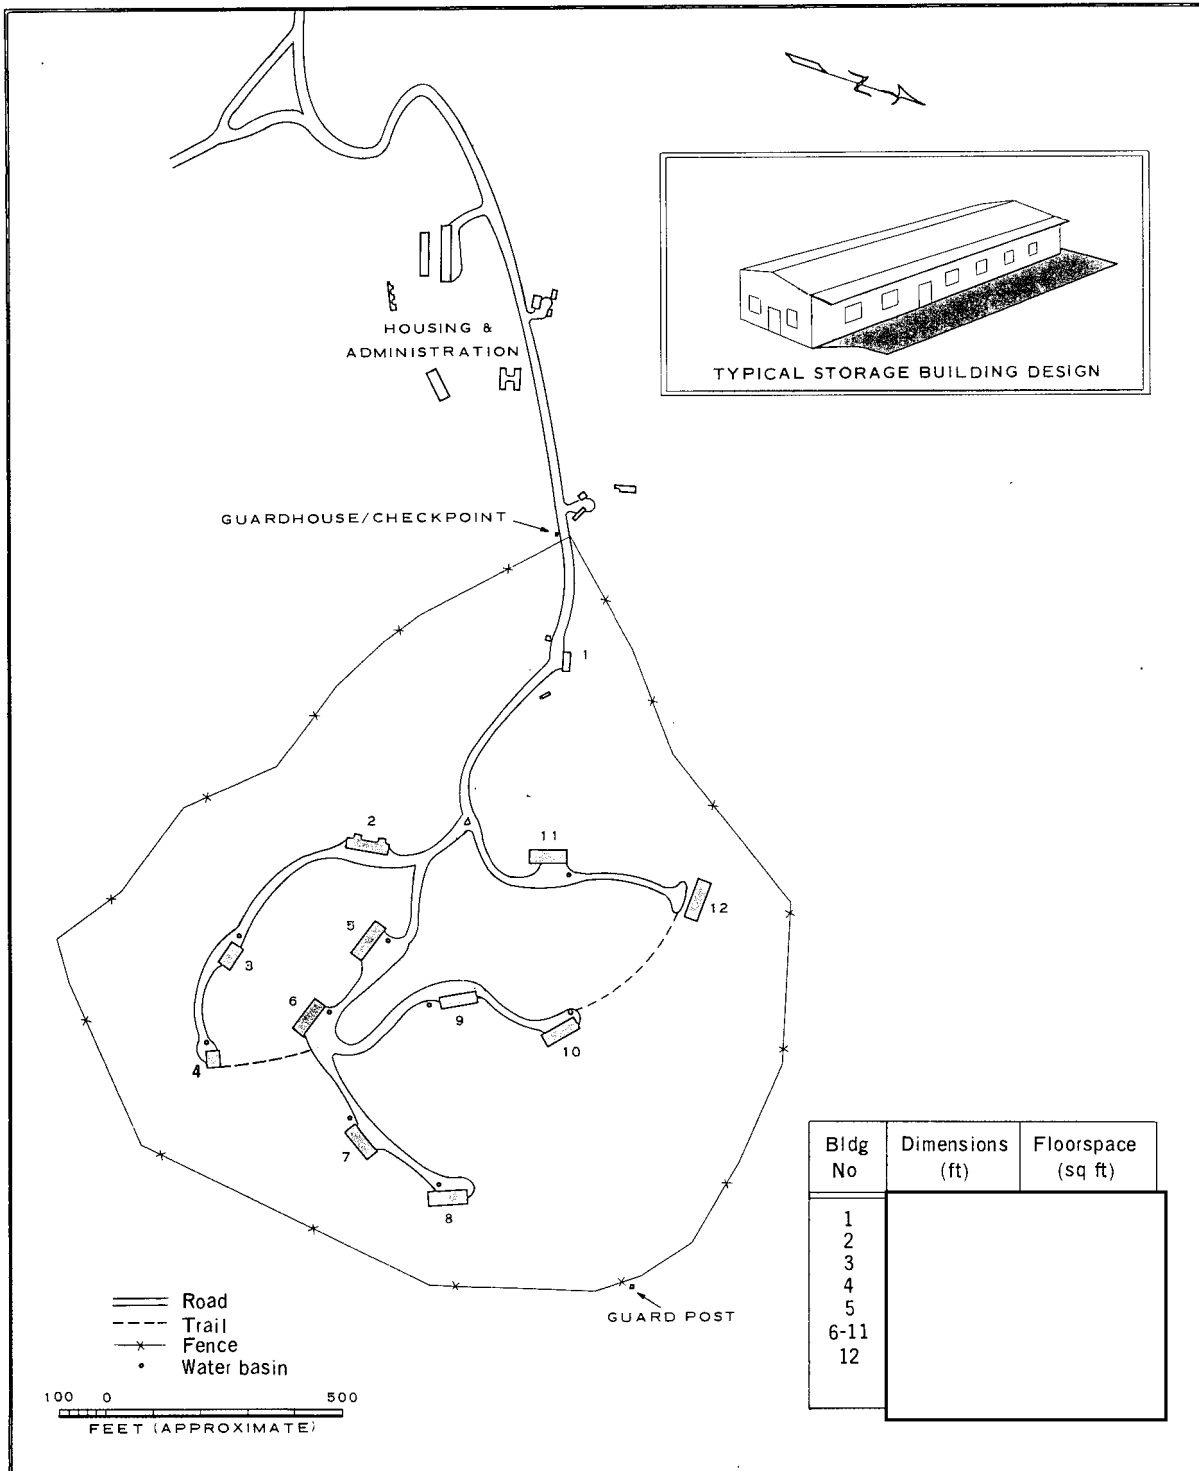
FIGURE 3. NAN-NING AMMUNITION DEPOT NE, CHINA.

Facilities in the storage area include 10 gable-roofed storage buildings (Items 3-12, Figure 3), 2 storage/support buildings (Items 1 and 2, Figure 3) and 2 small support buildings located near Building 1.

Although there are 4 different sizes of storage buildings, the buildings have the same basic design (Inset, Figure 3). These buildings have an overhanging roof along the side facing the road. The roof of Building 5 also overhangs in the rear. Entrances are located at the front and at each end of the buildings (Inset, Figure 3). In addition, windows are located on all sides of the buildings. The total number of windows per building varies according to the size of the building, from 9 in the smallest building to 19 in the larger buildings.

One of the storage/support buildings (Item 2, Figure 3) has 2 separate roof extensions which project to its rear.

Water basins, probably for use in case of fire, are located near most of the storage buildings (Figure 3).
