CIA/PIR-77049

CIA IMAGERY ANALYSIS DIVISION

PETROVSKIY SHIPYARD

LENINGRAD, USSR

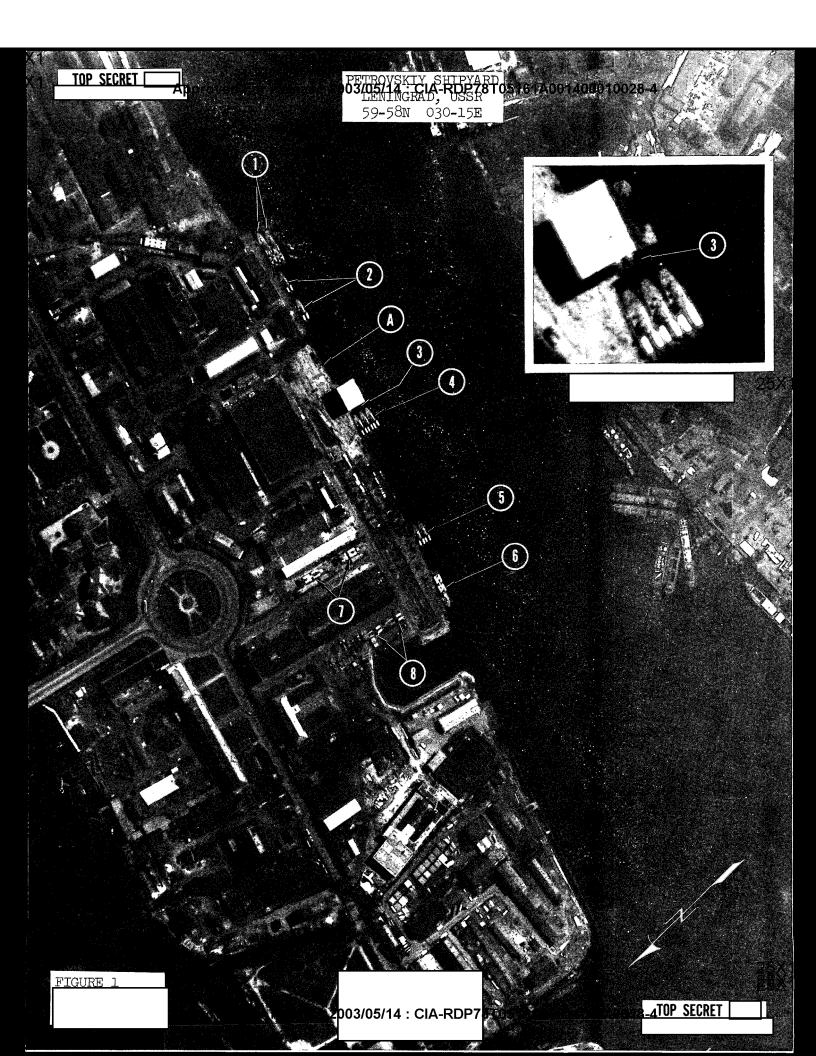
| | Approved For Release 2 ዋሪ መ 5 ታደር የይ ት-RDP78T05161A001400010028-4 |
|---|--|
| ı. | Two OSA Class PTFG alongside quay (LOA of each approx |
| 2. | Two KOMAR Class PTG alongside quay (LOA of each approx |
| 3. | Possible KOMAR Class PTG on ship lift (measurements undetermined). The probable stern and the after portion of two possible missile launched can be seen, when viewed in stereo with Frame 10 (Index 20), protruding from the west end of the ship lift structure (see inset). |
| 4. | Three KOMAR Class PTG moored near the west side of the ship lift (LOA of each |
| 5. | Two KOMAR Class PTG alongside quay (LOA of each |
| 6. | OSA Class PTFG alongside quay (LOA approx |
| 7. | Two OSA Class PTFG on open building/repair way (LOA of each See annotations 5 and 6, |
| 8. | Two KOMAR Class PTG out of water near side launching way (LOA of each See annotations 10 and 11, |
| Α. | Construction activity is visible on the quay and transverser between the ship lift and the large construction hall. Ground scarring is evident for a length of approximately 450 feet. Objects lying on the tracks of the transverser appear to render it inoperative for an additional distance of approximately 200 feet. At present the transverser appears to service only the area between the launching basin and the way containing the two OSA Class PTFG at annotation 7 above. |
