ATTACHMENT TO L-1101
06 JULY 1966
PAGE 1

ROAD CONDITIONS
PANHANDLE AREA, LAOS

NATIONAL PHOTOGRAPHIC INTERPRETATION CENTER
ROAD CONDITIONS
PANHANDLE AREA, LAOS

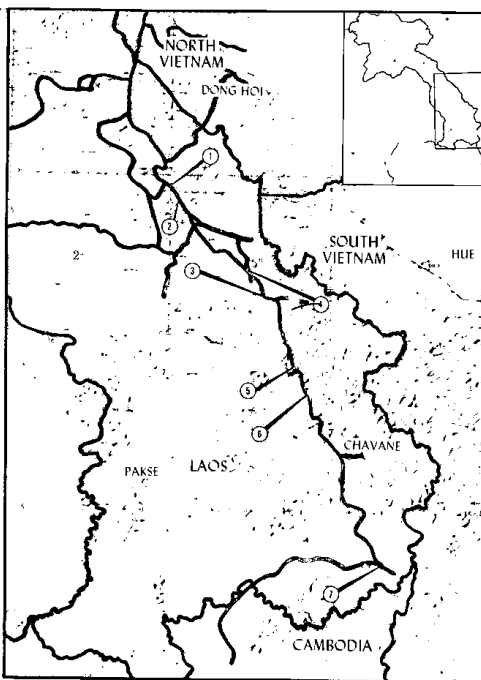
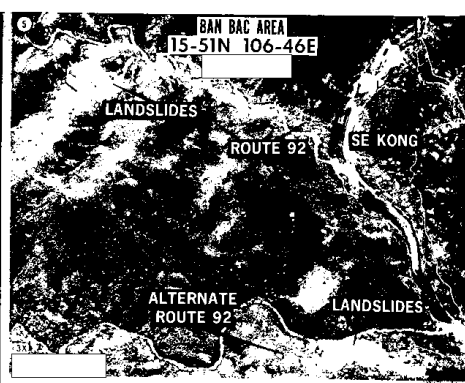
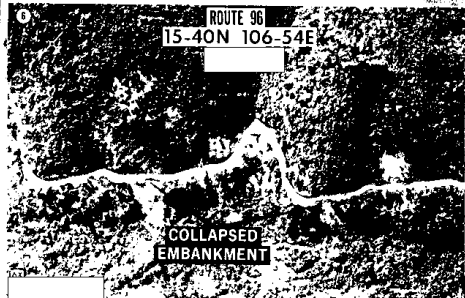
THIS BRIEFING BOARD DEPICTS ROUTES IN THE LAOTIAN PANHANDLE THAT HAVE BEEN RENDERED UNSERVICEABLE BY AIR STRIKES AND NATURAL DETERIORATION.

[REDACTED] REVEALS THAT ROUTE 911 HAS BEEN INTERDICTED AT THE FOLLOWING LOCATIONS (NOT ALL SHOWN ON GRAPHIC):

1702N 10558E	(UTM XD026842)
1701N 10555E	(UTM WD978818)
1659N 10555E	(UTM WD982795)
1655N 10559E	(UTM XD062717)
1653N 10601E	(UTM XD088670)

A TOTAL OF SIX DAMAGED/DESTROYED TRUCKS ARE OBSERVED ON ROUTE 911 AT 1655N 10559E.

[REDACTED] REVEALS THAT ROUTE 92 HAS BEEN INTERDICTED AT 1618N 10637E (UTM XD737026). IN THE AREA OF BAN BAC, NEAR THE SE KONG (RIVER), ROUTE 92 AT 1551N 10646E (UTM XC901538) AND ALTERNATE ROUTE 92 AT 1550N 10645E (UTM XC888523) ARE BOTH UNSERVICEABLE DUE TO NUMEROUS INTERDICTIONS AND LANDSLIDES.

[REDACTED] REVEALS A PARTIALLY COLLAPSED EMBANKMENT FROM WEATHERINGS ON ROUTE 96 AT 1540N 10654E (UTM YC033333), APPROXIMATELY TWELVE NM SOUTHEAST OF BAN BAC.

[REDACTED] DEPICTS INTERDICTION POINTS ON ROUTE 96/110 AT 1440N 10720E (UTM YB514236), APPROXIMATELY TWELVE NM WEST OF THE TRI-BORDER AREA OF CAMBODIA, LAOS, AND SOUTH VIETNAM.
