Approved For Release 2006/0 <u>3/16 : CIA-R60/N folds 50/0600020001-</u> 5		
(c) NATIONAL PHOTOGRAPHIC INTERPRETATION CENTER		
	REFERENCE: ATTACHMENT TO L-2337 28 NOVEMBER 1966 PAGE 1	
	SOVIET MERCHANT SHIP HAI PHONG ROADSTEAD, NORTH VIETNAM 2042N 10656E	25X1

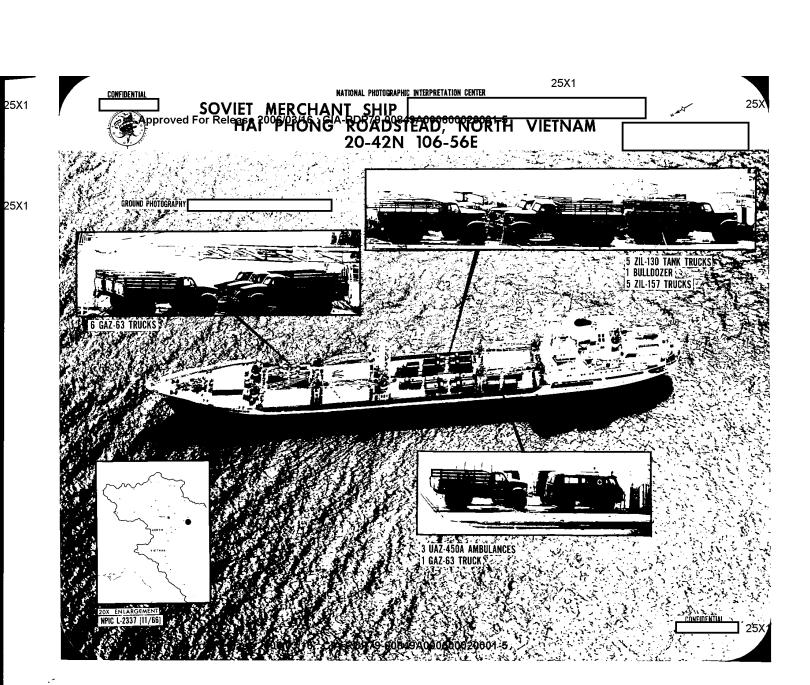
67-6-544

1.	SIGNIFICANCE:	
	PHOTOGRAPHY SHOWS A LARGE HATCH DRY CARGO	25X1
	FREIGHTER OF THE POLTAVA/PEREKOP CLASS, AT ANCHOR IN HAI PHONG ROADSTEAD.	
2.	LOCATION:	
	THE SOVIET MERCHANT SHIP IS "RIDING AT ANCHOR" IN THE CHANNEL OF THE	
	MOUTH OF THE CUA NAM TRIEU AT APPROXIMATELY 2042N 10656E.

3.	MISSION READOUT:	
	PHOTOGRAPHY FROM REVEALS THE SHIPS	25X1
	DECK CARGO TO CONSIST OF SEVEN GAZ-63 CARGO TRUCKS, FIVE ZIL-130 TANK	
	TRUCKS, FIVE ZIL-157 CARGO TRUCKS, AND THREE UAZ-450A AMBULANCES.	
		25X1
	SHOWS A PORTION OF THE DECK CARGO AND WAS OBTAINED AS THE SHIP PASSED	
	THROUGH THE SUEZ CANAL. A PARTIALLY CRATED BULLDOZER OF AN UNDETERMINED	
	TYPE SEEN IN THE INSERT IMMEDIATELY AFT OF THE TANK TRUCKS DOES NOT APPEAR	
	AS DECK CARGO ON THE BULLDOZER MAY HAVE BEEN OFF-LOADED	
	WHEN THE SHIP DOCKED AT KRUNG THEP (BANGKOK), THAILAND, OR IT MAY HAVE	
	BEEN TRANSFERRED TO ONE OF THE HOLDS.
