Basic Imagery Interpretation Report

Belogorsk Tactical SSM (SCUD) Barracks and Storage AL-5 Belogorsk, USSR

RCS 07/0077/69

25X'
DATE 0CTOBER 1968

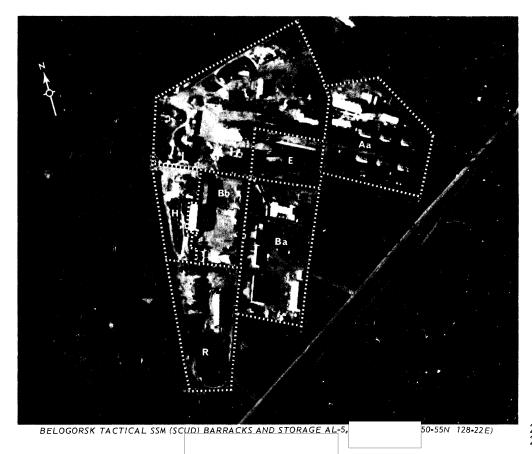
——— A _l	proved For Release 2008/06/25 : CIA-RDP79T00909/	4000200010039-2	25X1
	TOP SECRET RUFF		2071.
	IMAGERY ANALYSIS SERVICE		25X1
	BELOGORSK TACTICAL SSM (SCUD) BARRACKS AND	STORAGE AL-5*	
LOCATION:	3.7 nautical miles west of Belogorsk		
FUNCTIONA	ANALYSIS: (Functional analysis and vehicle	count derived from KH	25 X 1
Aa.	Barracks/Administration Area		
	<pre>1 Two/three-story barracks/administration building 1 Two-story barracks 1 One/two-story barracks 6 Probable quarters 1 Quarters 2 Probable storage buildings 5 Support buildings</pre>		25X1
Ab.	Barracks and Administration Area		
	1 T-shaped administration building	145 x 20 (base)	25X1
	2 Two-story barracks		
	3 Possible quarters 1 Long narrow support building 5 Small support buildings 1 Water tower		
Ba.	Vehicle Storage/Maintenance Area		
	3 Vehicle sheds	1 - 120 x 60 1 - 125 x 45	
	1 Drive-through vehicle maintenance building		25X1
	3 Small support buildings

<u>Vehicles</u>		
	7 Possible vehicles3 Unidentified vehicles		
Bb.	Vehicle Storage/Maintenance Area		
	3 Vehicle sheds		25X1
	l Vehicle maintenance building l Support building		
	Vehicles		
	l Possible cargo truck 4 Unidentified vehicles		
SCUD un	stallation cannot be confirmed from photograp it. No SCUD equipment has been identified an may be SCUD-related is the arch-roofed buil	d the only facil-

- IMAGERY ANALYSIS SERVICE
- E. Athletic Field and Obstacle Course
- H. Support Area
 - 2 Small support buildings
- R. Unidentified Area
 - 1 Arch-roofed building

- 3 Small support buildings 4 Small unidentified objects
