ROUTE 92 STATUS
BAN BAC AREA, LAOS1. SIGNIFICANCE:

THIS BRIEFING BOARD DEPICTS THE STATUS OF ROUTE 92 AND AN ALTERNATE ALIGNMENT OF ROUTE 92 IN THE BAN BAC AREA OF LAOS.

ROUTE 92 STATUS BAN BAC AREA, LAOS

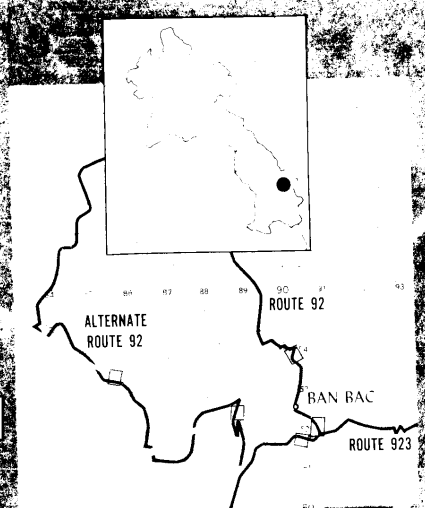
ALTERNATE ROUTE 92, PREVIOUSLY REPORTED AS BEING CLOSED (NPIC CABLES CITE 7072, DTG 302244Z, APRIL 1966, AND CITE 7113, DTG 040219Z, MAY 1966) TO AGAIN BE CLOSED AS A RESULT OF LANDSLIDES AND THE COLLAPSE OF THE ROAD EMBANKMENT AT 1550N 10645E (UTM XC888523). THERE IS NO APPARENT ATTEMPT BEING MADE TO REMOVE THE DEBRIS OR TO RESTORE THE COLLAPSED ROADBED.

ROUTE 92 IS CLOSED BECAUSE OF RECENT AIR STRIKES THAT HAVE RESULTED IN LANDSLIDES AT 1551N 10646E (UTM XC901538), 0.6 NM NORTH OF BAN BAC. THERE IS NO REPAIR WORK NOTED.

A PREVIOUSLY REPORTED FORD (NPIC CABLE CITE 6881, DTG 082314Z, APRIL 1966) CROSSING THE SE KONG (RIVER) AT 1550N 10647E (UTM XC908522) SHOWS NO SIGNS OF RECENT VEHICULAR USE AND APPEARS UNSERVICABLE DUE TO HIGH WATER AND BOMB CRATERS IN THE VICINITY.

EIGHT NEWLY OBSERVED DESTROYED TRUCKS ARE NOTED IN A TRUCK PARK AT 1551N 10644E (UTM XC857533) 1.6 NM NORTHWEST OF THE CLOSED SEGMENT OF ROUTE 92 ALTERNATE. SIX NEWLY OBSERVED DESTROYED TRUCKS ARE ALSO OBSERVED ON BOTH SIDES OF ROUTE 923, 0.3 NM SOUTHWEST OF THE UNSERVICEABLE FORD.

DAMAGED/DESTROYED TRUCK
