AGTR 4 (ex-AG 167) BELMONT (ex-Iran Victory)  
AGTR 5 (ex-AG 168) LIBERTY (ex-Simmons Victory)

*The Israeli Attack on the USS Liberty*

The Israeli Attack on the USS Liberty

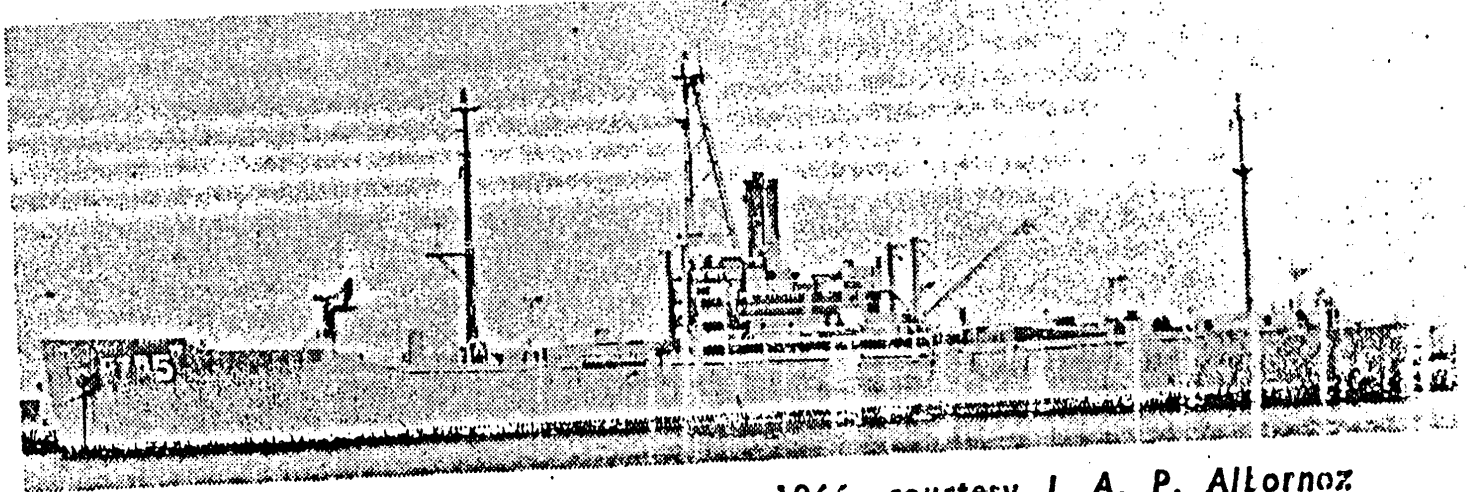
LIBERTY

Displacement: 7,190 tons light (10,680 tons full load)  
Dimensions: 455 (o.a.) $\times$ 62 $\times$ 24 feet  
Machinery: Turbine. S.H.P.: 8,500=18 kts.  
Complement: 280

Modified "Victory" ships. Conversion completed by Willamette Iron & Steel, Portland, Ore., in Sep. and Dec., commissioned 2 Nov. and 30 Dec. 1964, respectively. Mobile bases for research in communications and electromagnetic radiation.
