CORONA PROGRAM HISTORY

VOLUME I

PROGRAM OVERVIEW

19 May 1976

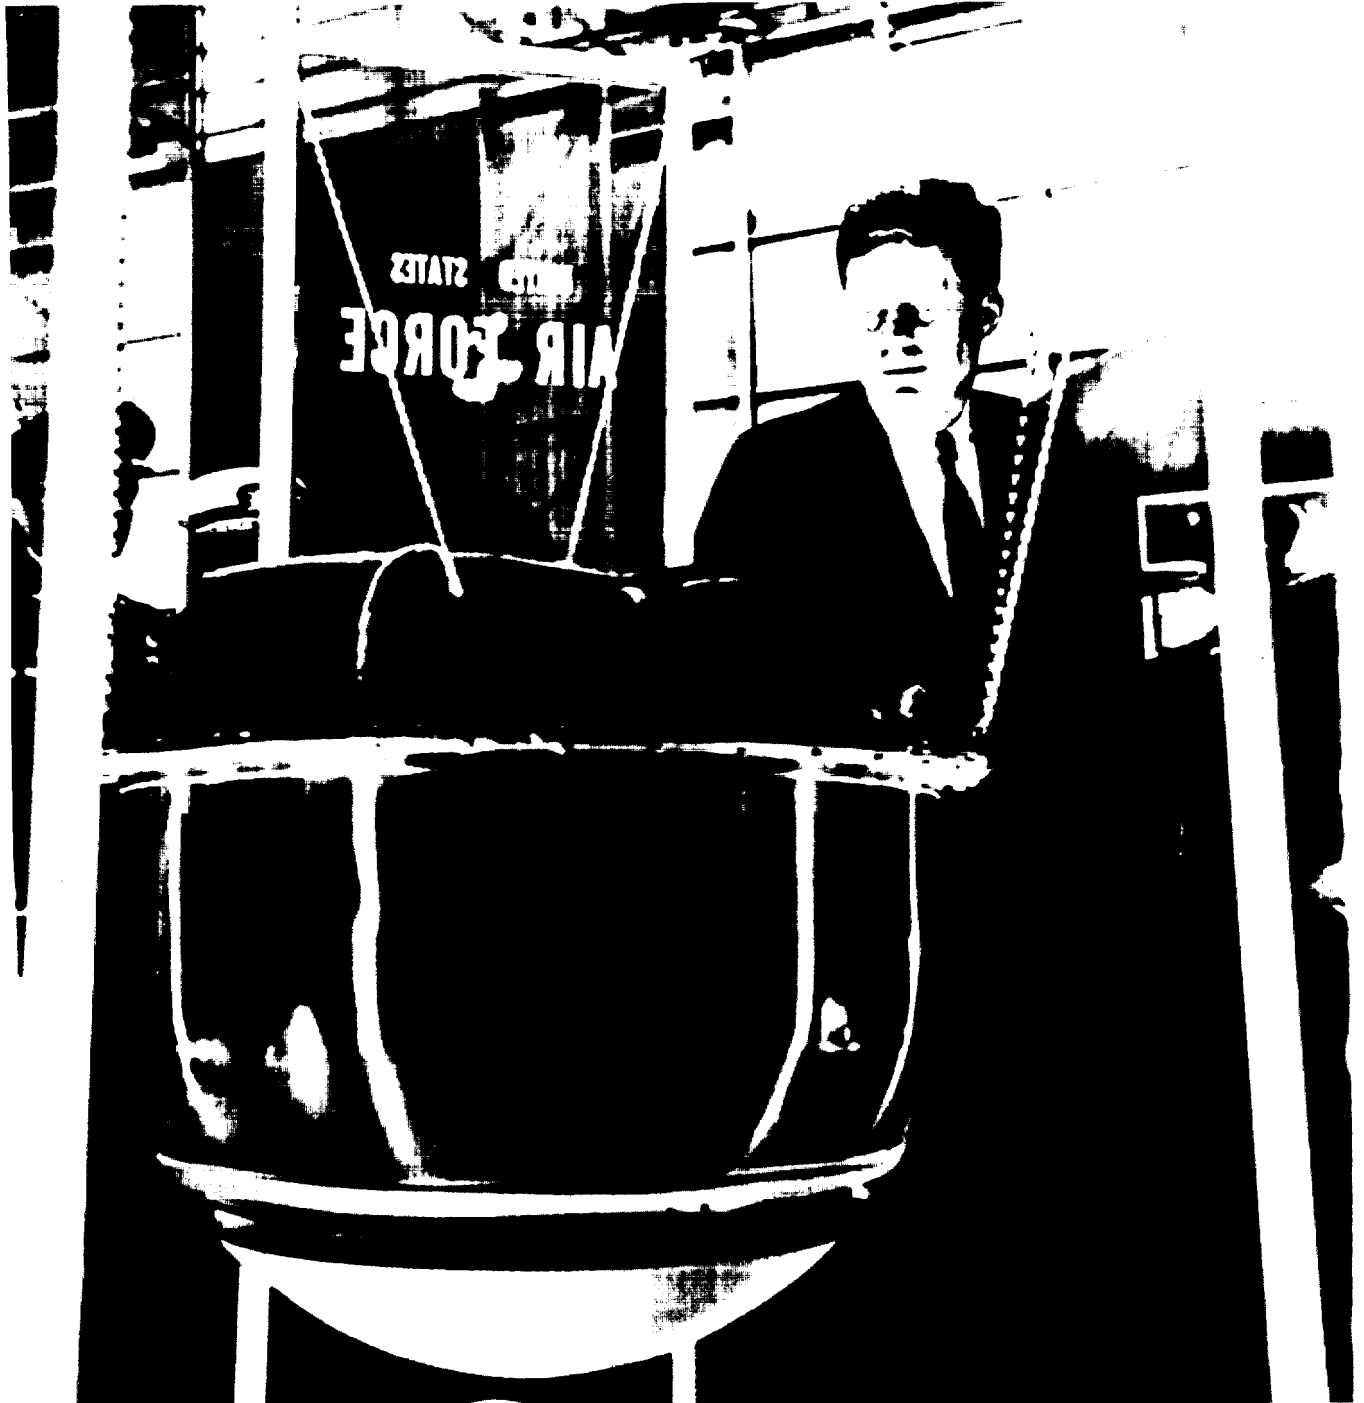
Figure 6-2

ANOTHER FIRST - FILM RECOVERED

Captain Harold E. Mitchell of the 6593rd Test Squadron piloting a C-119 (flying boxcar) called Pelican 9 and crew successfully hooked the descending capsule on his third pass. Upon arrival at Hickam Air Force Base, Hawaii, Captain Mitchell was decorated with the Distinguished Flying Cross and members of his crew were awarded the Air Medal for their accomplishments. Ironically, Captain Mitchell and the Pelican 9 had been one of the primary recovery aircraft for DISCOVERER XIII; however, failure to make an aerial recovery on this mission relegated them to a backup position for DISCOVERER XIV. Figure 6-1 is a photograph of Captain Mitchell, another crew member, and the Pelican 9. A photograph of then Senator Kennedy viewing the DISCOVERER XIV capsule on display at Vandenberg AFB is presented as Figure 6-2.

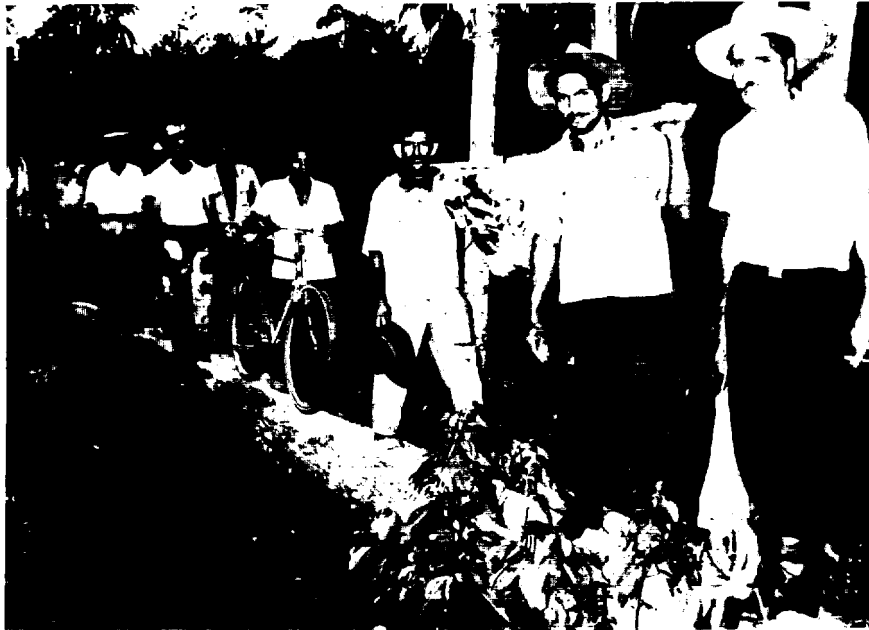
Figure 8-1

SRV being carried out of La Fria on foot by Campesinos.

Sold to the U. S. Air Force

The story rated only a dozen lines in the New York Times of August fifth, but the local Venezuelan press had a field day. Diario Catolico, of San Cristobal, along with a lengthy report, published three pictures of the capsule showing the charred roll of film on the takeup spool. The photographs are reproduced in Figure 8-1. The Daily Journal handled the story in lighter vein with this parody of Longfellow:
