DEVELOPMENT OF THE

LOCKHEED SR-71 BLACKBIRD

Clarence L. Johnson Senior Advisor Lockheed Corporation

J58/SR-71 PROPULSION INTEGRATION
OR
THE GREAT ADVENTURE INTO THE TECHNICAL UNKNOWN

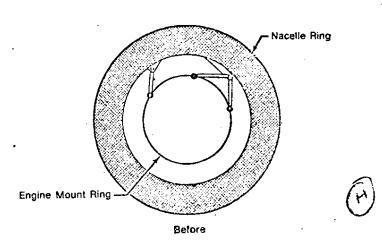
Figure 7. Engine Mount

Originally, the engine was mounted on a stiff rail structure at the top of the nacelie with a stabilizing link from the top of the engine rear mount ring to the aircraft structure as shown in Figure 7. To solve the crushing problem Pratt & Whitney Aircraft redesigned the rear mount ring so that a tangential link could be installed between the engine and the outboard side of the nacelle. This maintained a finite distance between the nacelle and engine under all conditions. See Figure 8.

A mounting-related problem occurred under certain conditions of down load on the wing. At at these conditions, the outer half of the nacelle would rotate into the engine and crush the engine plumbing and anything else in the way.
