CIA IMAGERY ANALYSIS DIVISION		
COUNTRY	COORDINATES	
North Vietnam	22 09N/104 23E VK 368493	
	BRIEF NO:	
	COUNTRY

LOCATION: 0.5 nm NE of Lang Bun on the Hanoi - Lao Cai Rail Line

CIA IMAGERY ANALYSIS DIVISION COUNTRY COORDINATES Lang Bun R. R. Bridge 22 09N/104 23E Bridge No. 1 on NF 48-6 North Vietnam VK 368493 BRIEF NO: MAP <u> AMS L509 NF 48-6</u> PIB - 65002

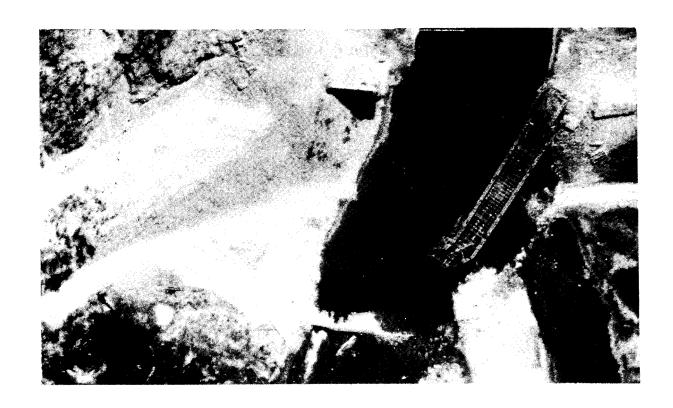
STATUS: Span destroyed, one abutment destroyed

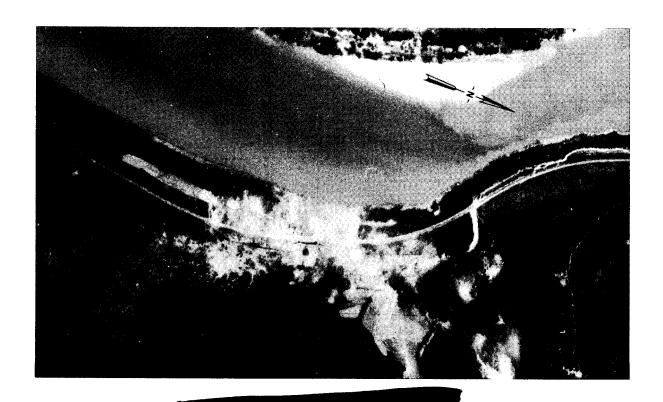
Span partially damaged; approaches interdicted.

None.

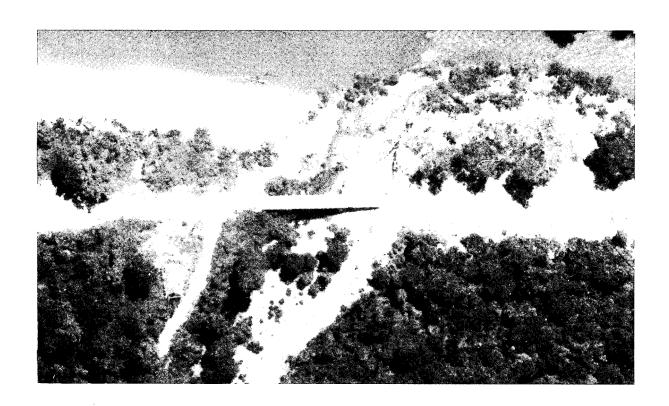
CIA IMAGERY ANALYSIS DIVISION NAME COUNTRY COORDINATES			
	Ban Ta Xa Hwy. Bridge Bridge No. 15 on NE 48-2	North Vietnam	19 18N - 104 20E VG 305334	
25X1	MAP AMC TEOO NE /		BRIEF NO: PIB - 65088 October 1965	-
	AMS 1509 NE Z			······································
25X1	LENGTH WIDTH TYPE Deck	MATERIAL CON NO. OF SPANS 3 LENGTH OF EACH SPAN	crete	25X
	status: One end of one span	dropped, one abutment dama	ged.

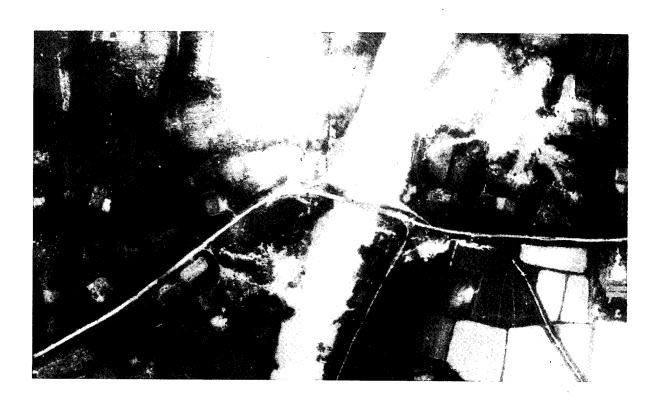
2 spans severely damaged

None

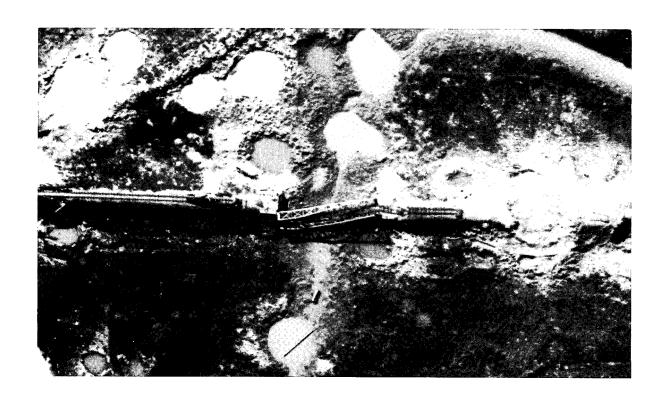
STATUS: Severely damaged, Bridge twisted and off abutment on one end.

Unserviceable

COMPENSATIVE ACTION: None

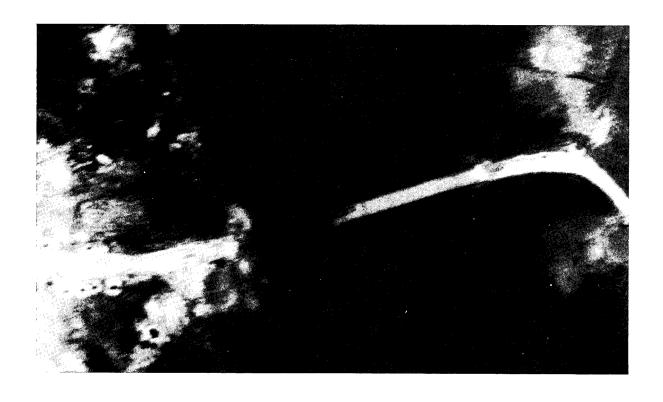
STATUS: Approximately 70' of bridge dropped. Bridge is unserviceable.

compensative action: None

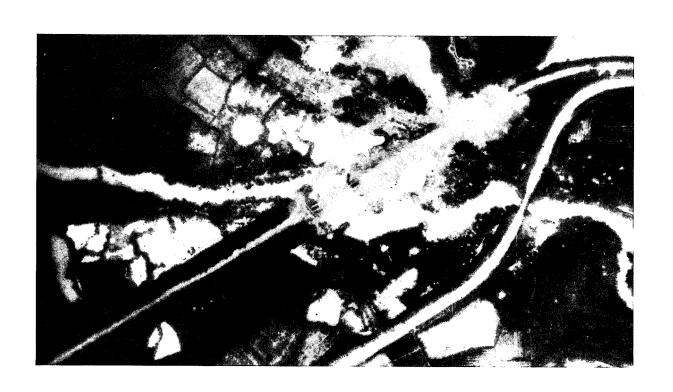
CIA IMAGEF	RY ANALYSIS DIVIS	ION		
•	NAME		COUNTRY		COORDINATES	
		R.R. Bridge . 18 on NE 48-3-18	North Vietnam		19 09N 105 36E WG 643 186	
25X1					BRIEF NO:	
20/(1					PIB - 65135	
		MS L509 NE 48-3			October 1965	
25X1	DESCRIPTION: LENGTH WIDTH TYPE	7 N.M. E. of Ngoc Diem on Deck			nd concrete y 3	25X1
		Heavy damage to all spans to be intact.	s, one abutment	damaged,	, piers appear

Adjacent ford

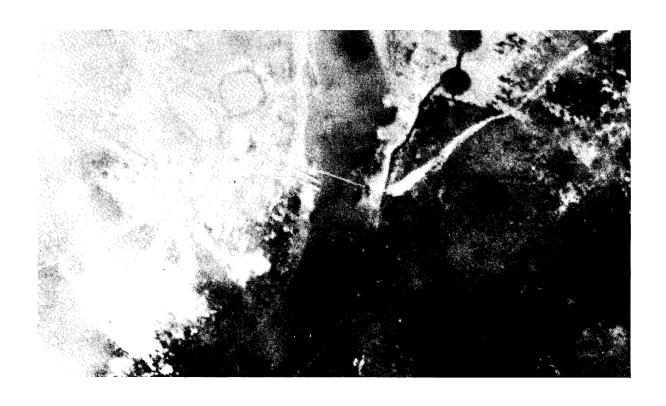
Competely destroyed

compensative action: None

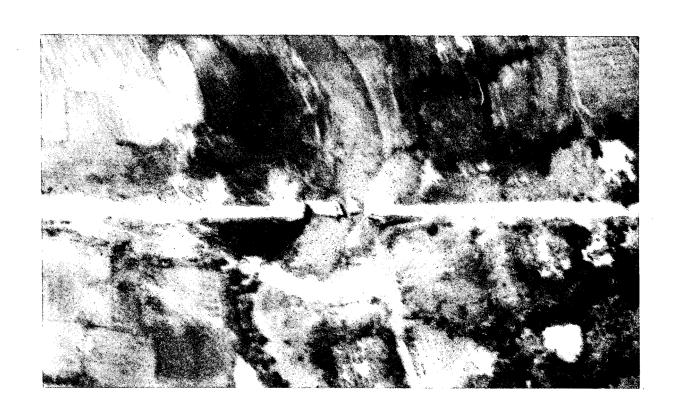
Two spans destroyed, one pier damaged, abutments intact, bridge unserviceable.

Ford
